**Thames
Tideway Tunnel**

Environmental Statement

Volume 3: Project-wide effects assessment appendices

E.1 Building damage assessment Stage 3 report – Listed Buildings

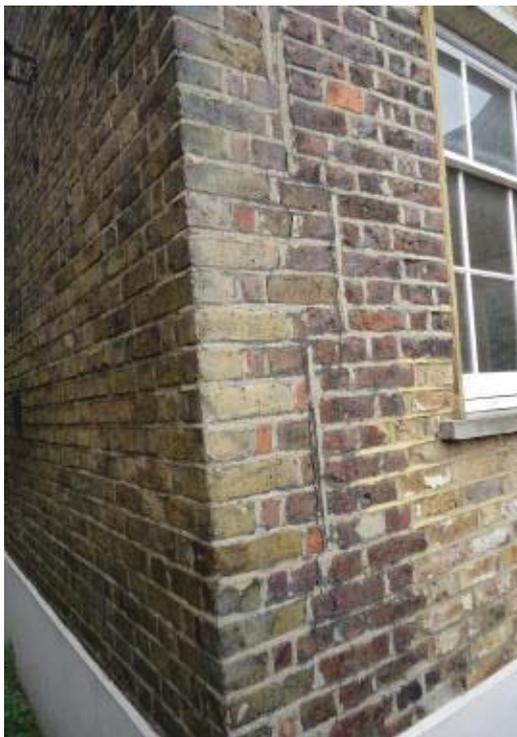
Water damage and vegetation due to faulty down-pipe

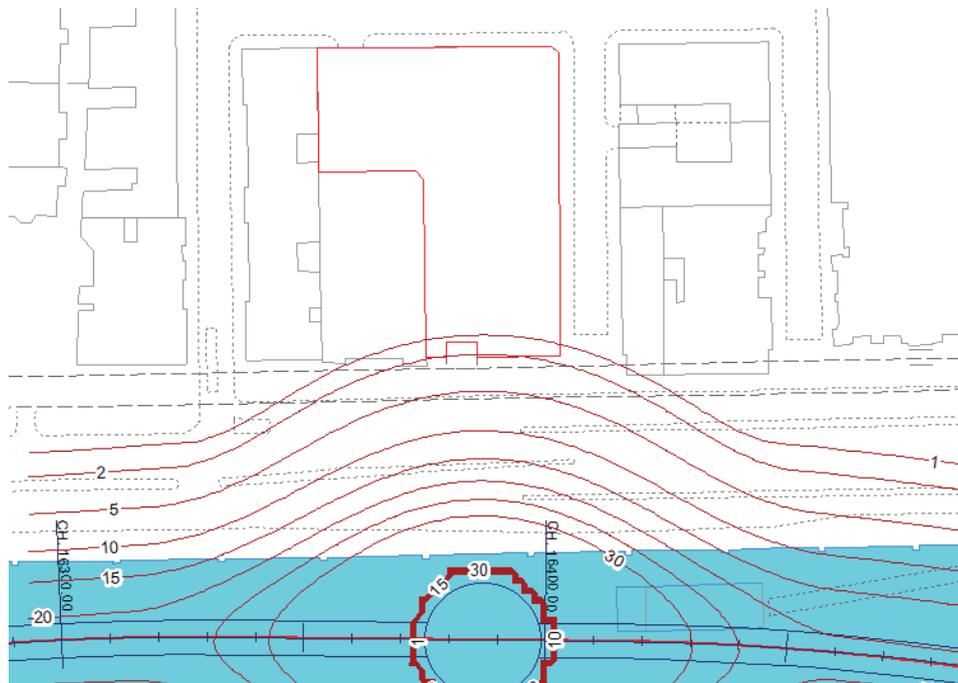
Settlement contours generated at +82.03mTD, at 2/3 depth of assumed 25m long piles;

As shown above the building extends to the 2mm settlement contour. However the method of modelling used for the shaft in the Xdisp model is considered to be conservative (giving the shaft a greater influence on ground movement).

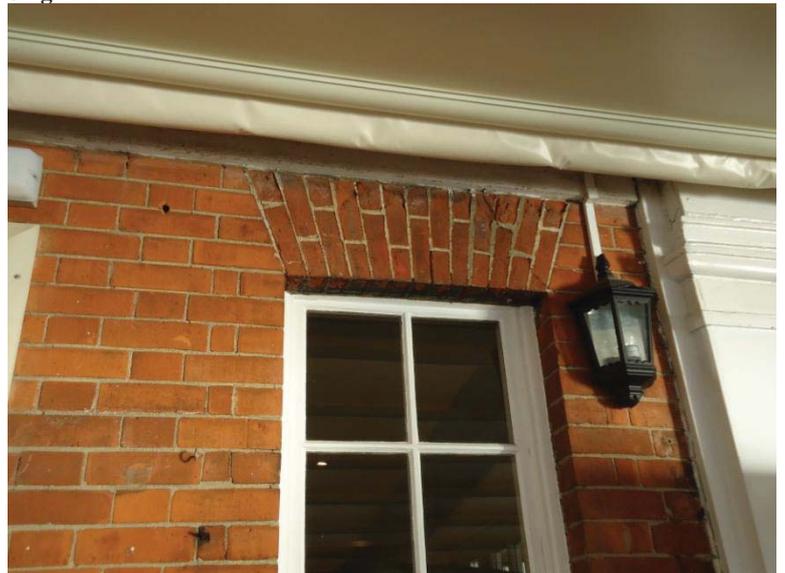
Brick arch with cement mortar and some brickwork failure

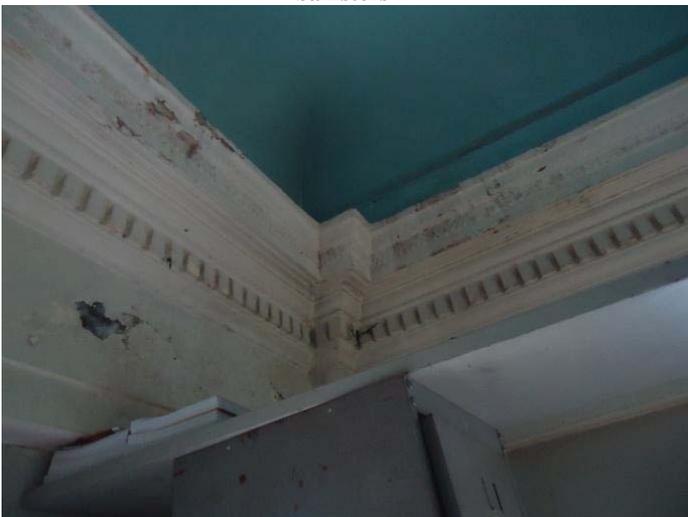
Damage from water ingress to the plasterwork of the main hall

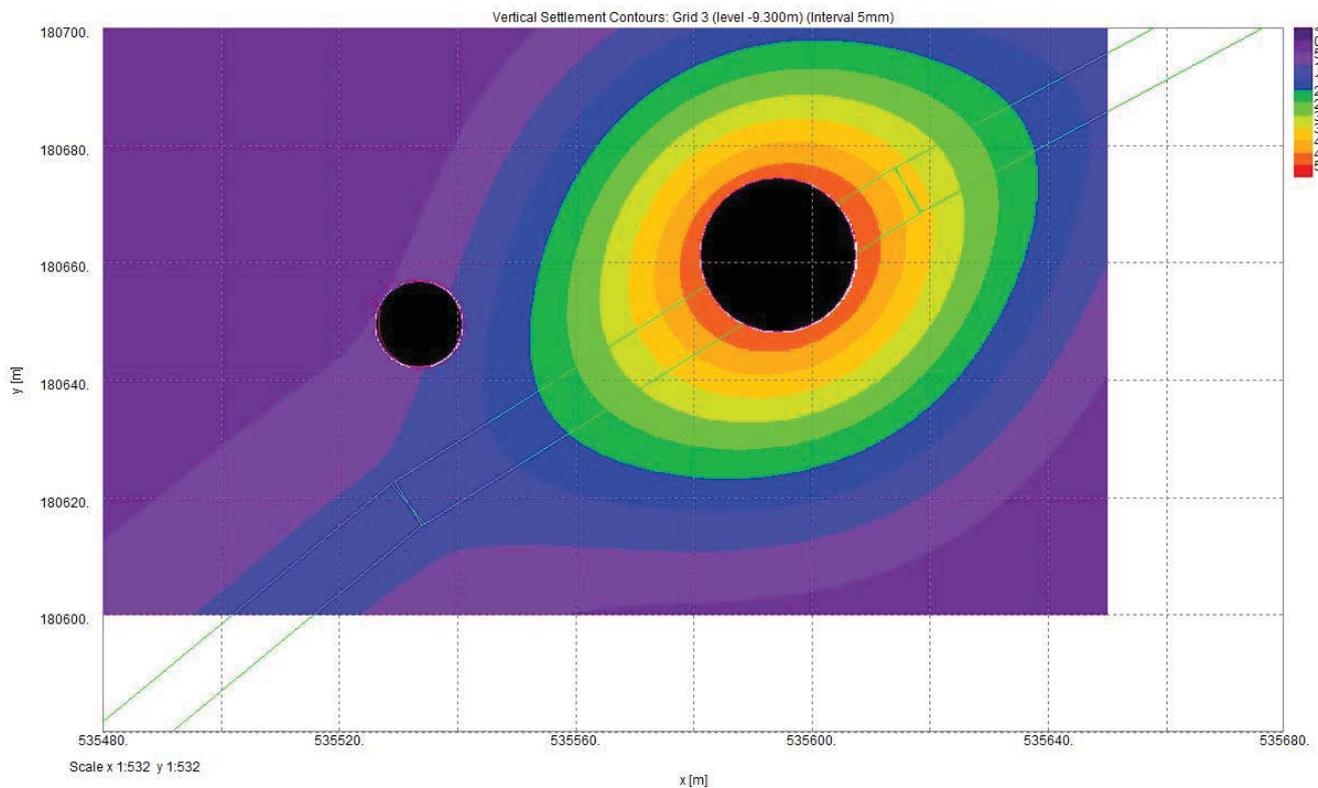
Settlement contours at +92.7mTD (at shaft base):

The results fall within category 0, risk of negligible damage, with a maximum tensile strain of 0.036% and maximum settlement of 12.2mm.

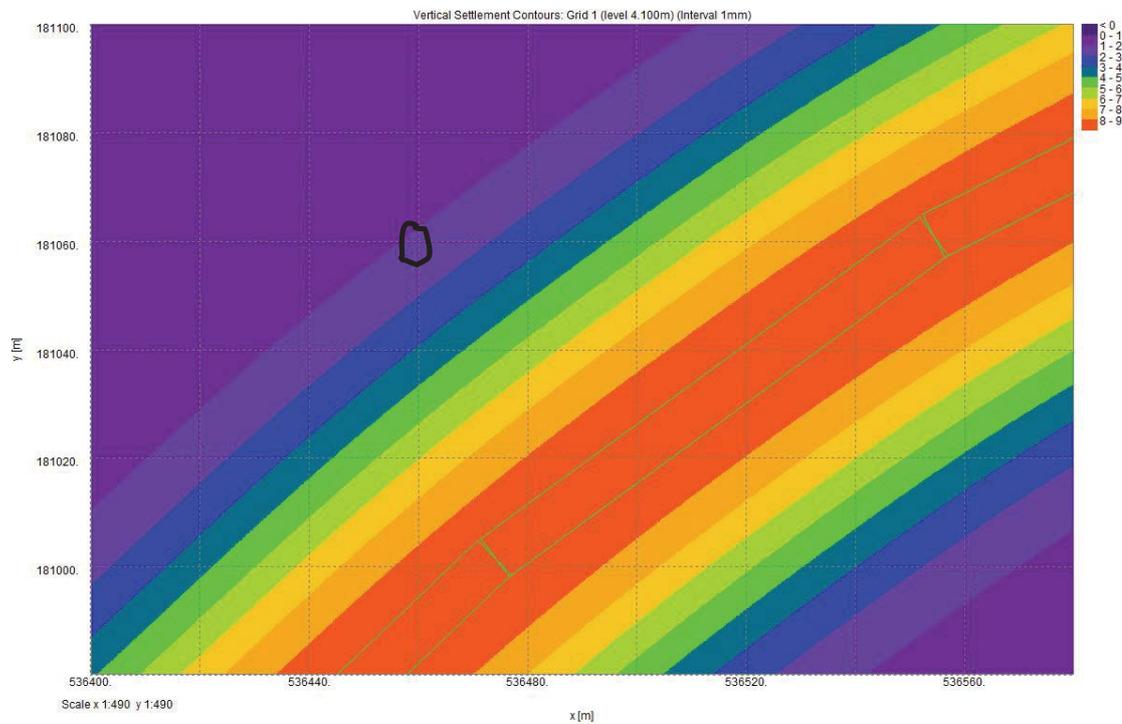
Settlement contours taken at +104.1mTD, position of accumulator tower and chimney outline shown by black circular shape.

The results fall within category 0, risk of ‘negligible’ damage, with a maximum tensile strain of 0.004% and maximum settlement of 1.5mm calculated.

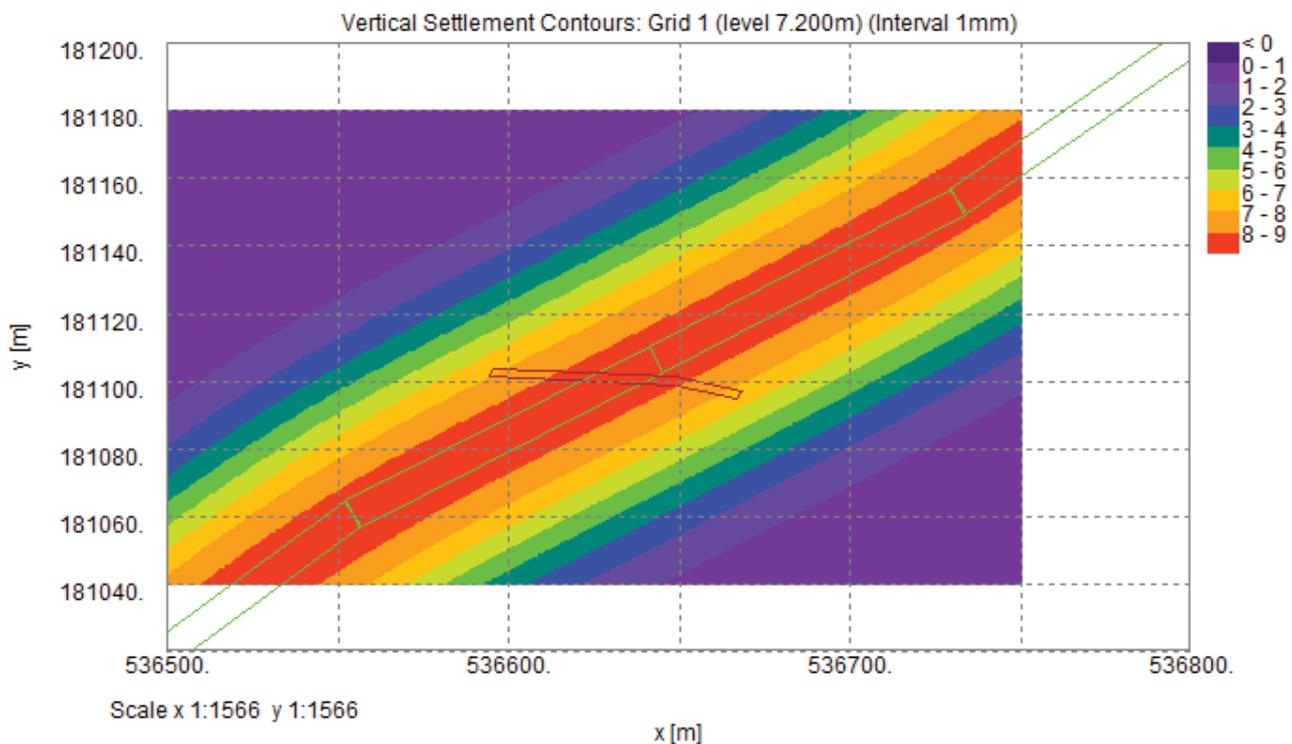
Settlement contours at +107.2mTD:

The results fall within category 0, risk of negligible damage, with a maximum tensile strain of 0.0006% and maximum settlement of 8.5mm calculated.

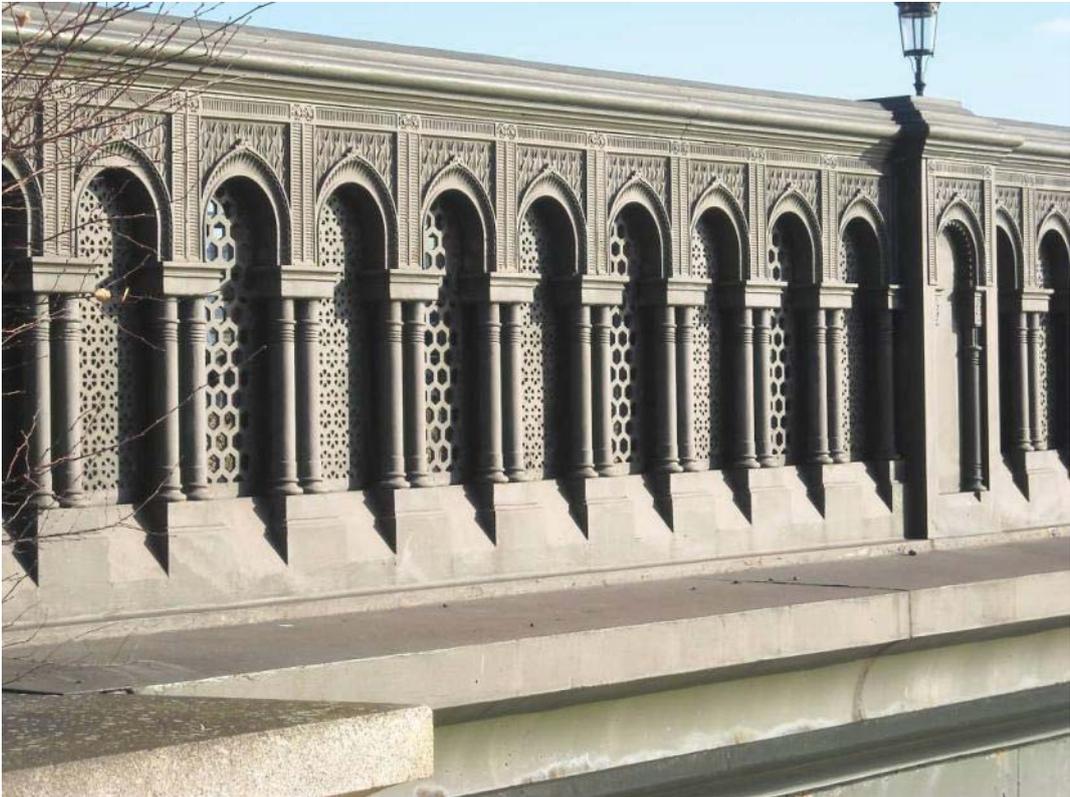
Vol 3 Plate E.22 Typical cracking to cast-iron balustrade

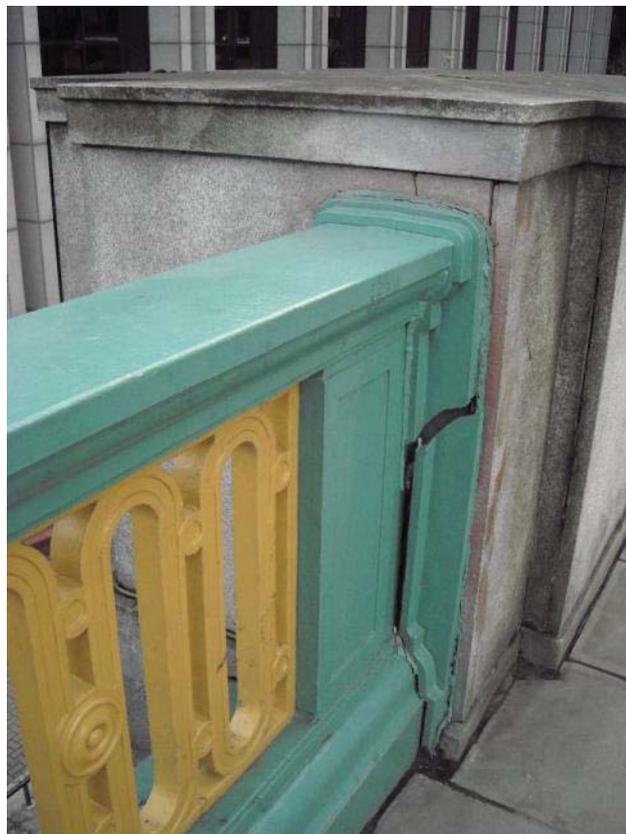
Vol 3 Plate E.94 Typical damage to cast-iron balustrade

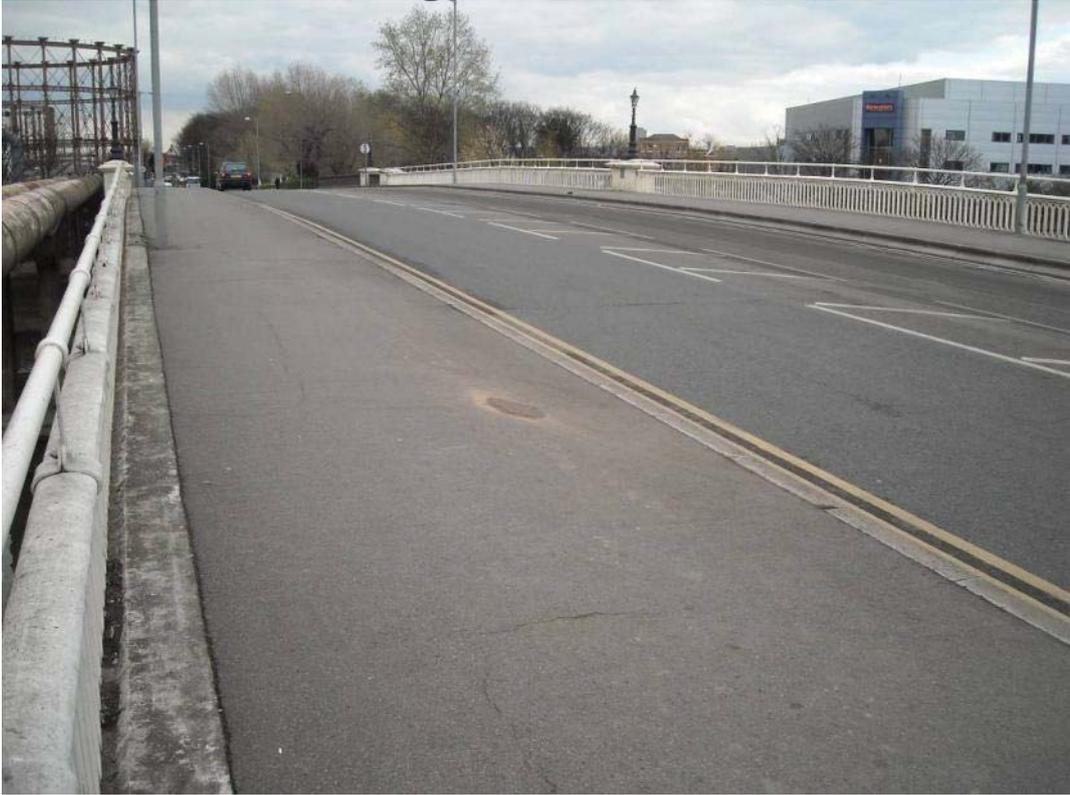
Vol 3 Plate E.134 Cast-iron balustrade and handrail, note cracking
