**Thames
Tideway Tunnel**

Environmental Statement

Volume 23: Deptford Church Street appendices

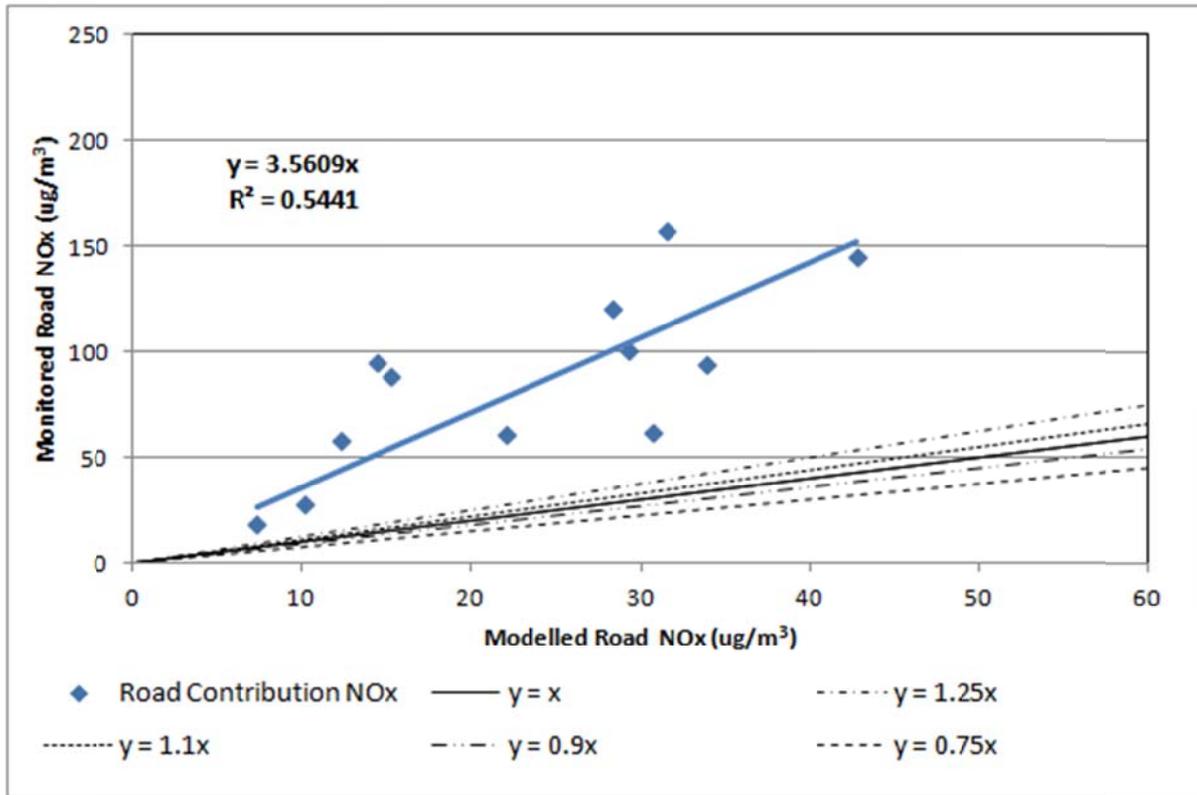
Vol 23 Plate B.1 Air quality - monitored road NO_x vs. modelled road NO_x

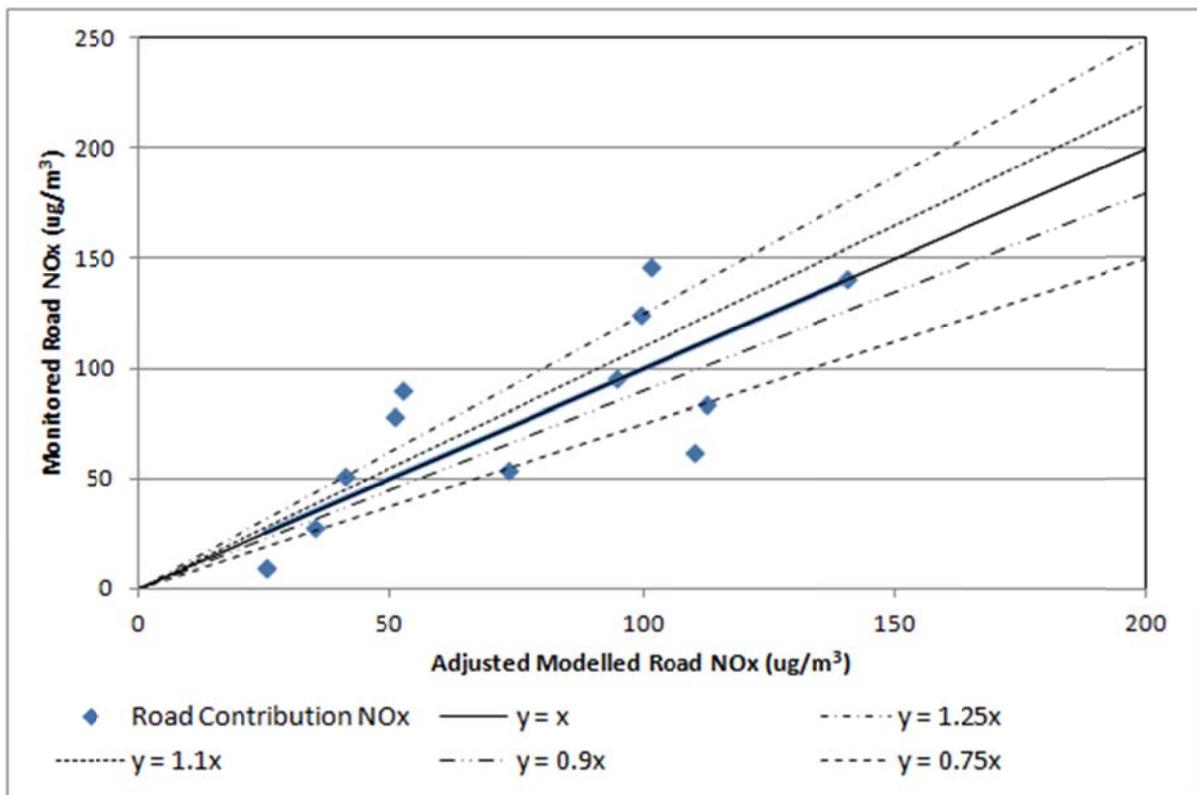
Vol 23 Plate B.2 Air quality – monitored road NO_x vs. adjusted modelled road NO_x

- B.1.4 Applying the NO_x adjustment factor and then calculating NO₂ concentrations, as shown in Vol 23 Plate B.2, provides better overall agreement between actual and predicted data. The subsequent linear regression calculation for monitored versus modelled total NO₂, as shown in Vol 23 Plate B.3, indicated that eight of the twelve modelled concentrations were within 10% of the measured value and the remaining four were within 25% of the modelled value.

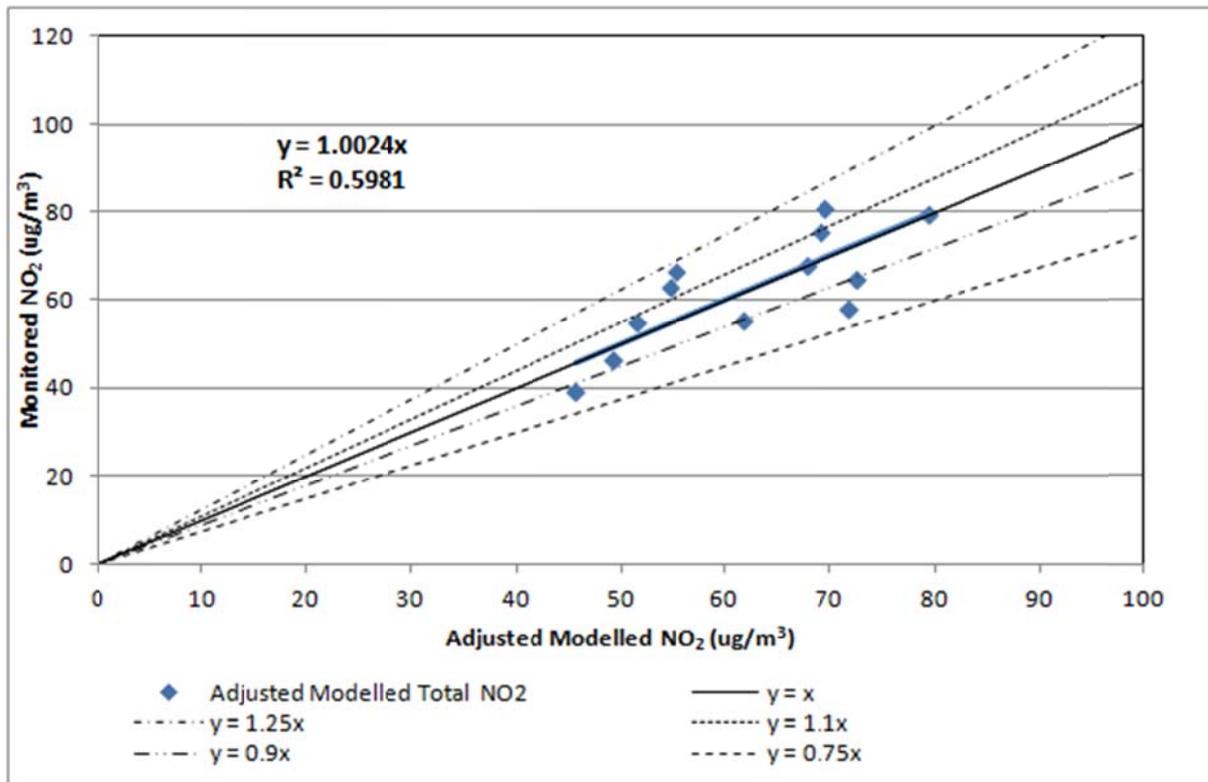
Vol 23 Plate B.3 Air quality – total monitored NO₂ vs. total adjusted modelled NO₂

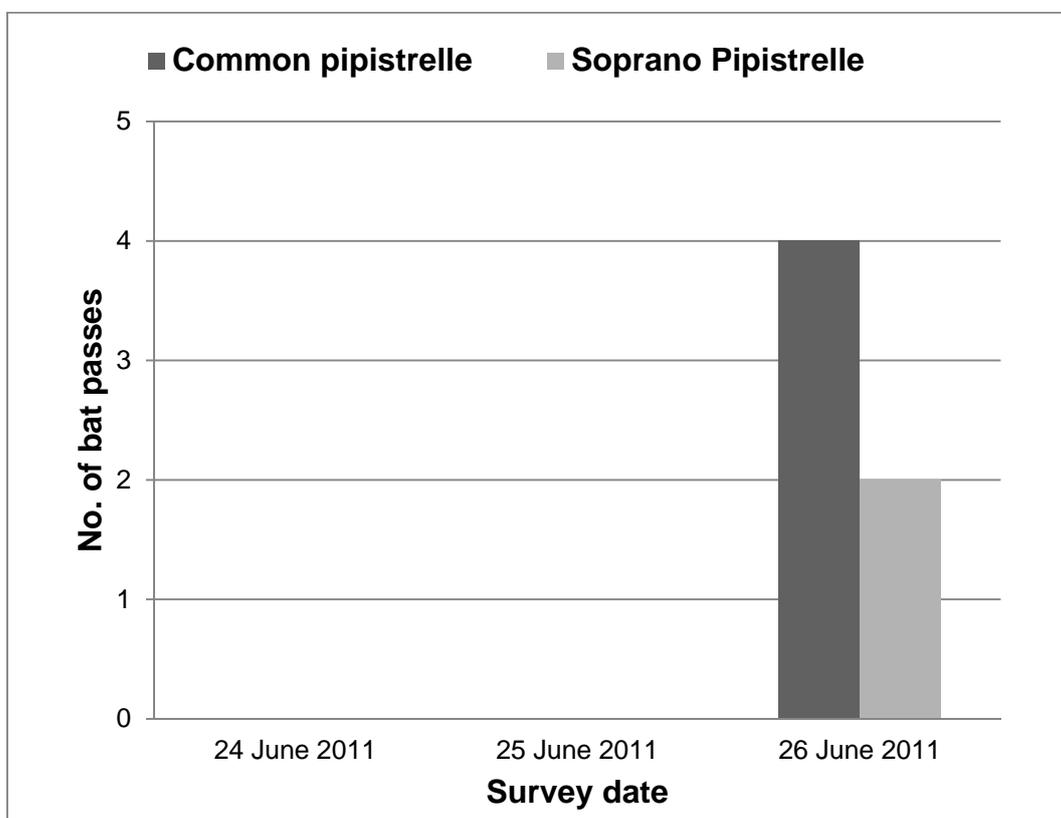
Vol 23 Plate D.1 Terrestrial ecology – bat passes recorded during remote recording surveys at one location at Deptford Church Street.

D.1.13 The remote recording surveys recorded two species of bats using the site, common pipistrelle (*Pipistrellus pipistrellus*) and soprano pipistrelle (*Pipistrellus pygmaeus*), which were both recorded on one night out of the three and in low numbers (Vol 23 Plate D.1). A maximum of six bat passes were recorded, with none recorded close to sunset or sunrise, indicating that bats are not roosting within close proximity to the site.

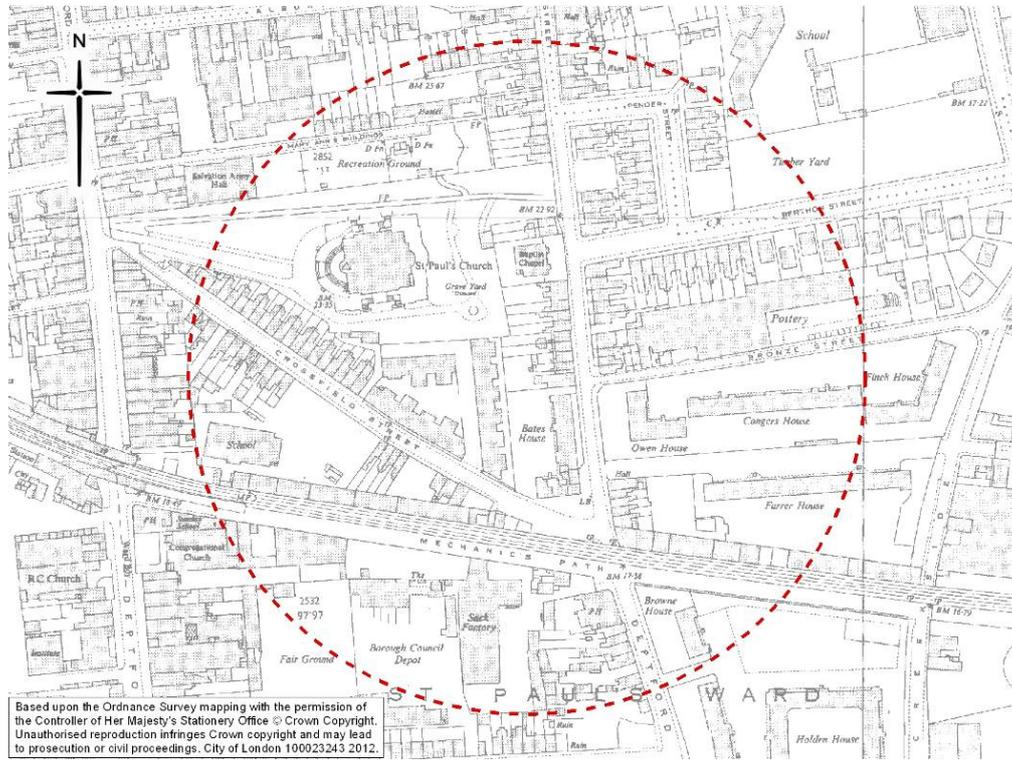
Vol 23 Plate E.5 Historic environment – Ordnance Survey 25” scale map of 1947 (not to scale)

- E.4.33 The Ordnance Survey revised edition 25" map of 1947 (Vol 23 Plate E.5) shows Deptford Church Street widened to its present extent within the eastern site boundary. The terraced houses in the southeastern corner of the site had been replaced with a large L-shaped building named 'Bates House', fronting onto Deptford Church Street, with a large back garden. The extant wall within the site, (**HEA 1B**), is shown separating the residential buildings from the rest of the site.

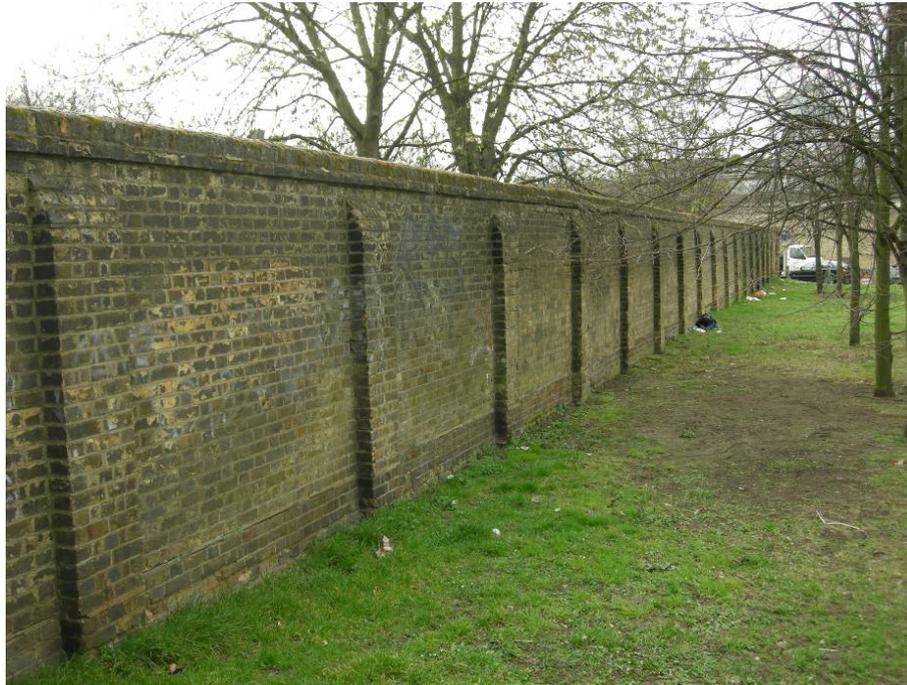
Vol 23 Plate E.7 Historic environment – Brick wall running through the site (HEA 1b); standard lens; looking southeast

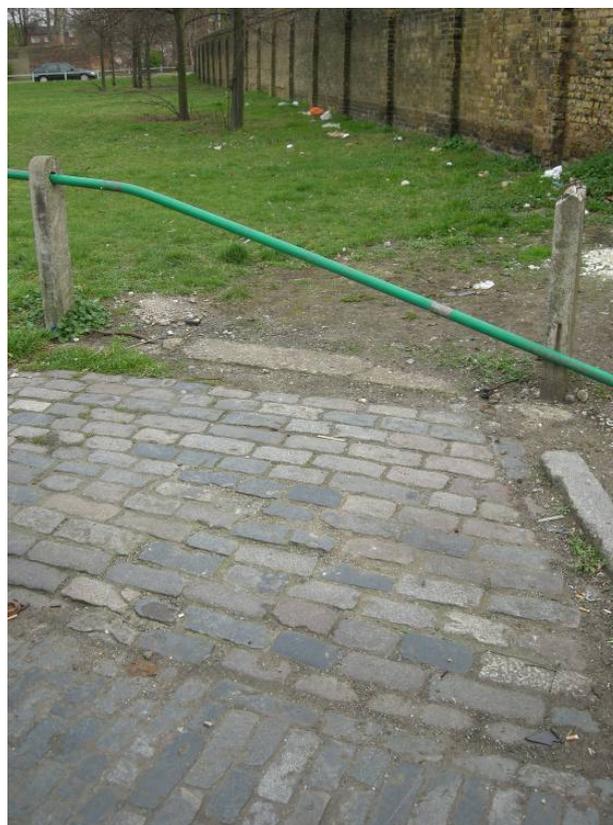
Vol 23 Plate E.8 Historic environment – Original 19th century cobbled surface (HEA 1c) of the southern entrance to a lane behind the rectory buildings; standard lens; looking north

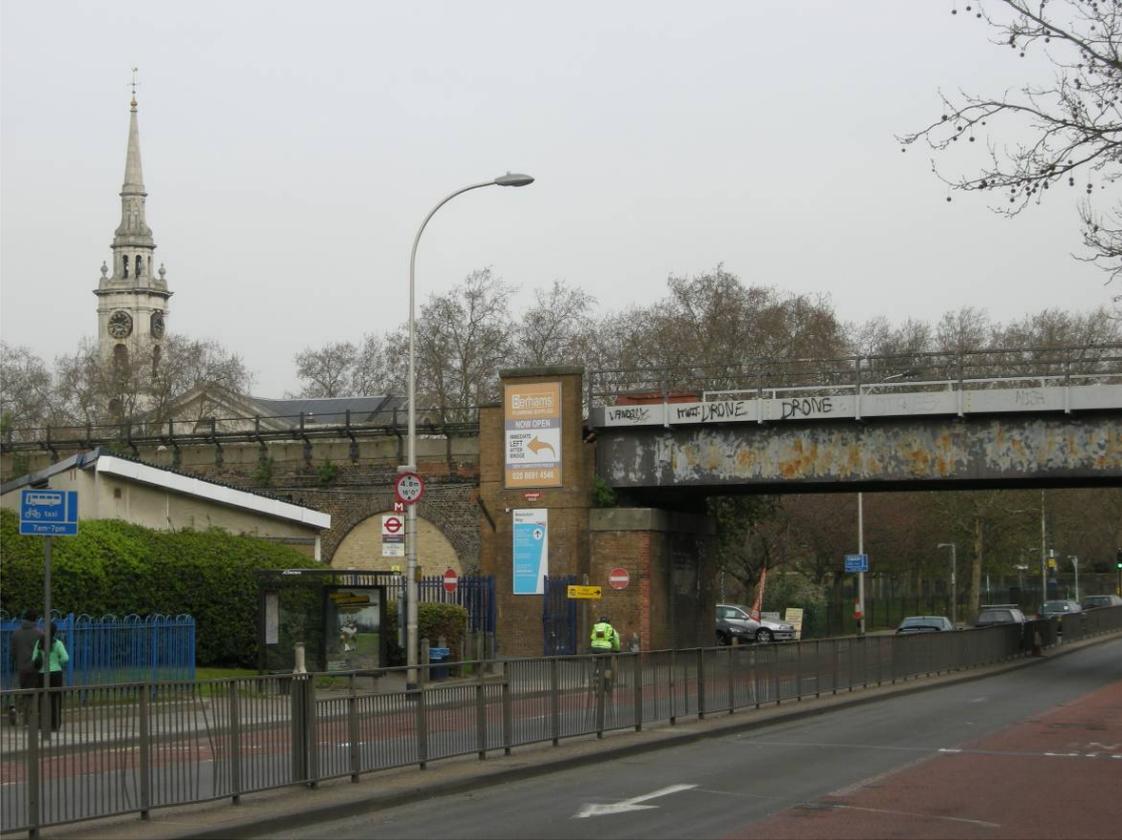
Vol 23 Plate E.9 Historic environment – mid 19th-century viaduct for the London and Greenwich Railway (HEA 1d); view to the northwest showing the modern concrete deck replacement over Deptford Church Street (within the site). Standard lens.

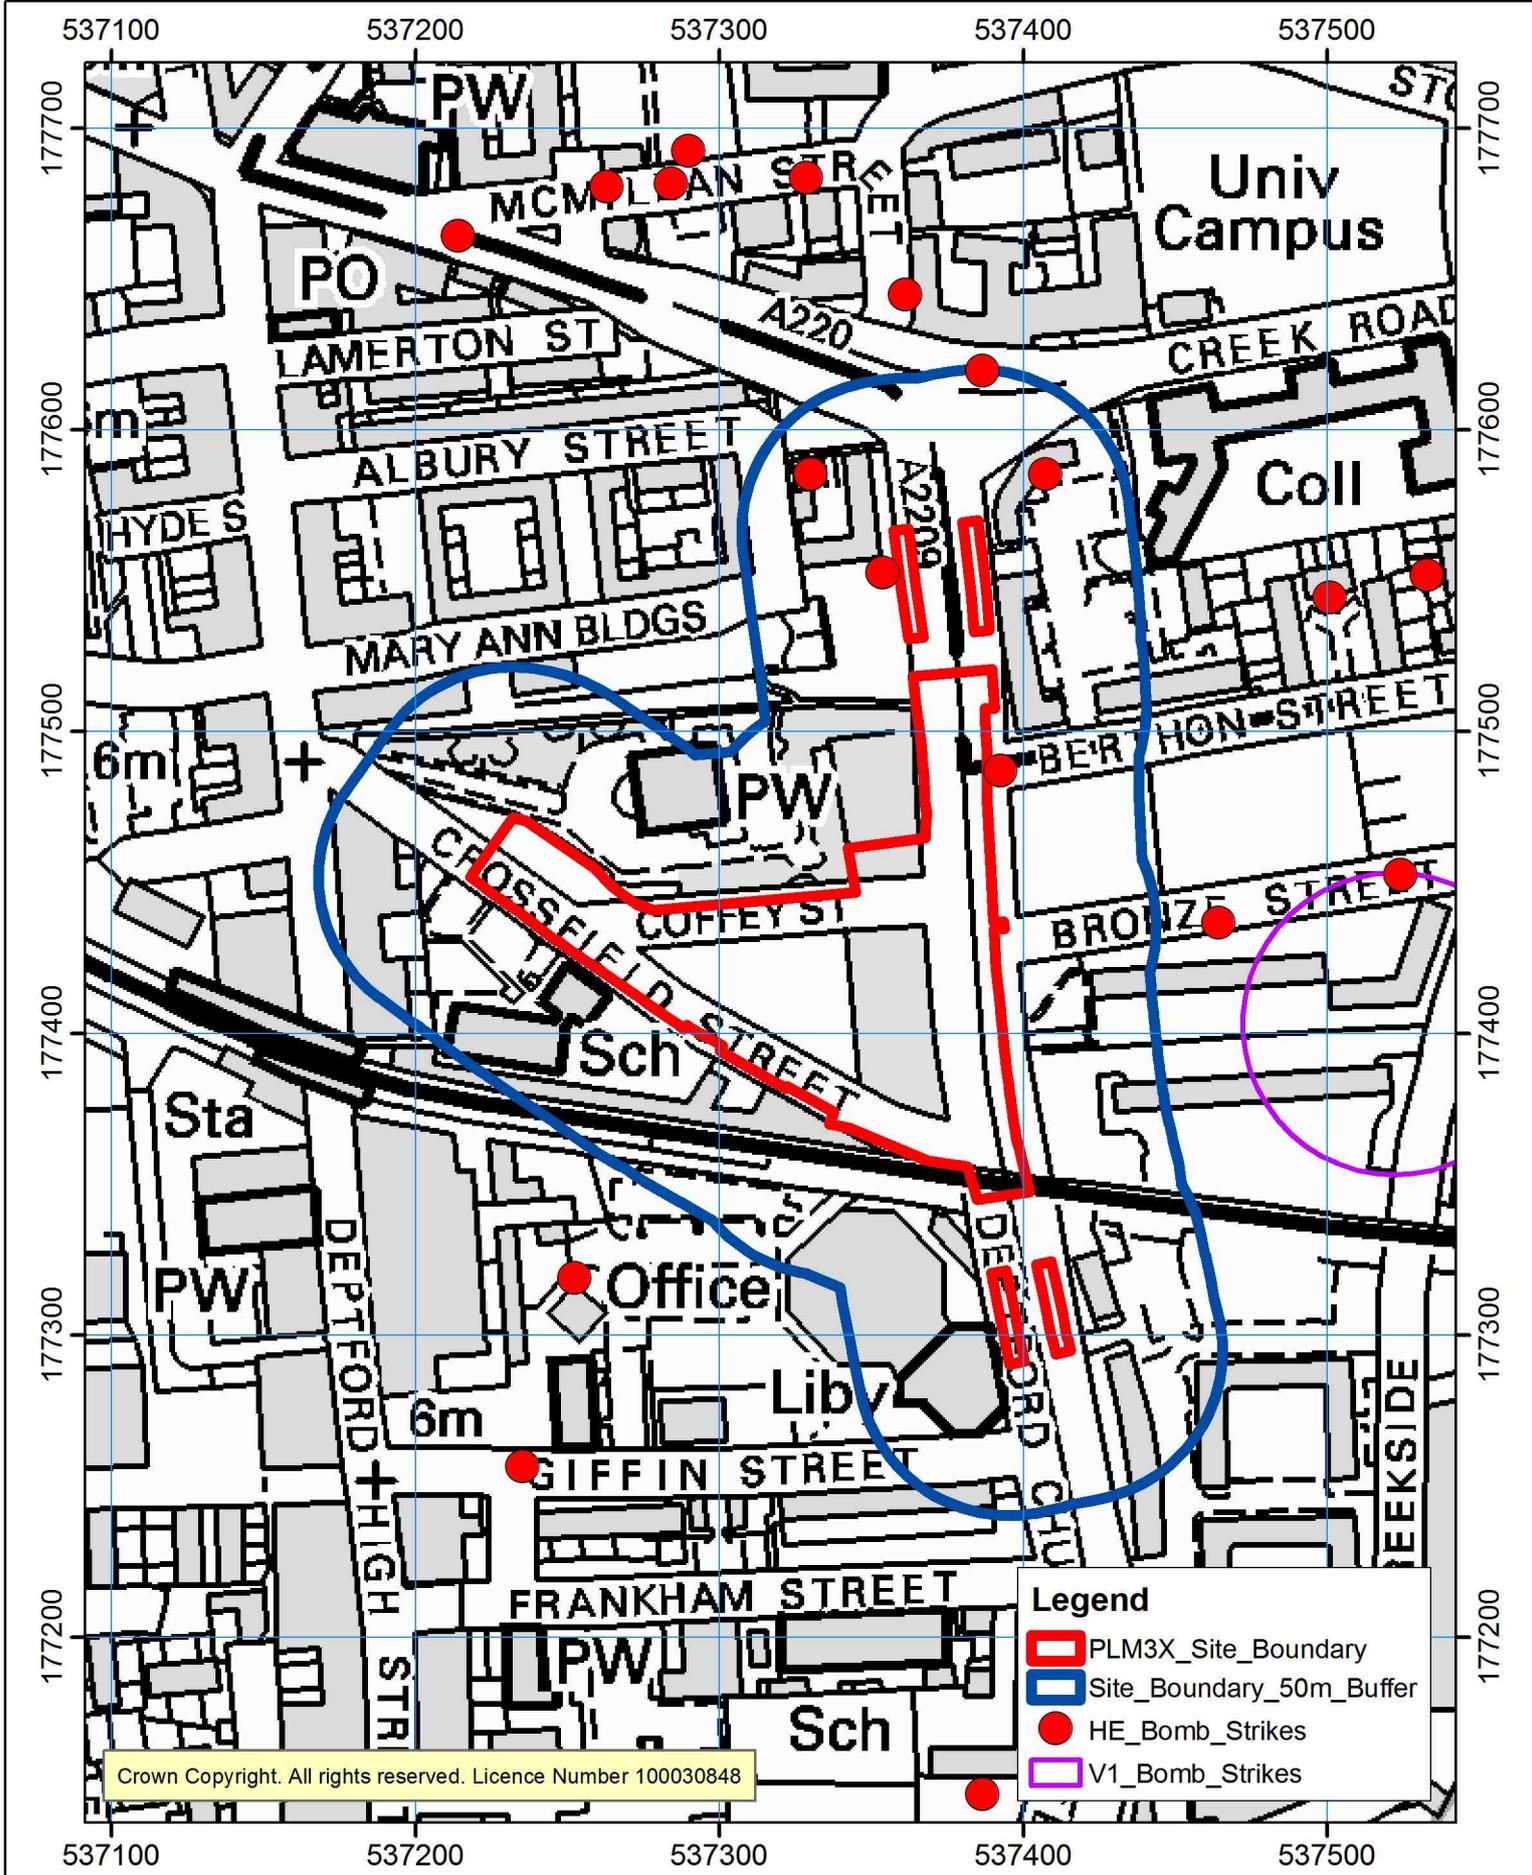
Figure 6

WWII HE Bomb Strikes (Figure 6)	<p>Air Raid Precaution (ARP) reports indicate that no bomb strikes occurred within the Work Area. However, five bomb strikes occurred within the buffered Site boundary and twelve strikes occurred within 100m of the buffered Site boundary. Additionally, one V1 strike occurred approximately 70m to the west of the Site.</p>
WWII Bomb Damage (Figure 7)	<p><i>London County Council</i> (LCC) bomb damage maps indicate bomb damage throughout the southern and western aspect of the Work Area and buffered Site boundary, ranging from “blast damage; minor in nature” to “damage beyond repair”.</p>
WWII HE Bomb Density (Figure 8)	<p>The Study Site is located within the <i>Deptford Metropolitan Borough</i>, which recorded 453 HE bombs per 1,000 acres.</p> <p>This figure does not include incendiary devices, as they were often released in such large numbers that they were seldom recorded.</p>

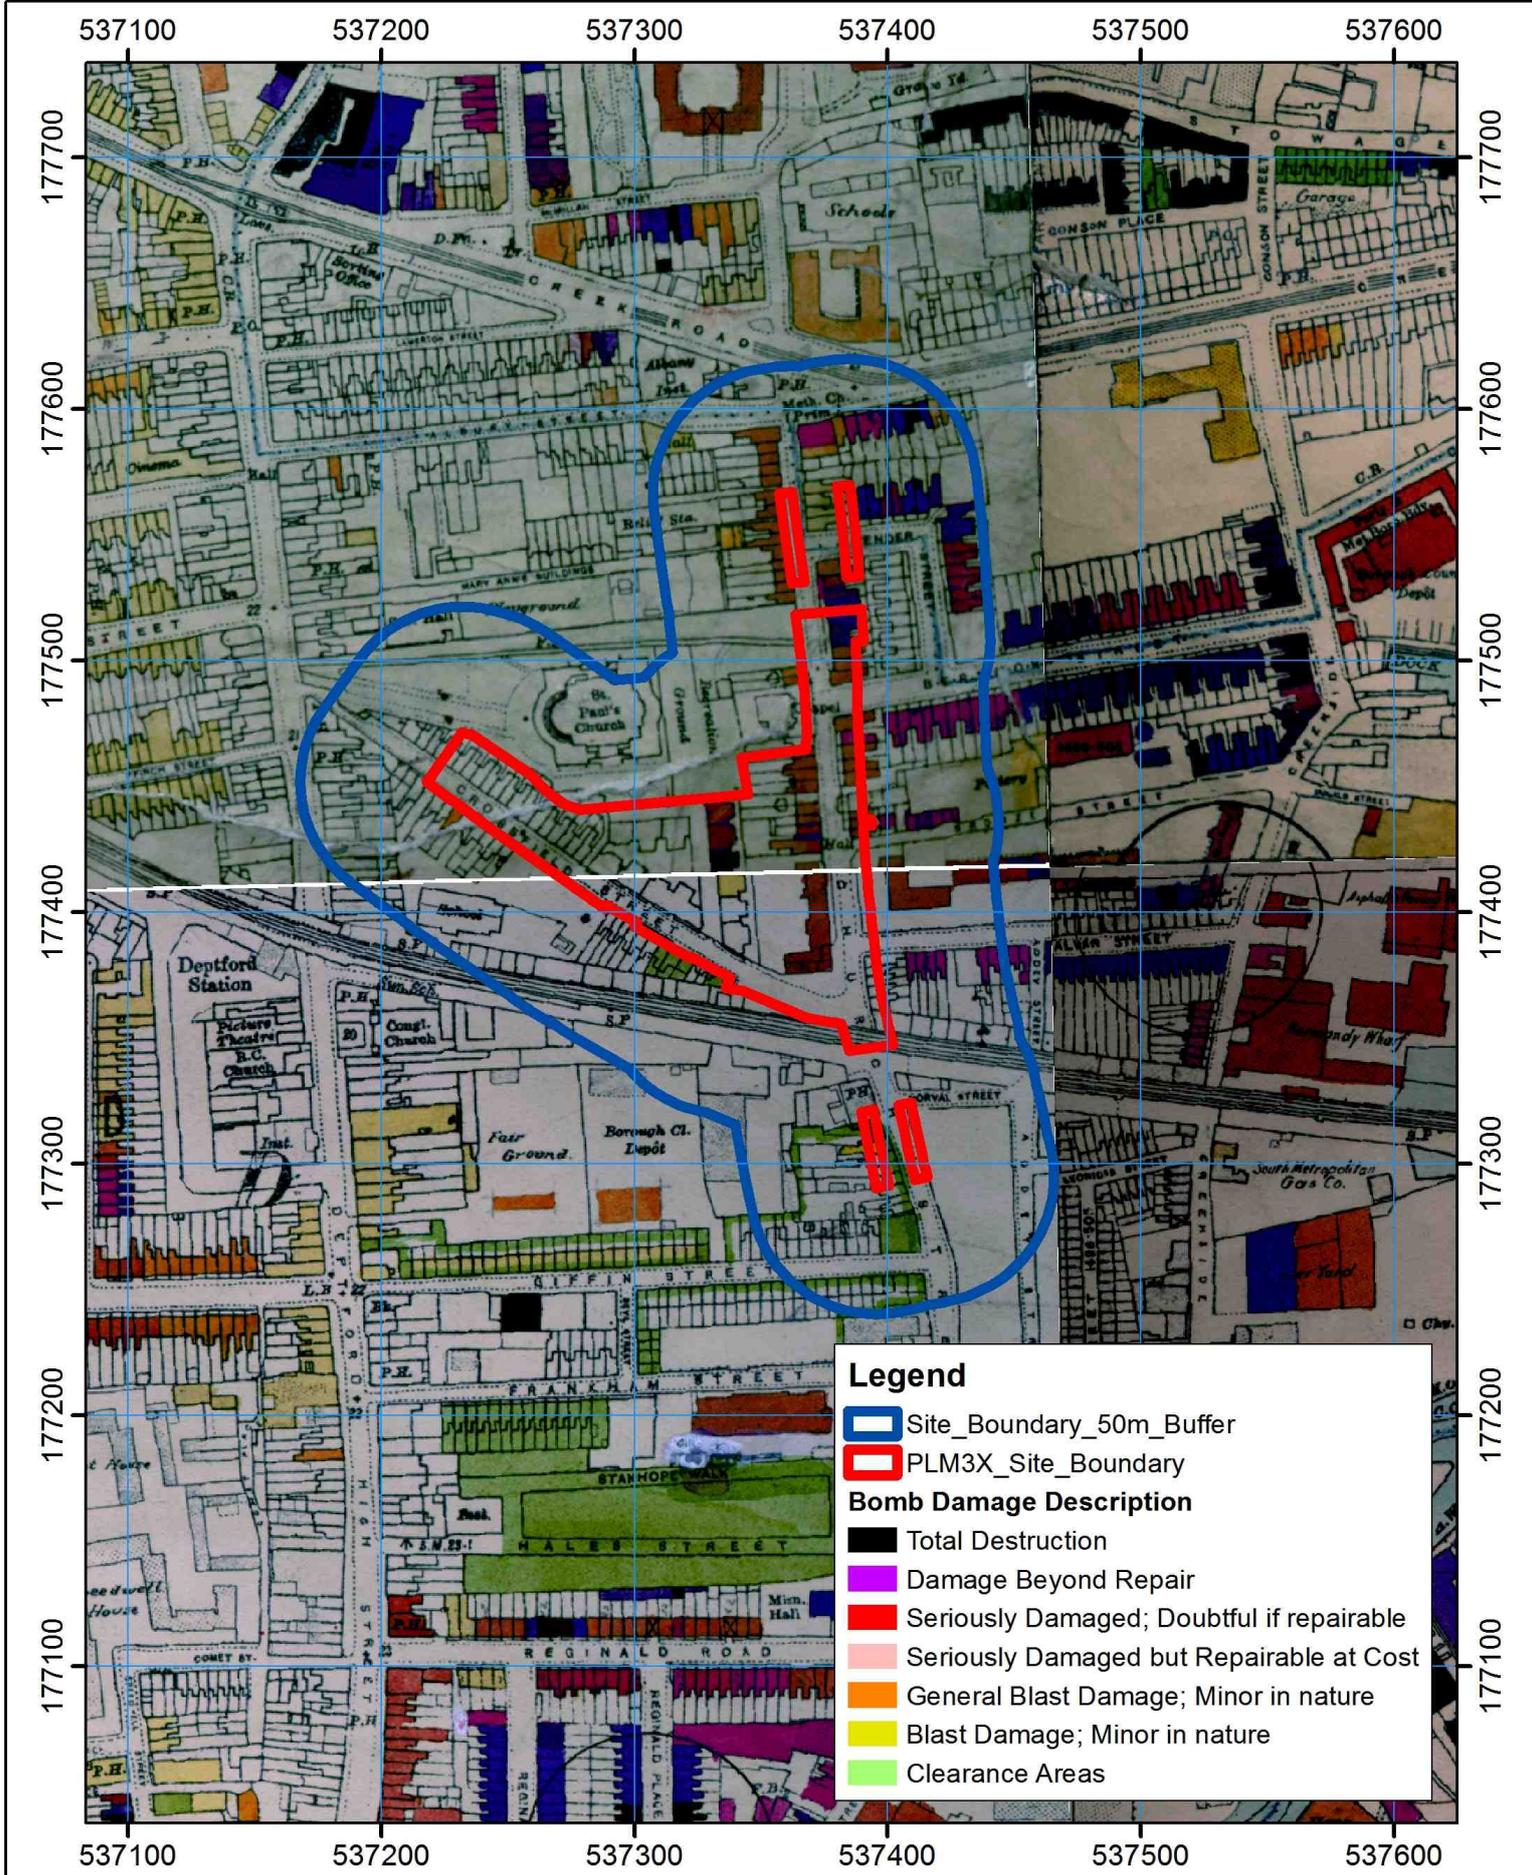
Figure 7

Thames Tideway Tunnel - Work Area PLM3X London County Council Bomb Damage Map

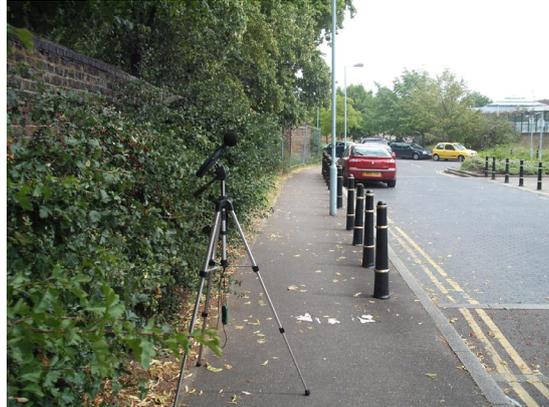
Vol 23 Plate G.1 Noise – measurement location DCS01

Note: On public footpath along Coffey Street, looking southeast (façade measurement)

G.1.12 The following plates (Vol 23 Plate G.1 to Vol 23 Plate G.4) illustrate the noise measurement locations.

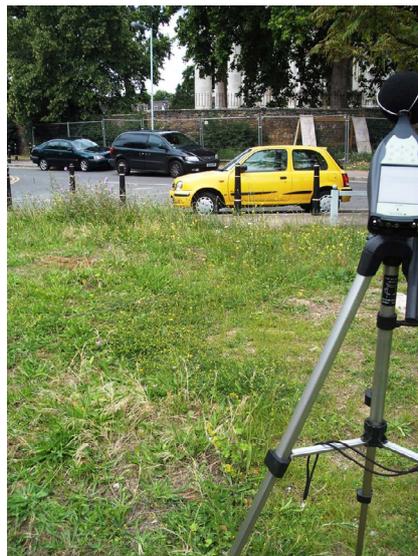
Vol 23 Plate G.2 Noise – measurement location DCS02

Note: Grassed verge on public footpath adjacent to Crossfield Street, looking north towards public footpath along Coffey Street and St Paul's church

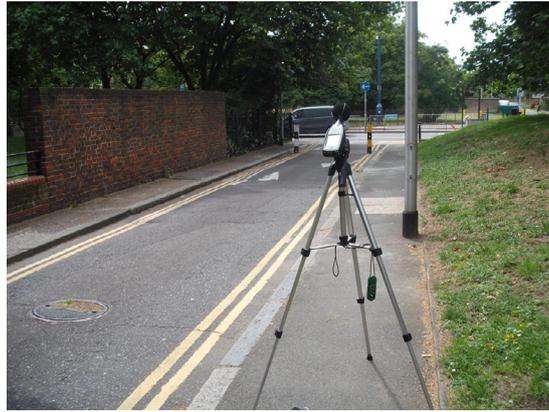
Vol 23 Plate G.3 Noise – measurement location DCS03

Note: On public footpath along Bronze Street, looking west towards Deptford Church Street intersection

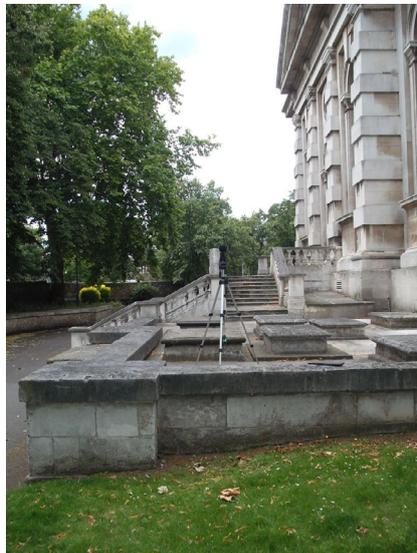
Vol 23 Plate G.4 Noise – measurement location DCS04

Note: Within grounds of St Paul's church, looking west

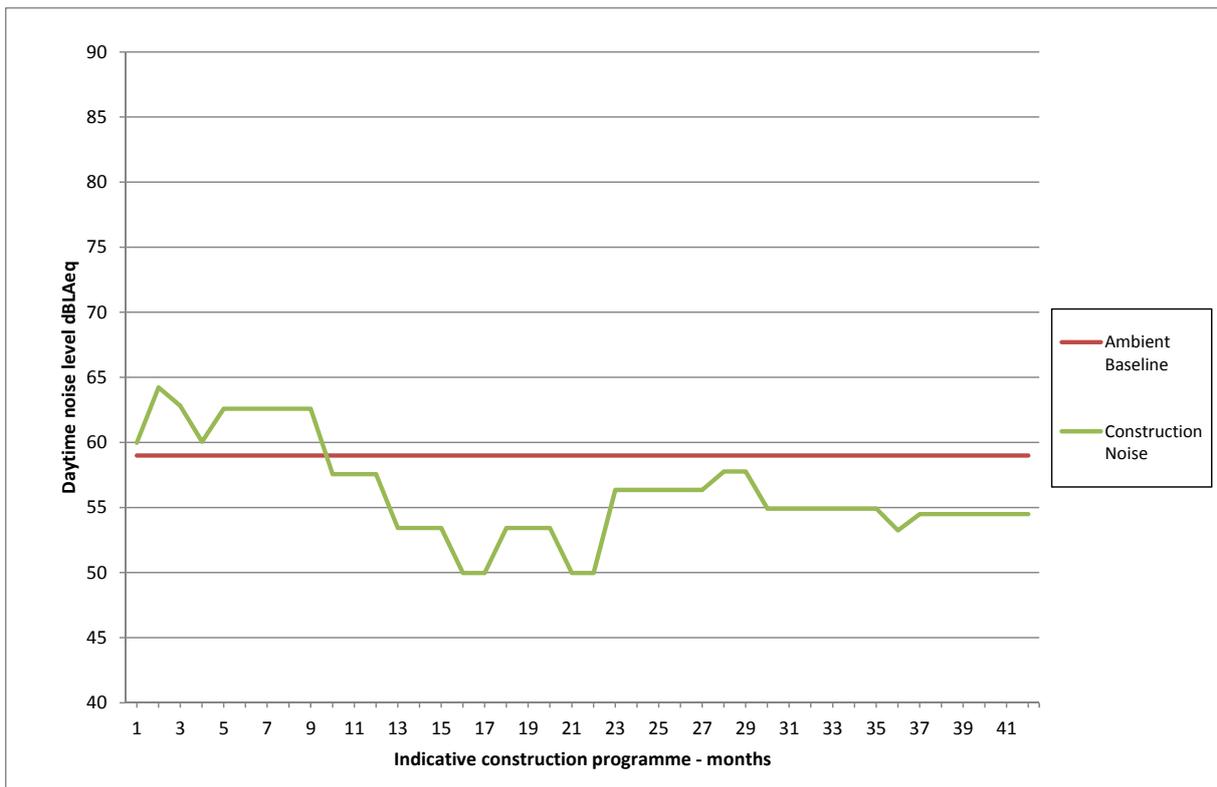
Vol 23 Plate G.5 Noise – Average monthly daytime noise level over duration of construction – St. Joseph’s Primary School (DC1)

G.2.5 The predicted construction noise over time at each receptor is shown in the figures below. It should be noted that these representations are for the worst-case scenarios for noise exposure at the upper floors. For comparison with the construction noise, the figures also show either the potential significance criterion threshold for residential receptors, or the ambient noise level. This comparison is discussed in the main assessment text. The night-time noise levels have also been assessed for the short period of night-time works; these results are described in the main assessment text and not presented here.

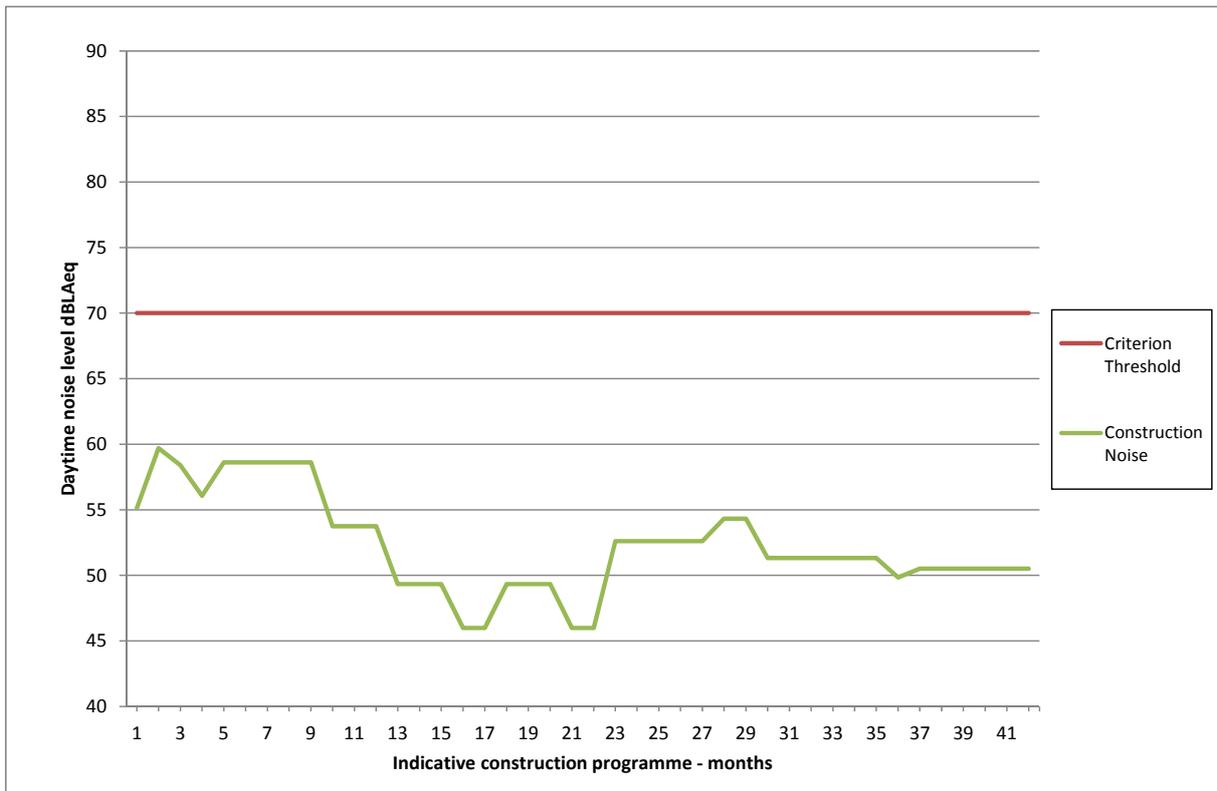
Vol 23 Plate G.6 Noise – Average monthly daytime noise level over duration of construction – 134-160 Deptford High Street (DC2)

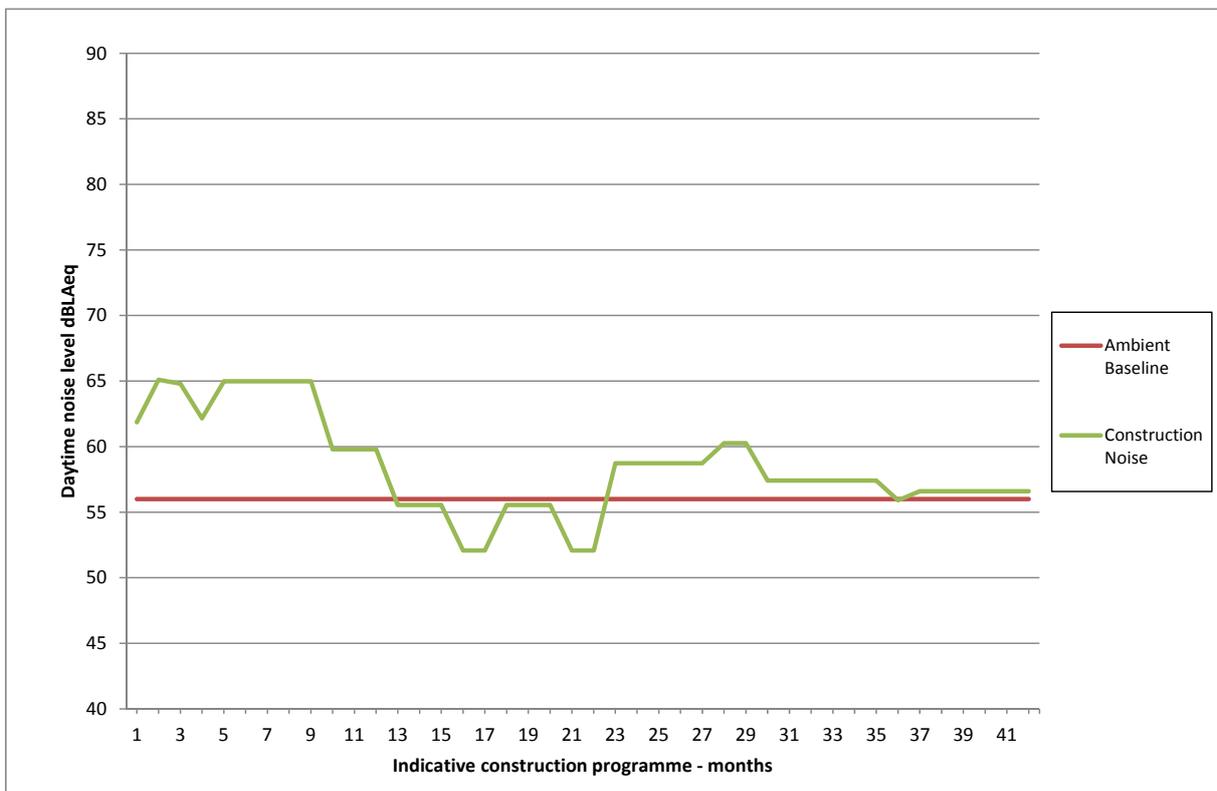
Vol 23 Plate G.7 Noise – Average monthly daytime noise level over duration of construction – St Paul’s Church (DC3)

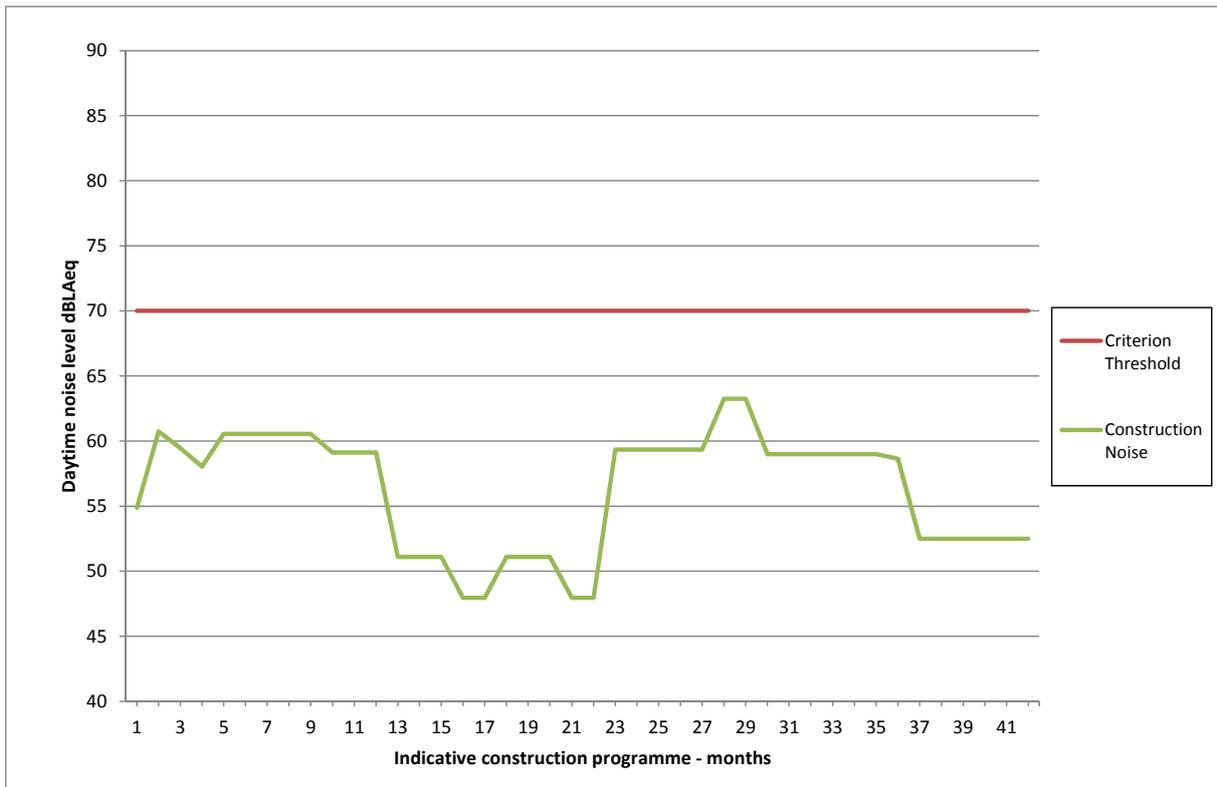
Vol 23 Plate G.8 Noise – Average monthly daytime noise level over duration of construction – 1-22 Berthon Street (DC4)

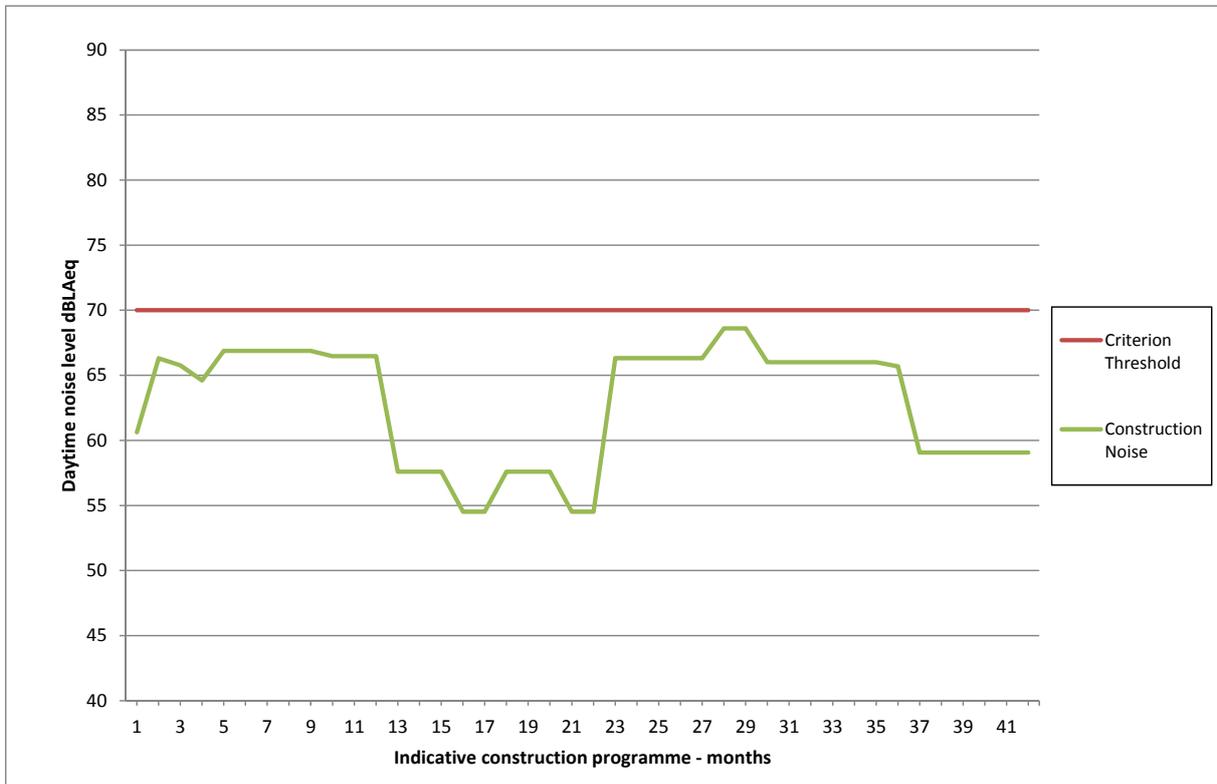
Vol 23 Plate G.9 Noise – Average monthly daytime noise level over duration of construction – Congers House (DC5)

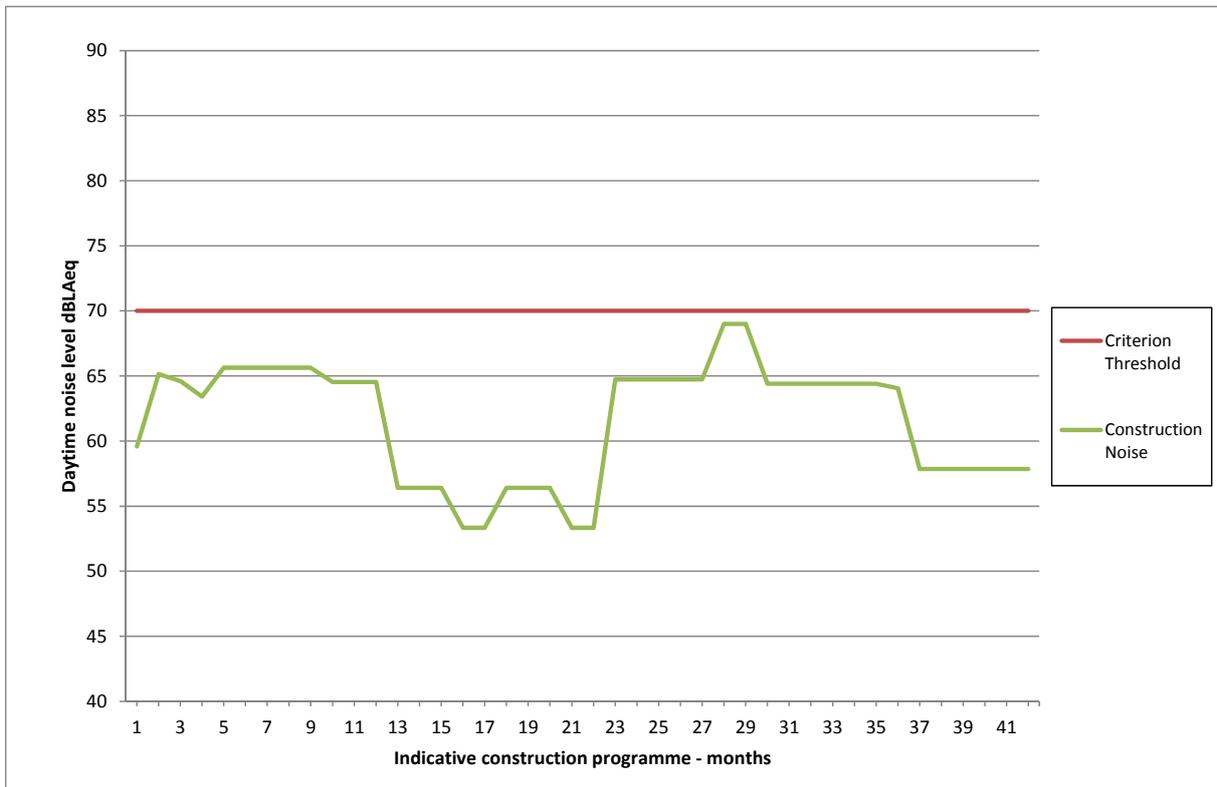
Vol 23 Plate G.10 Noise – Average monthly daytime noise level over duration of construction – Farrer House (DC6)

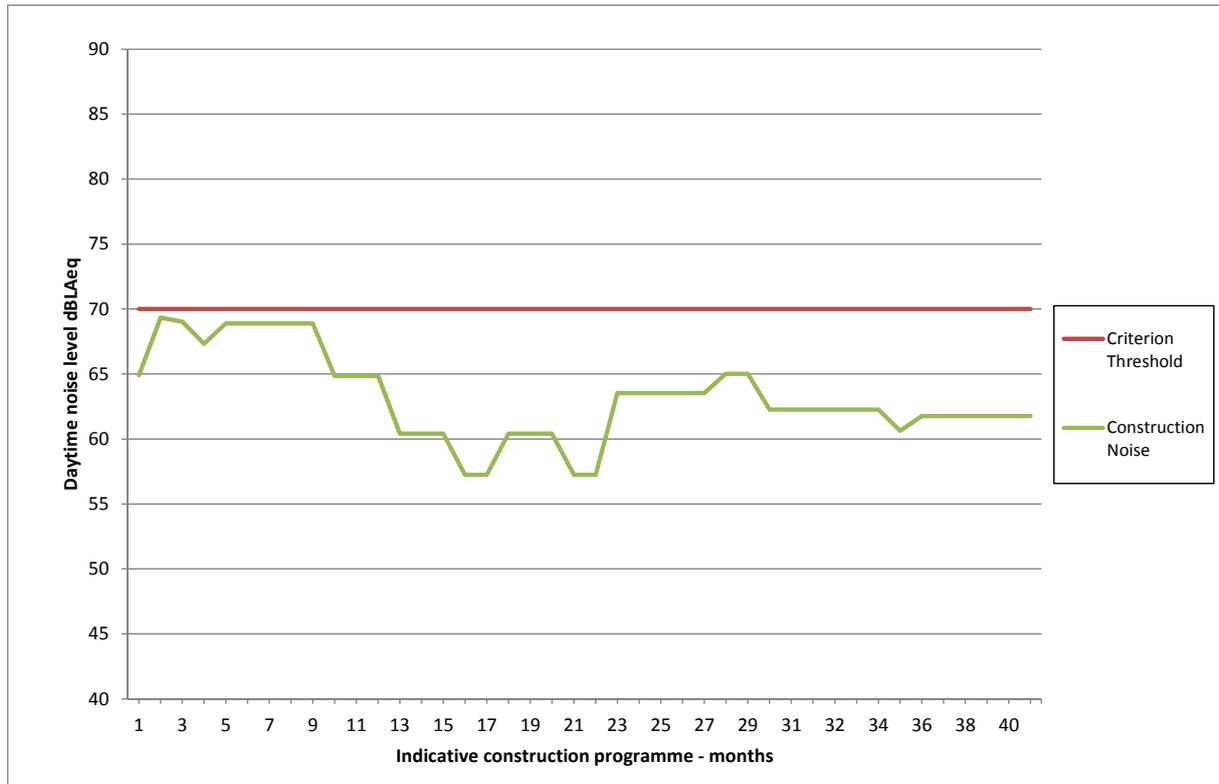
Vol 23 Plate G.11 Noise – Average monthly daytime noise level over duration of construction – Resolution Way (DC7)

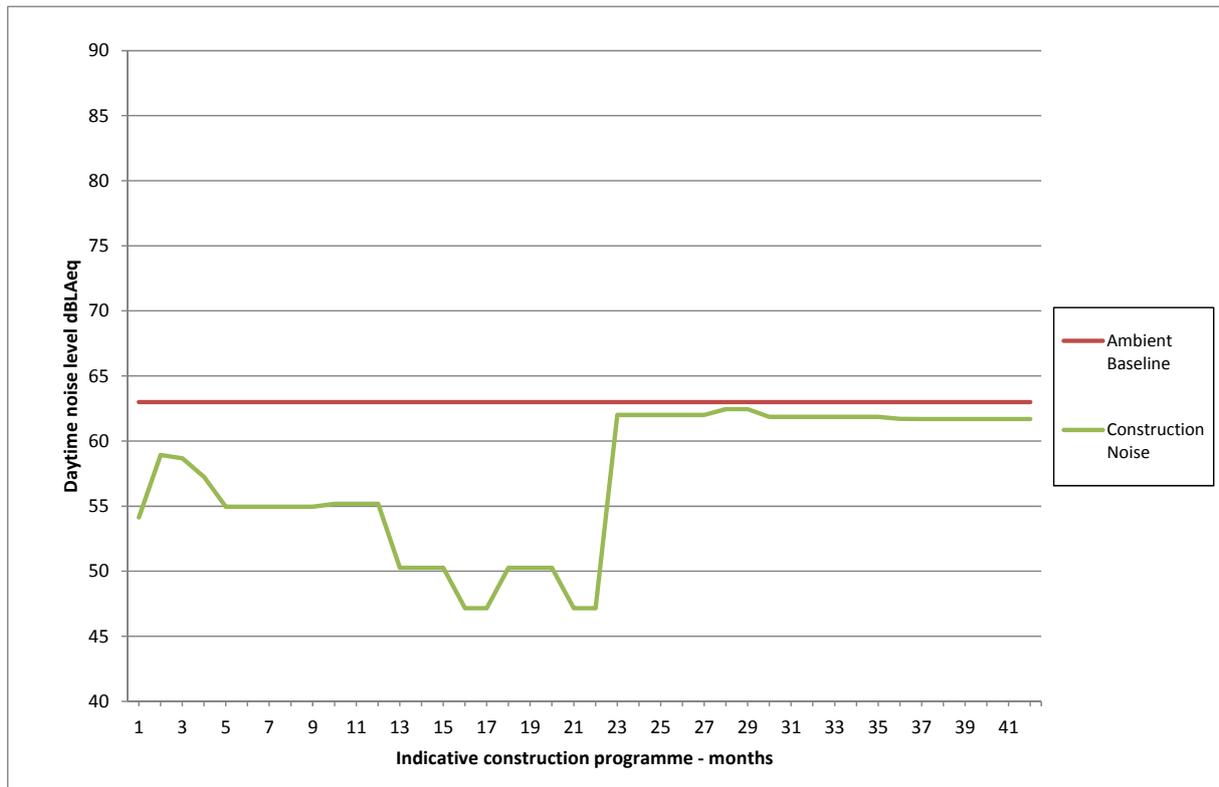
Vol 23 Plate G.12 Noise – Average monthly daytime noise level over duration of construction – Tidemill Academy (DC8)
