**Thames
Tideway Tunnel**

Environmental Statement

Volume 23: Deptford Church Street appendices

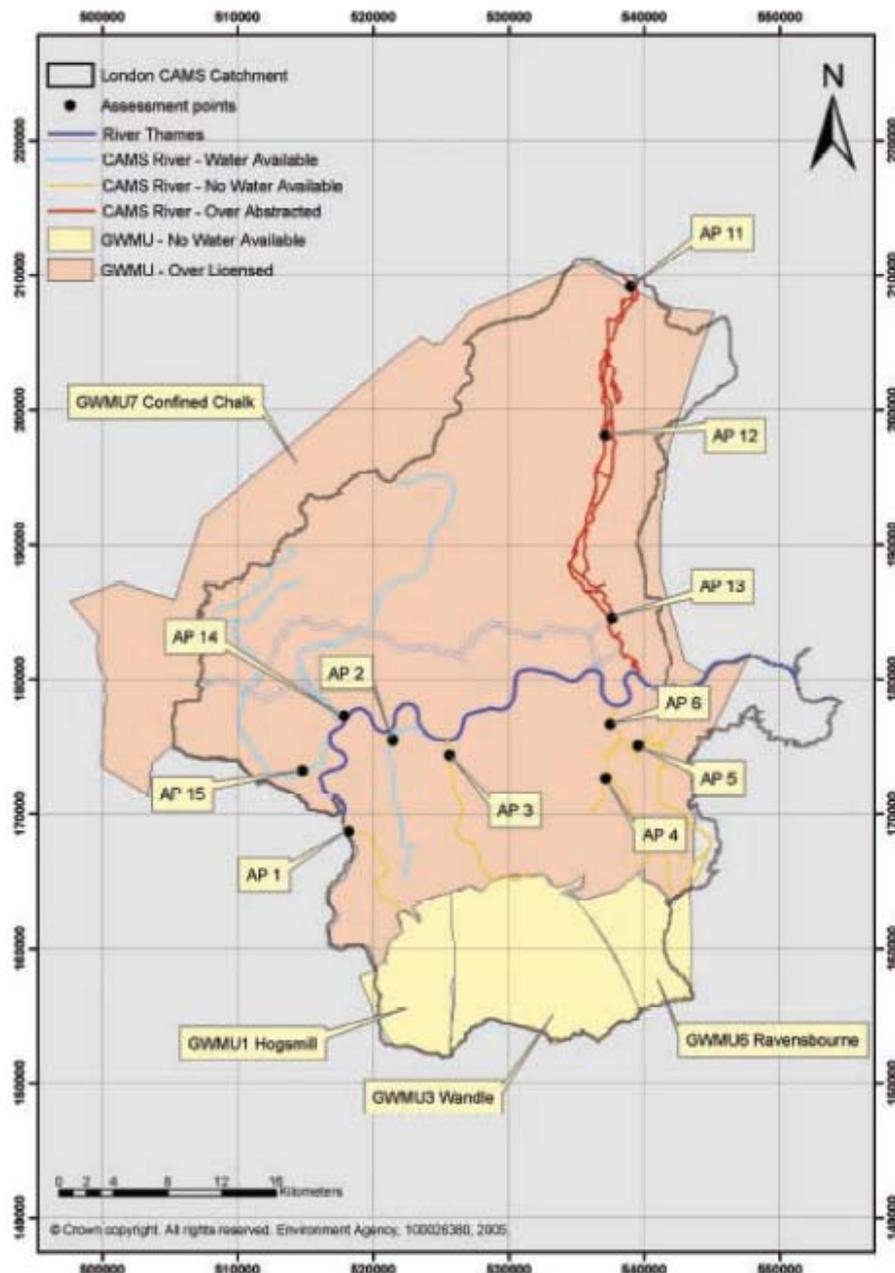
Vol 23 Plate K.1 Groundwater – confined chalk licensing

Note: GWMU – groundwater management unit, AP – assessment point

- K.4.3 The estimated dewatering volumes required at Deptford Church Street from the lower aquifer of less than 200m³/d and within the most restrictive abstraction licensing limit set by the EA of 0.2MI/d (200m³/d) for Central and South London (EA, 2006). Therefore a detailed local assessment is unlikely to be required by the EA.
