**Thames
Tideway Tunnel**

Environmental Statement

Doc Ref: **6.2.05**

Volume 5: Hammersmith Pumping Station appendices

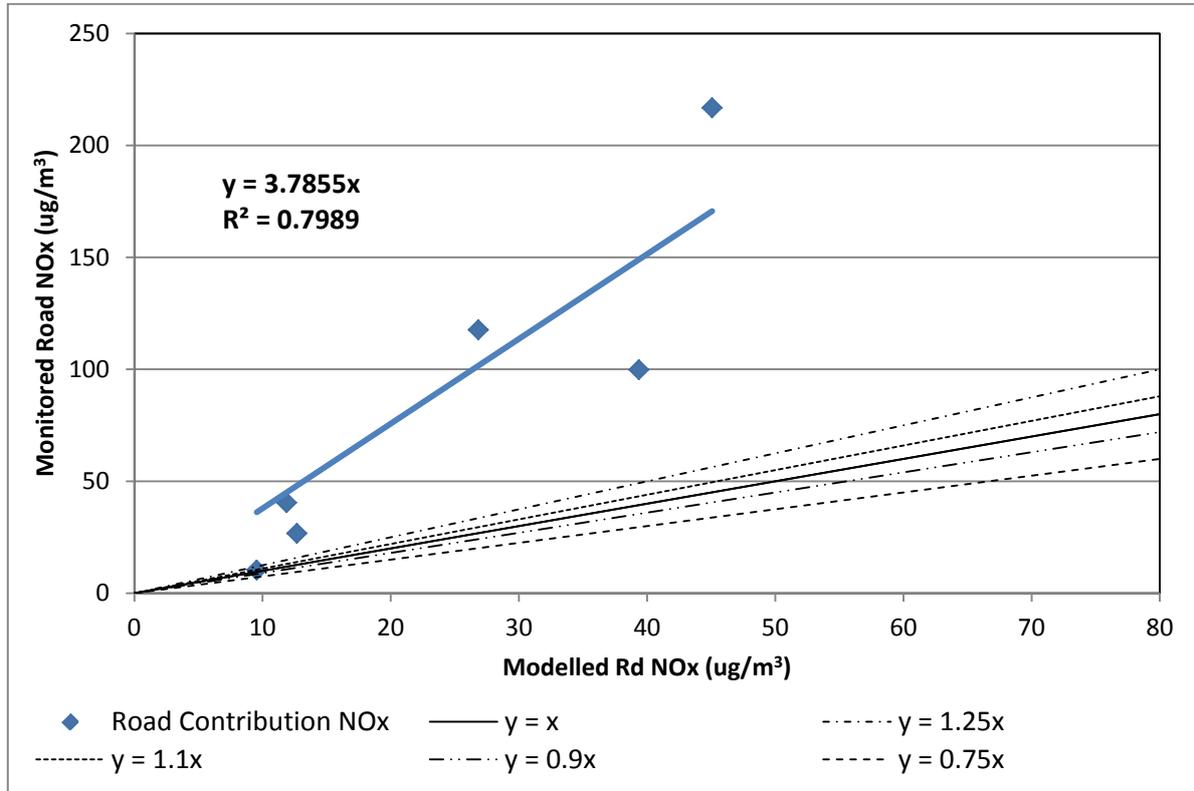
Vol 5 Plate B.1 Air quality - monitored road NO_x vs. modelled road NO_x

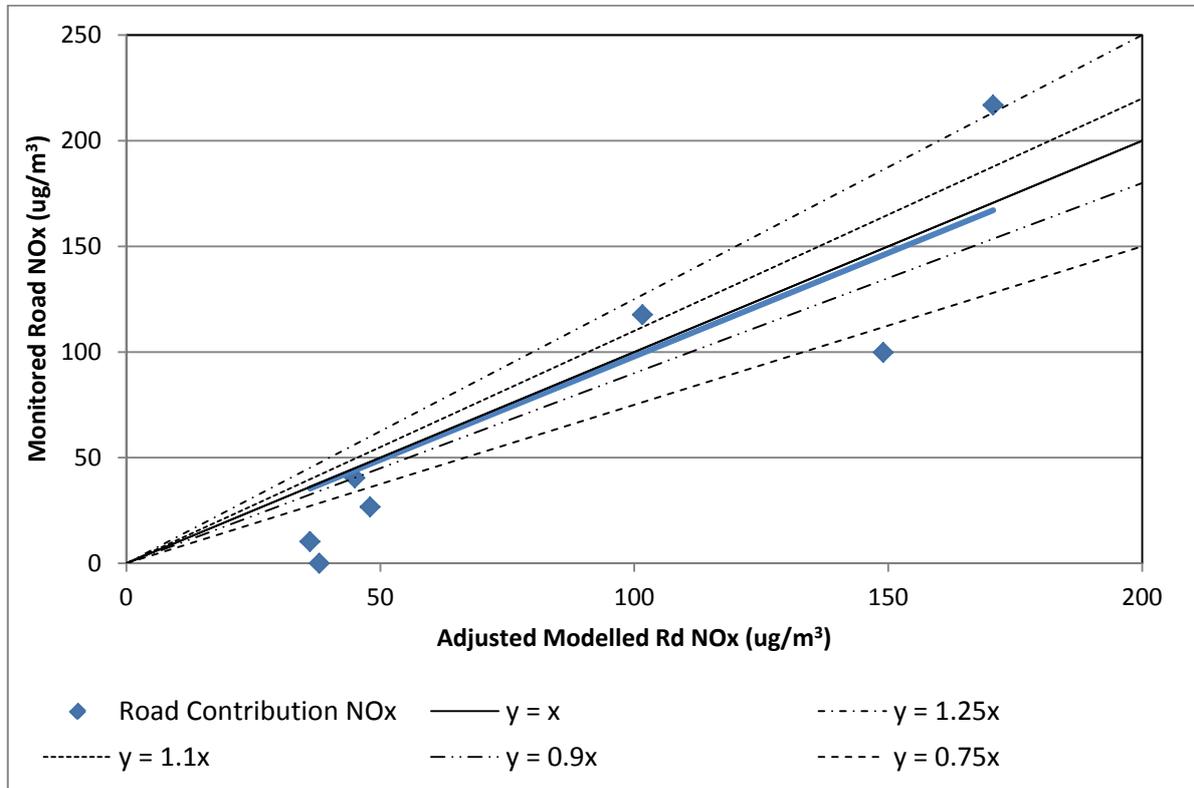
Vol 5 Plate B.2 Air quality – monitored road NO_x vs. adjusted modelled road NO_x

- B.1.4 Applying the NO_x adjustment factor and then calculating NO₂ concentrations, as shown in Vol 5 Plate B.2, provides better overall agreement between actual and predicted data. The subsequent linear regression calculation for monitored versus modelled total NO₂, as shown in Vol 5 Plate B.3, indicated that two of the six modelled concentrations were within 10% of the measured value and that the other four were within 25% of the modelled value.

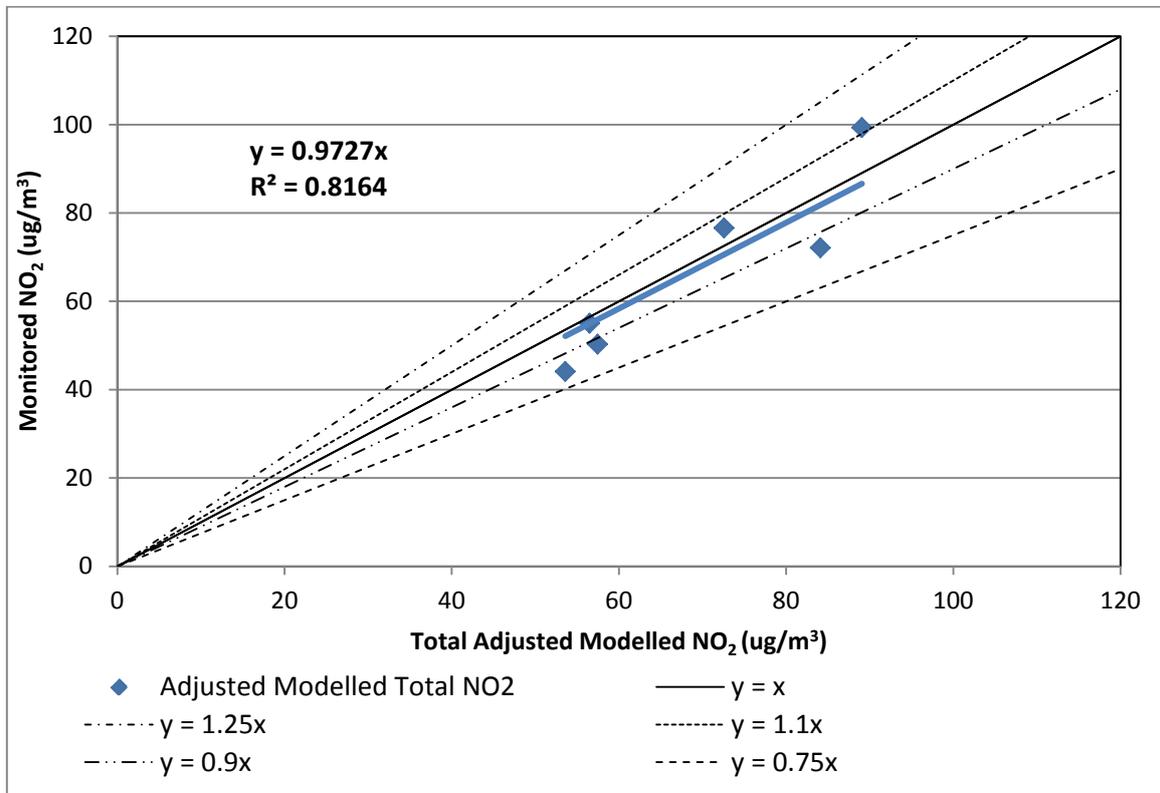
Vol 5 Plate B.3 Air quality – total monitored NO₂ vs. total adjusted modelled NO₂

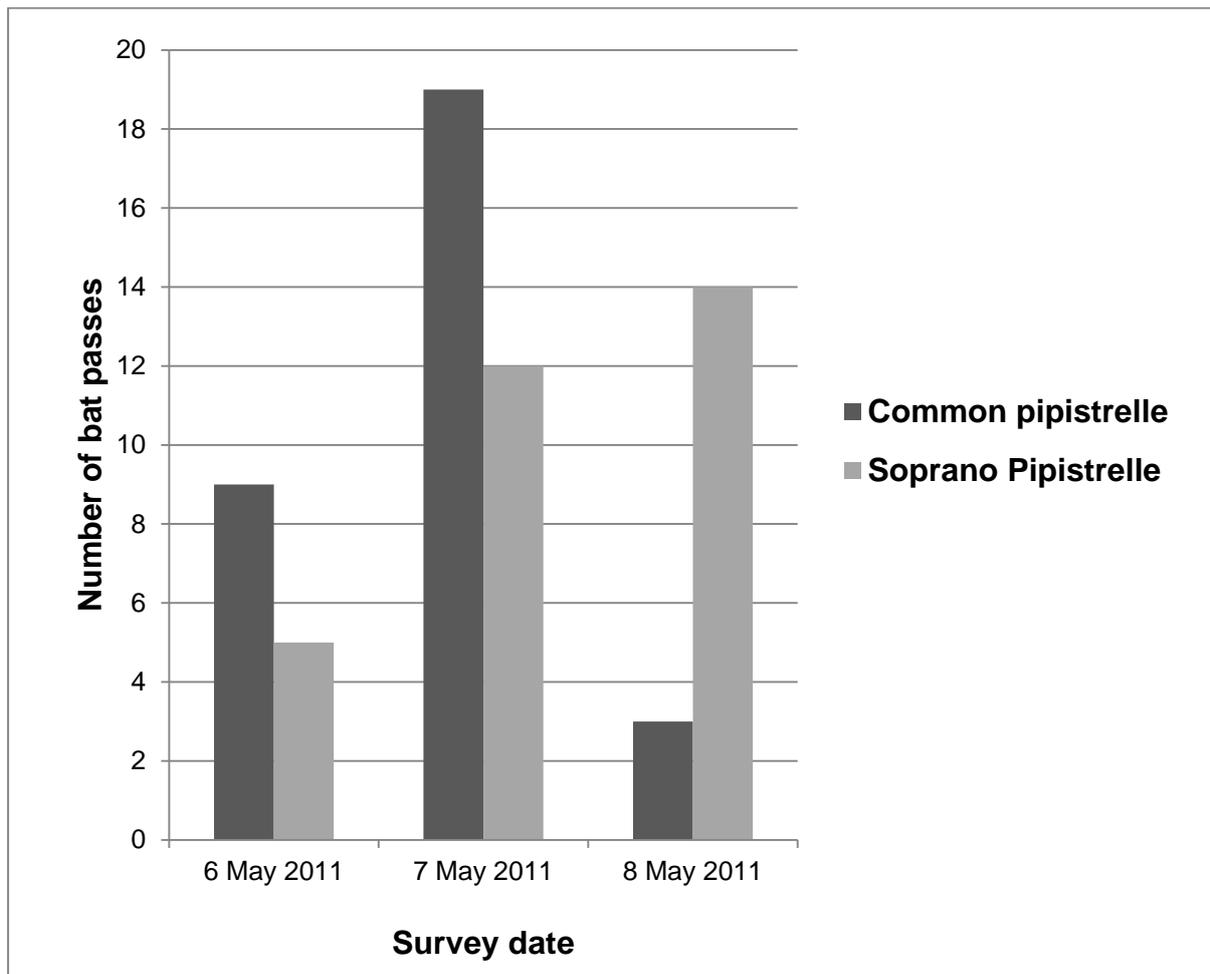
Vol 4 Plate D.1 Terrestrial ecology – bat passes recorded during remote recording survey at Hammersmith Pumping Station

- D.1.9 The bat triggering (remote recording) survey was undertaken over three nights between 6 and 8 May 2011 in suitable weather conditions (see Vol 4 Table D.2).
- D.1.10 The survey recorded two species of bat using the site: common pipistrelle (*Pipistrellus pipistrellus*); and soprano pipistrelle (*Pipistrellus pygmaeus*) (see Vol 4 Plate D.1). A maximum of 19 common pipistrelle bat passes across the three nights was recorded on the second night. Fewer passes were recorded on the first and third nights (nine and three bat passes respectively).

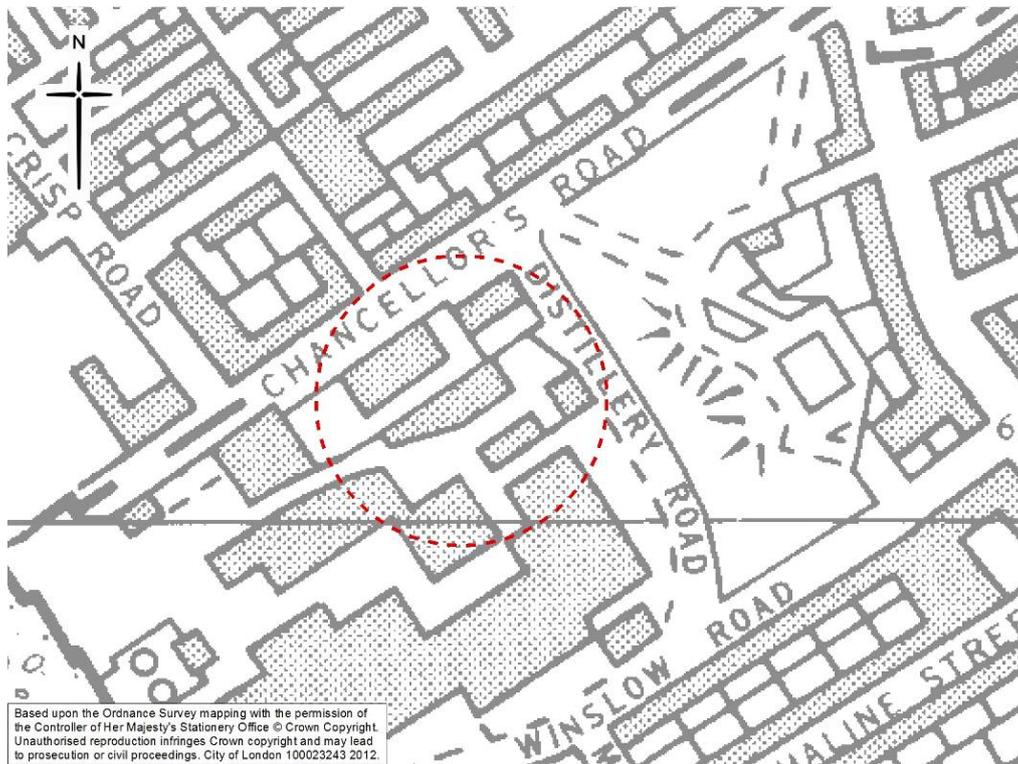
Vol 5 Plate E.8 Historic environment – Ordnance Survey 1:10,000 scale map of 1976 (not to scale)

- E.4.24 Then Ordnance Survey 1:10,000 scale map of 1976 (Vol 5 Plate E.8) no longer shows the terraced houses in the northern part of the site: these have been demolished and replaced with a single industrial building and the existing pumping station. The houses to the east of the site have been demolished, and the area – including the old Distillery Lane – is now an open space with the new Distillery Road on its southwestern side, forming the northeastern site boundary. To the south, the buildings of the distillery have also been replaced by other industrial buildings.

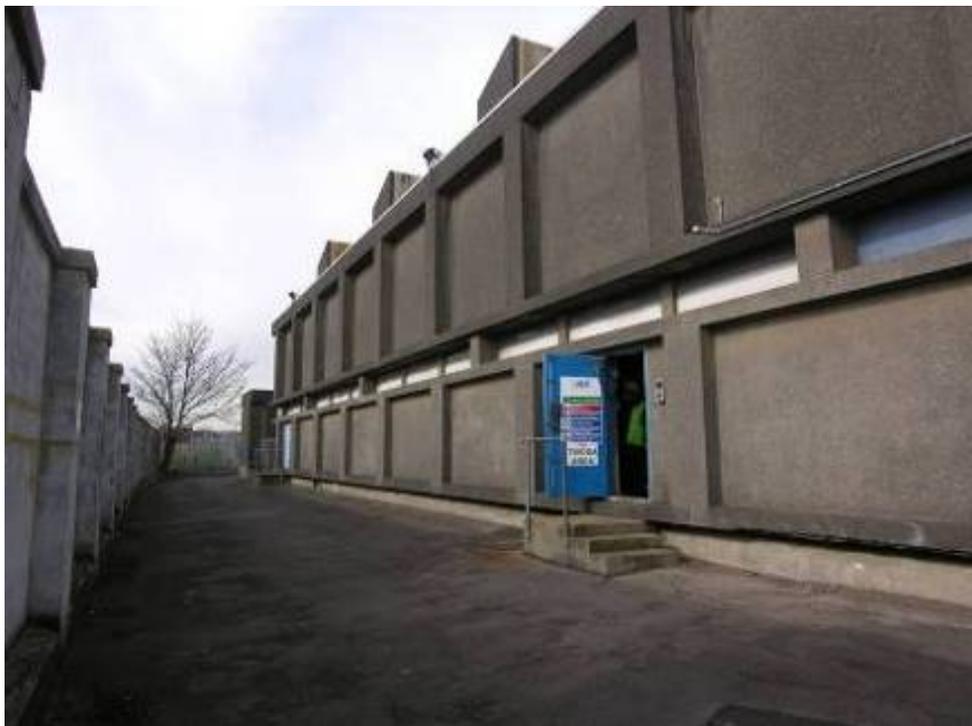
Vol 5 Plate E.9 Historic environment – south side of the Hammersmith Pumping Station (HEA 1A)

March 2011; standard lens, looking west (MOLA 2011)

HEA Ref no.	Description	Site code/ GLHER ref/ List Entry Number
1A	Hammersmith Pumping Station. A modern (1960s) complex of concrete buildings including a control station (incorporating a bronze plaque from the original pumping station) and The Screen House.	---
1B	Hammersmith Embankment, Winslow Road, Distillery Road, W6. An archaeological evaluation by Museum of London Archaeology Service (MoLAS, now MOLA) in 2001. Evidence for a medieval or earlier water channel (Parr's Ditch, which was covered in the 19th century) was found in the eastern part of the site, overlaid by brick foundations of 18th-century date. An undated gully, lined with posts, was uncovered in another area. Elsewhere substantial deposits of made ground indicated that the site had been severely truncated in the 19th century.	WIO01
1C	Hammersmith Embankment, Winslow Road / Chancellor's Road, W6. An archaeological excavation by MoLAS in 2005. Three areas of excavations were undertaken. Evidence of Early Saxon activity was recorded in the form of pits and ditches. Extensive remains associated with 17th-century glass bead manufacture were recorded. The remains of a brick clamp presumably associated with documented brick making by Nicholas Crisp(e) in the 17th	WIZ05

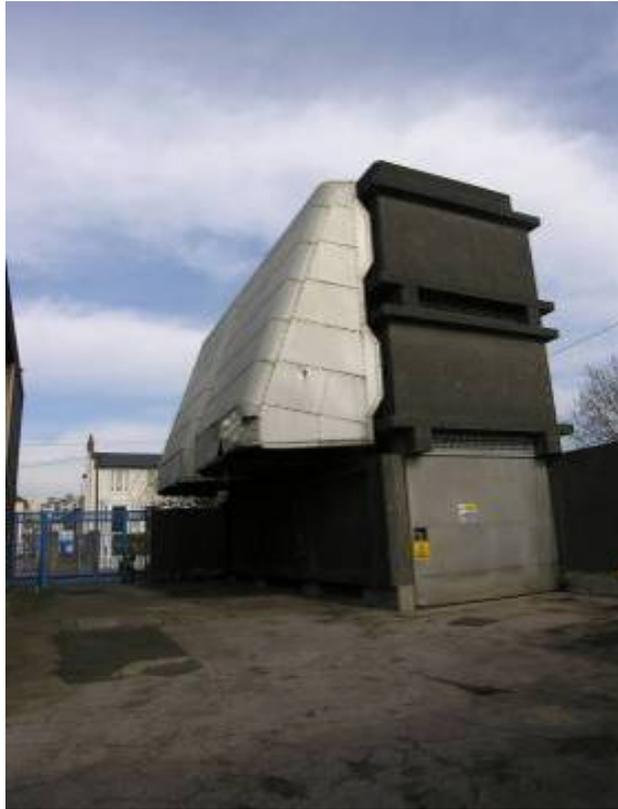
Vol 5 Plate E.10 Historic environment – The Screen House, Hammersmith Pumping Station (HEA 1A)

March 2011; standard lens, looking north (MOLA 2011)

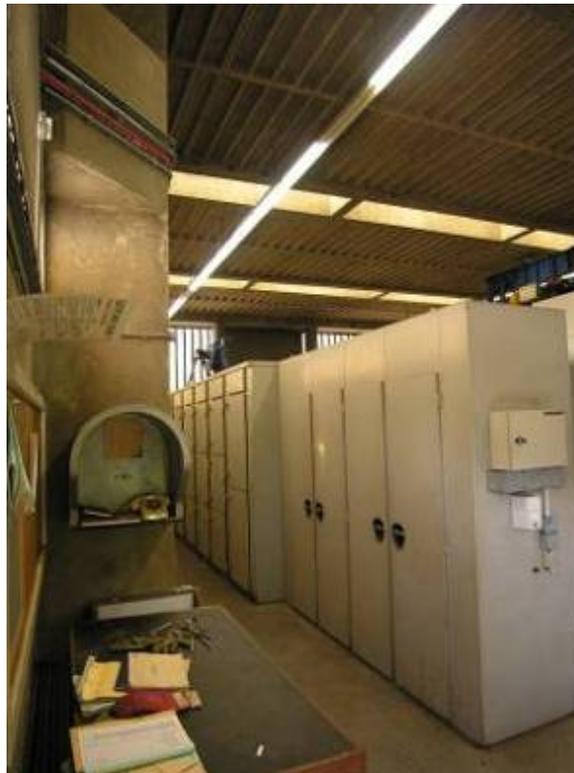
Vol 5 Plate E.11 Historic environment – internal view of Hammersmith Pumping Station (HEA 1A), ground floor

March 2011; standard lens (MOLA 2011)

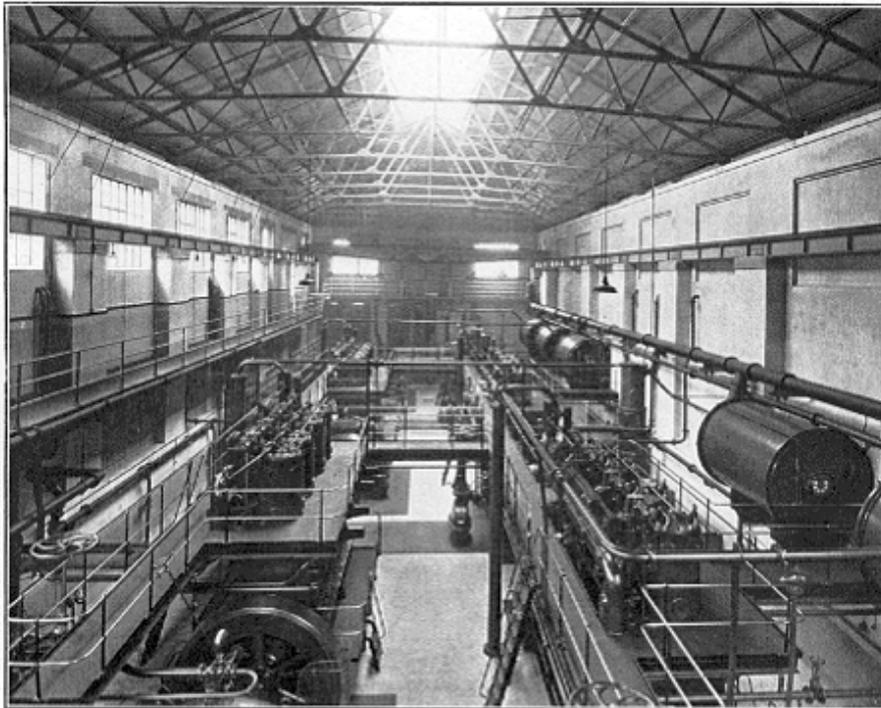
Vol 5 Plate E.14 Historic environment – view within the original Hammersmith Pumping Station (HEA 13) from the article *Main Drainage of London* by Sir G. W. Humphreys, 1930. His name appears on the plaque now in the 1966 building

HAMMERSMITH STORM WATER PUMPING STATION—GAS ENGINES AND CENTRIFUGAL PUMPS.
1922-24.

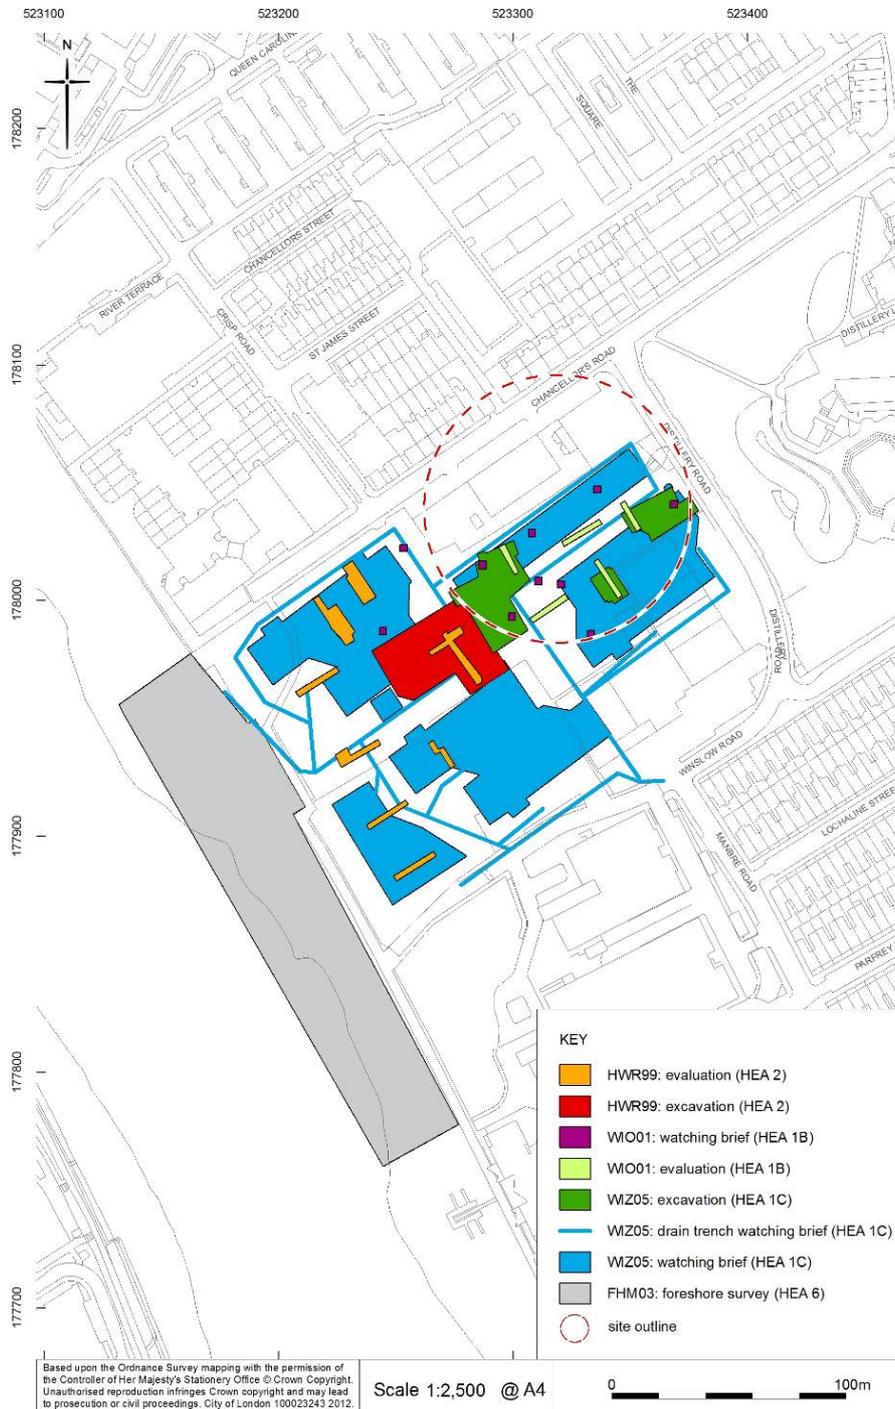
Vol 5 Plate E.16 Historic environment – areas of archaeological investigation in the vicinity of the site, 1999–2007

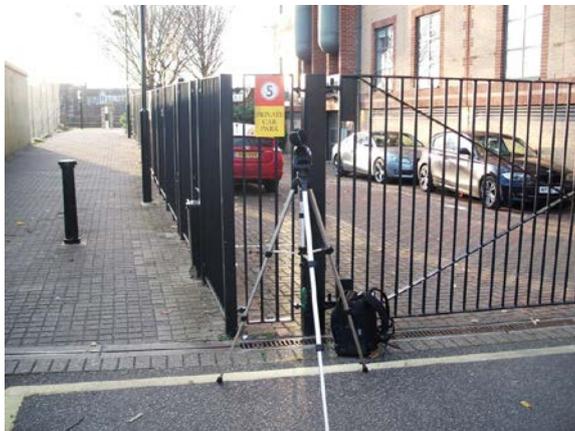
Vol 5 Plate G.1 Noise measurement location HAM01

Note: On public footpath at the end of Chancellor's Road, looking southwest towards River Thames

G.1.14 The following plates (Vol 5 Plate G.1 to Vol 5 Plate G.4) illustrate the noise measurement locations.

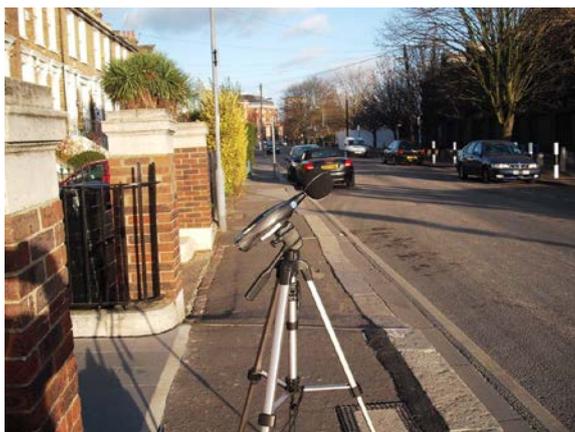
Vol 5 Plate G.2 Noise measurement location HAM02

Note: On public footpath along Chancellor's Road, in front of residential dwellings, looking northeast

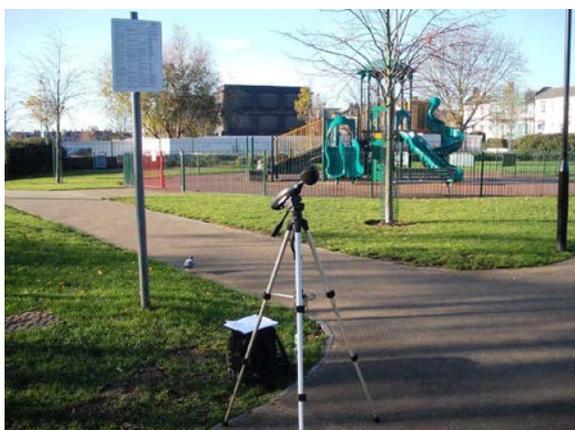
Vol 5 Plate G.3 Noise measurement location HAM03

Note: On public footpath within Frank Banfield Park, looking north

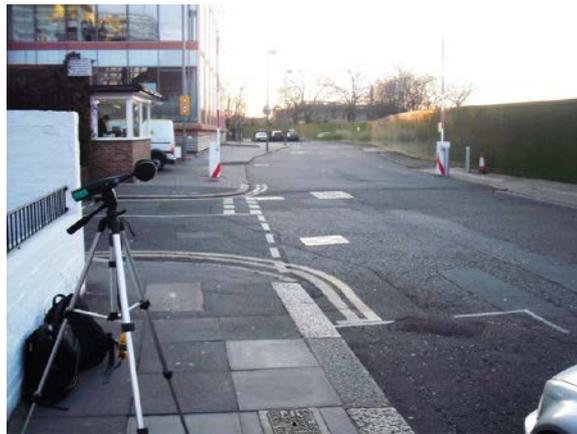
Vol 5 Plate G.4 Noise measurement location HAM04

Note: On public footpath along Winslow Road, in front of residential dwellings looking southwest

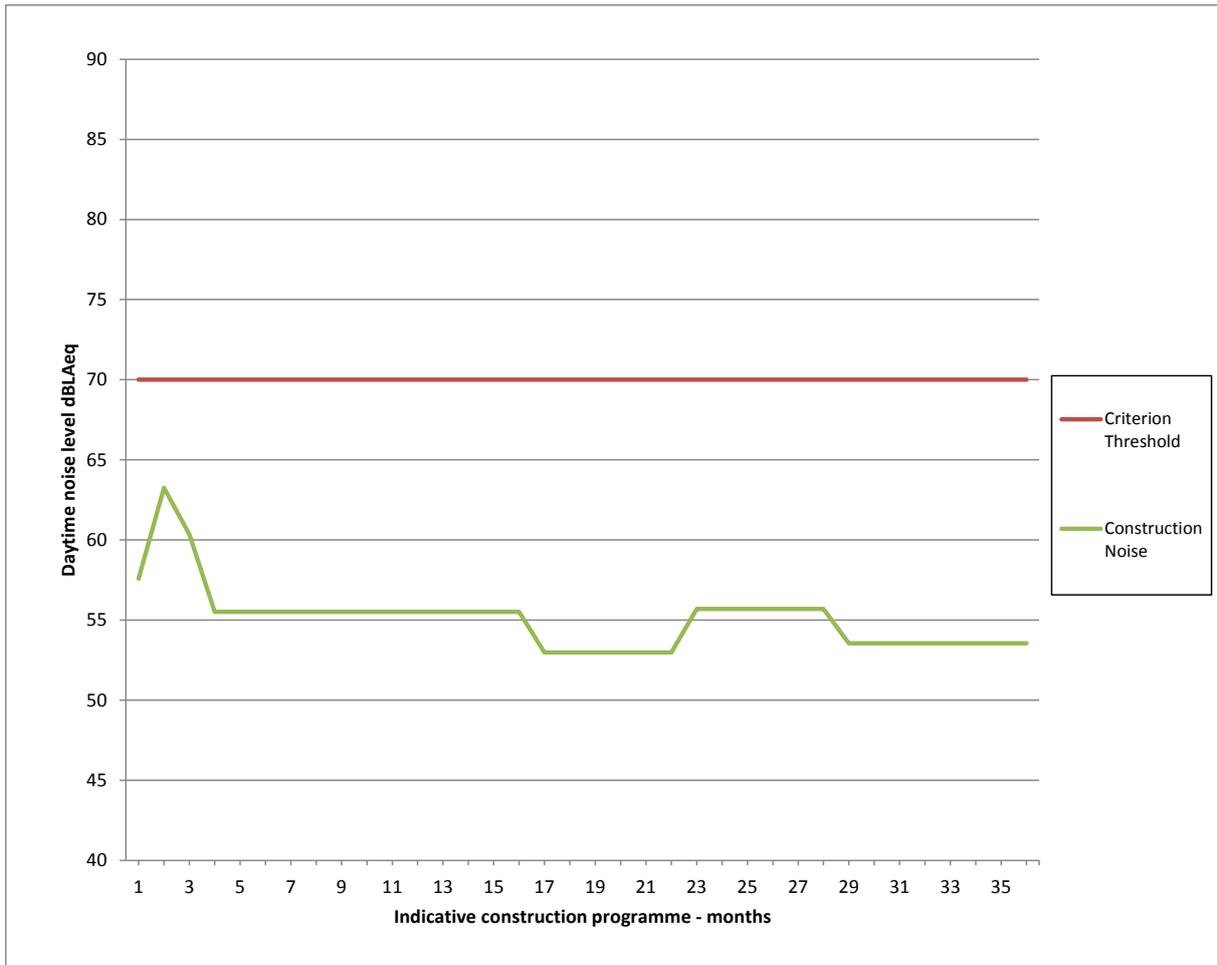
Vol 5 Plate G.5 Average monthly daytime noise level over duration of construction – 48-64 Chancellor’s Road (HA1)

G.2.5 The predicted construction noise over time at each receptor is shown in the figures below. It should be noted that these representations are for the worst-case scenarios for noise exposure at the upper floors. For comparison with the construction noise, the figures also show either the potential significance criterion threshold for residential receptors, or the ambient noise level. This comparison is discussed in the main assessment text. The night time noise levels have also been assessed for the short period of night time works, these results are described in the main assessment text and not presented here.

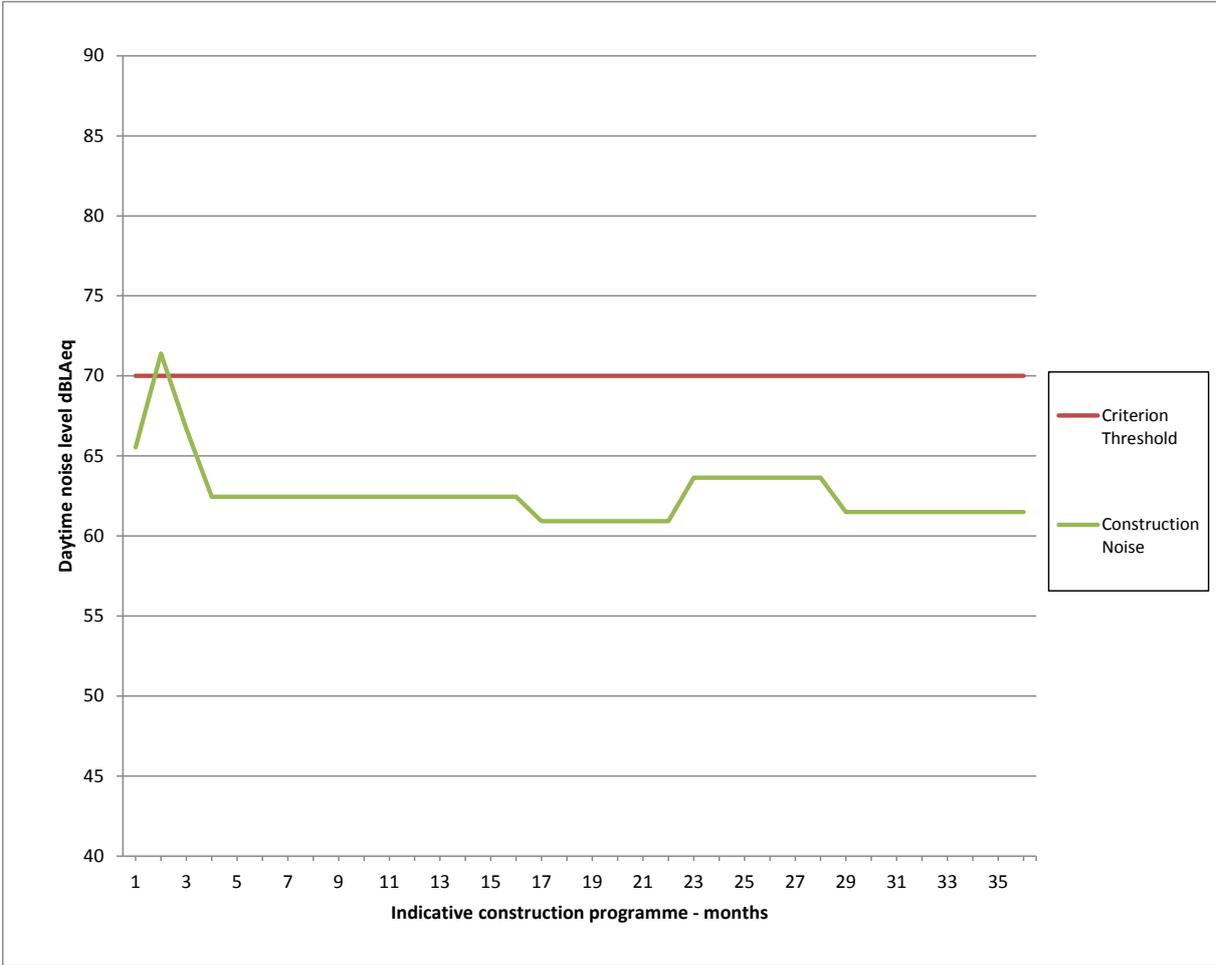
Vol 5 Plate G.6 Average monthly daytime noise level over duration of construction – 28-44 Chancellor’s Road (HA2)

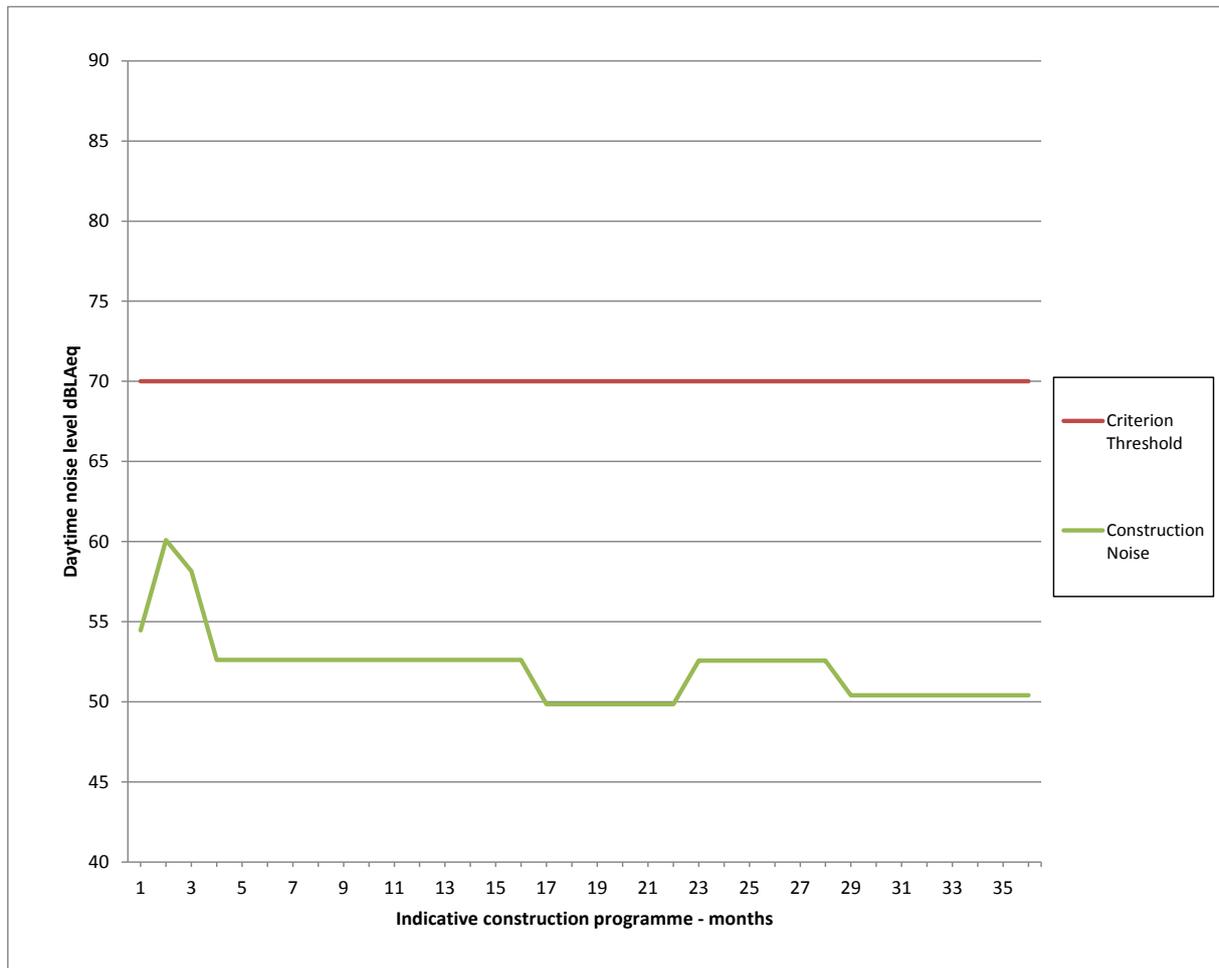
Vol 5 Plate G.7 Average monthly daytime noise level over duration of construction – 82-104 Fulham Palace Road (HA3)

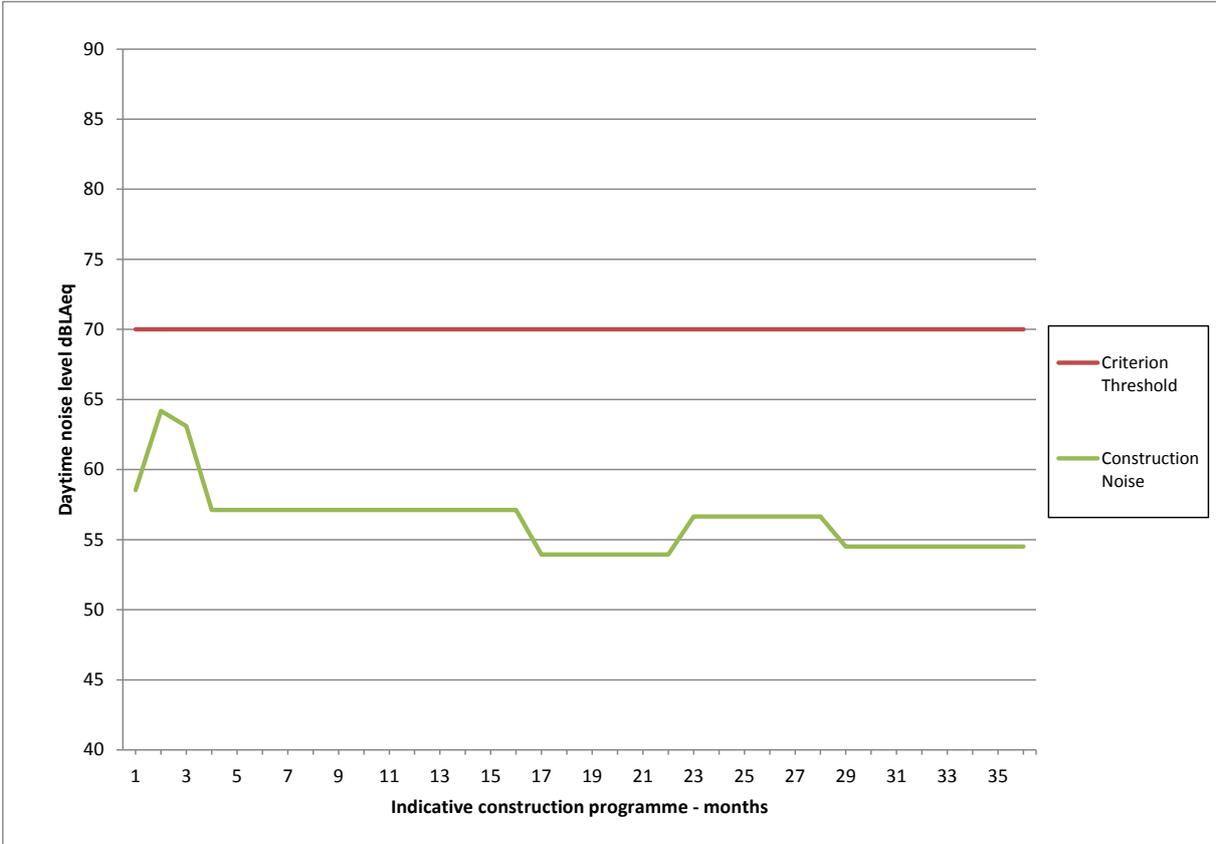
Vol 5 Plate G.8 Average monthly daytime noise level over duration of construction – 11 Winslow Road (HA4)

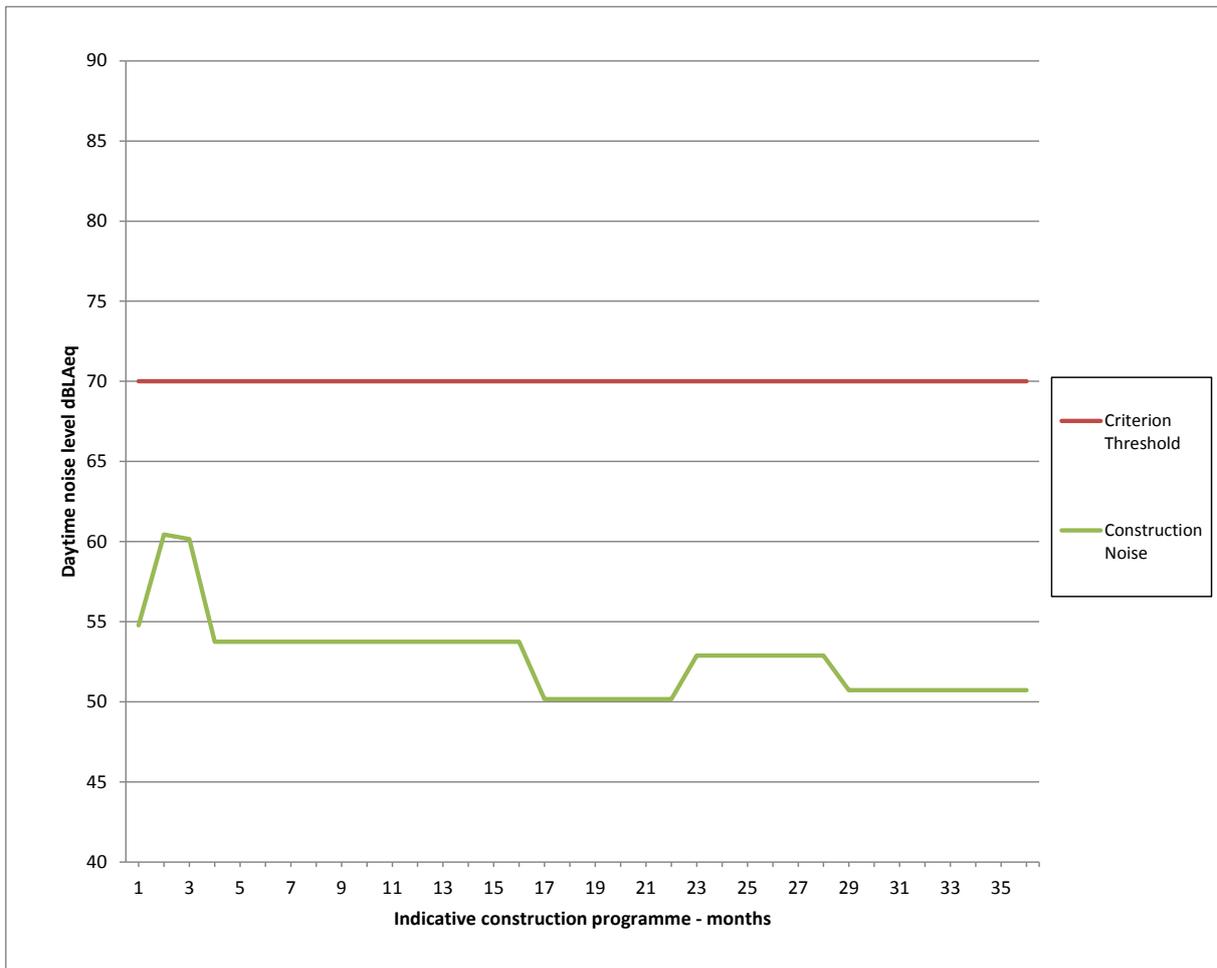
Vol 5 Plate G.9 Average monthly daytime noise level over duration of construction – 43 Winslow Road (HA5)

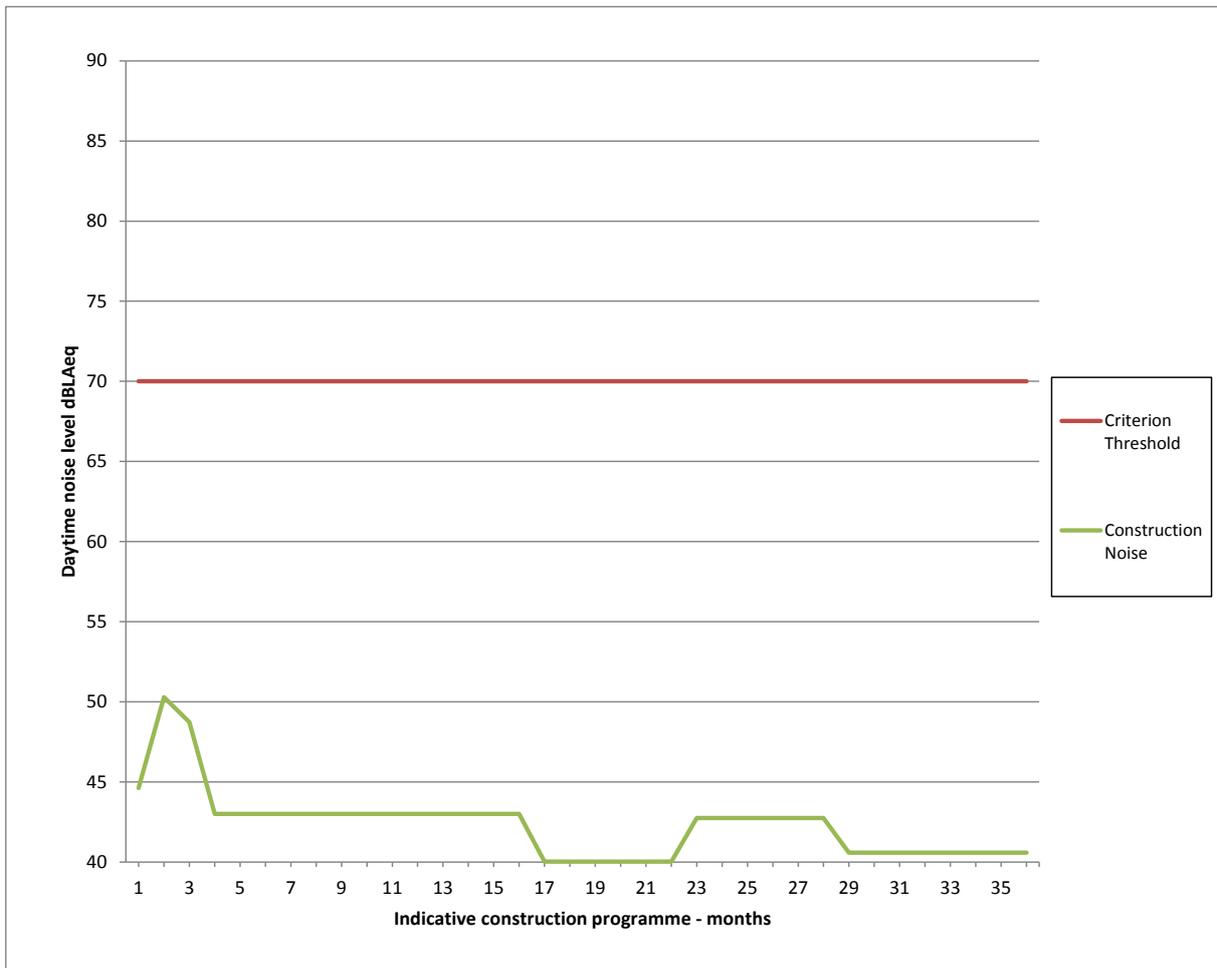
Vol 5 Plate G.10 Average monthly daytime noise level over duration of construction - 106-111 Riverview Gardens (HA6)

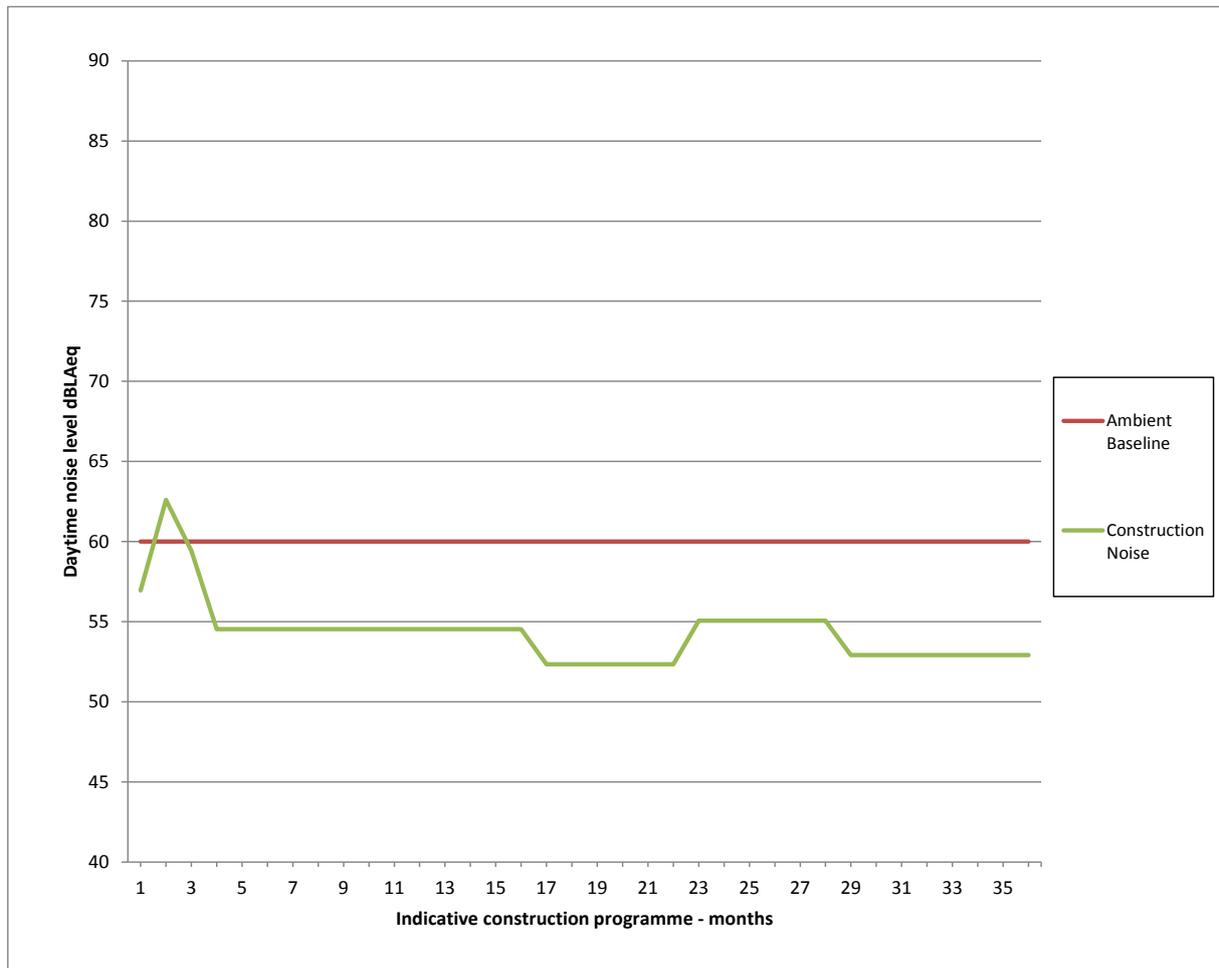
Vol 5 Plate G.11 Average monthly daytime noise level over duration of construction – Frank Banfield Park (HA7)

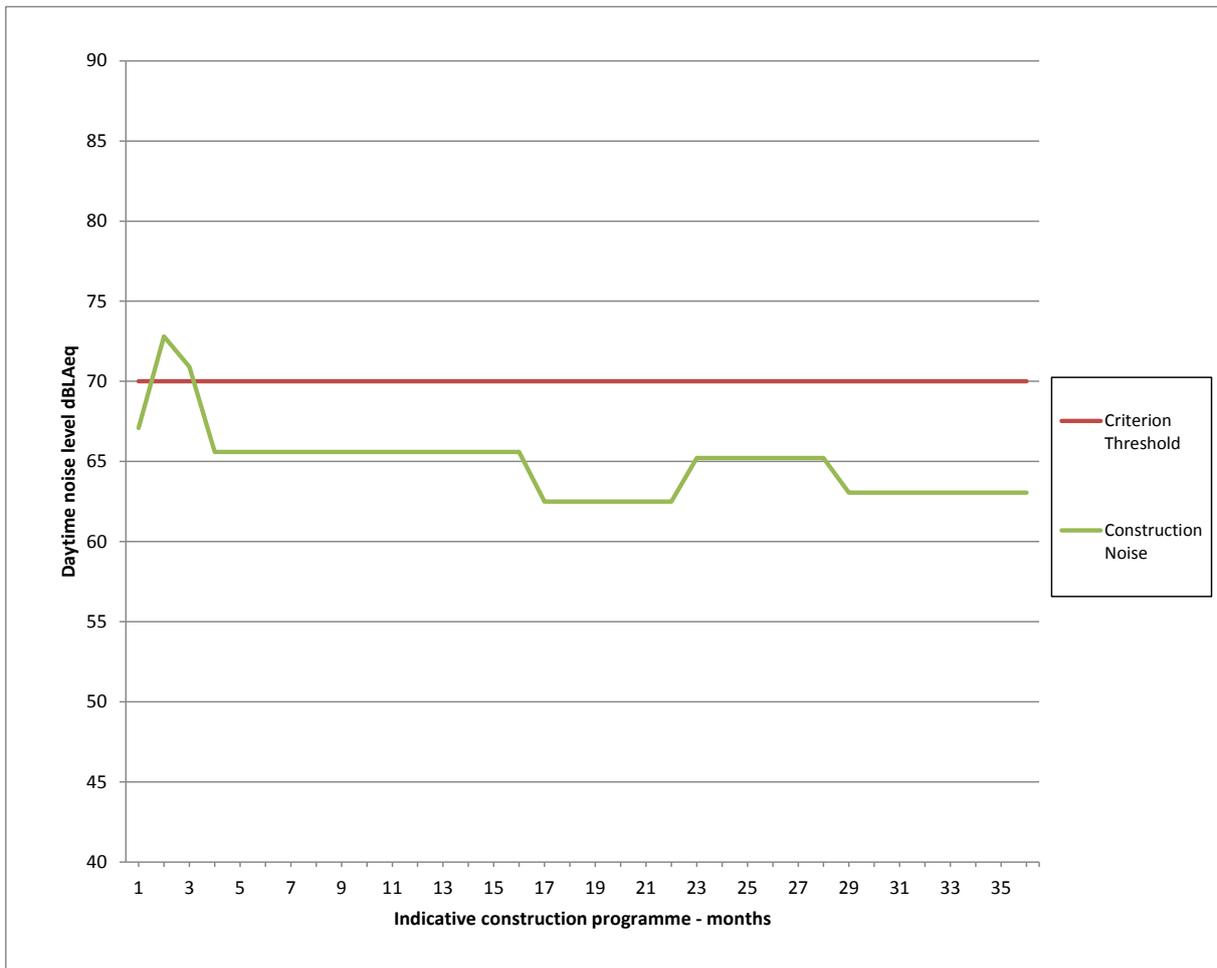
Vol 5 Plate G.12 Average monthly daytime noise level over duration of construction – Fulham Reach Phase 1 Block A (HA8)

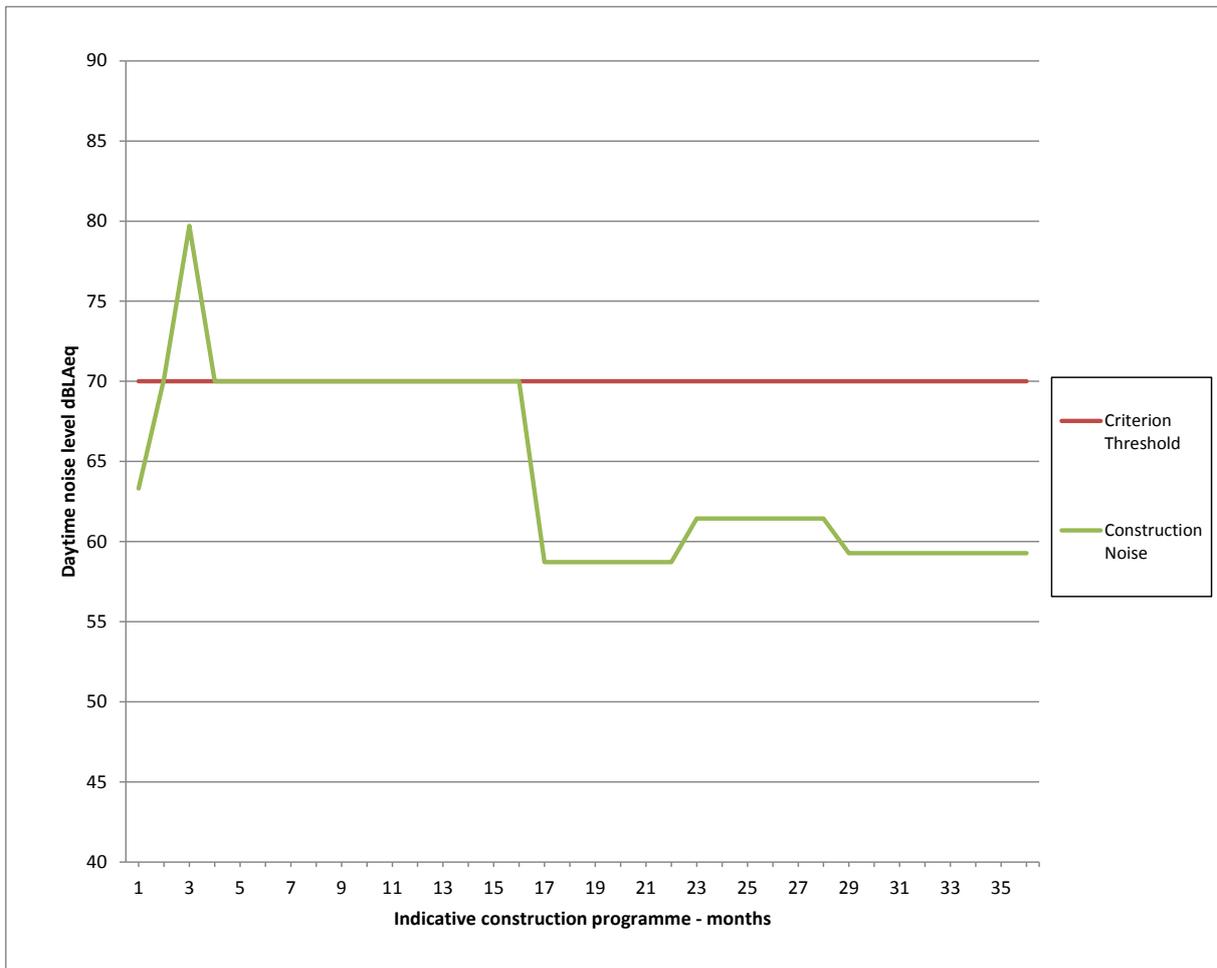
Vol 5 Plate G.13 Average monthly daytime noise level over duration of construction - Fulham Reach Phase 2 Block B (HA9)

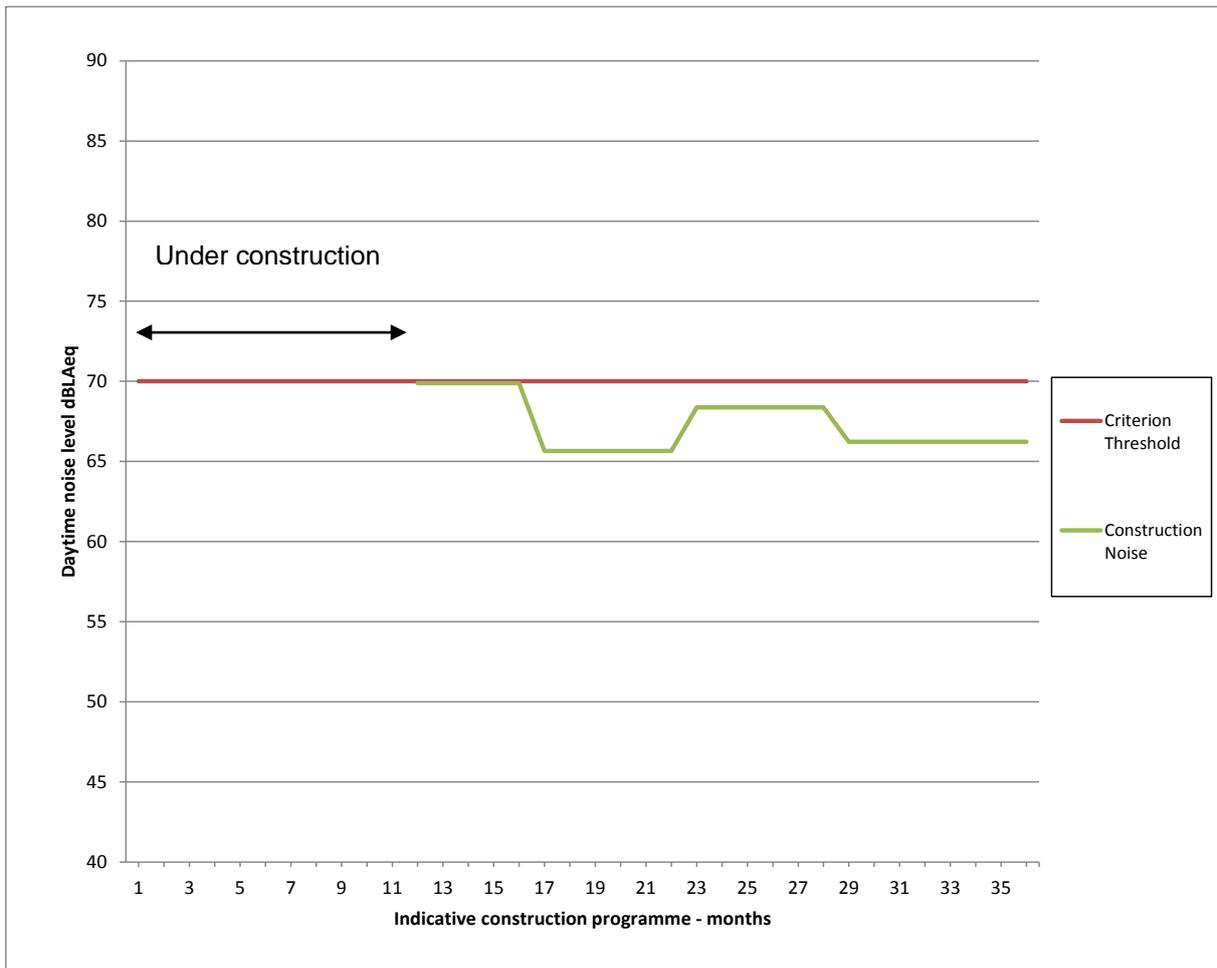
Vol 5 Plate G.14 Average monthly daytime noise level over duration of construction - Fulham Reach Block F (HA11)
