**Thames
Tideway Tunnel**

Environmental Statement

Volume 3: Project-wide effects assessment appendices

E.1 Building damage assessment Stage 3 report – Listed Buildings

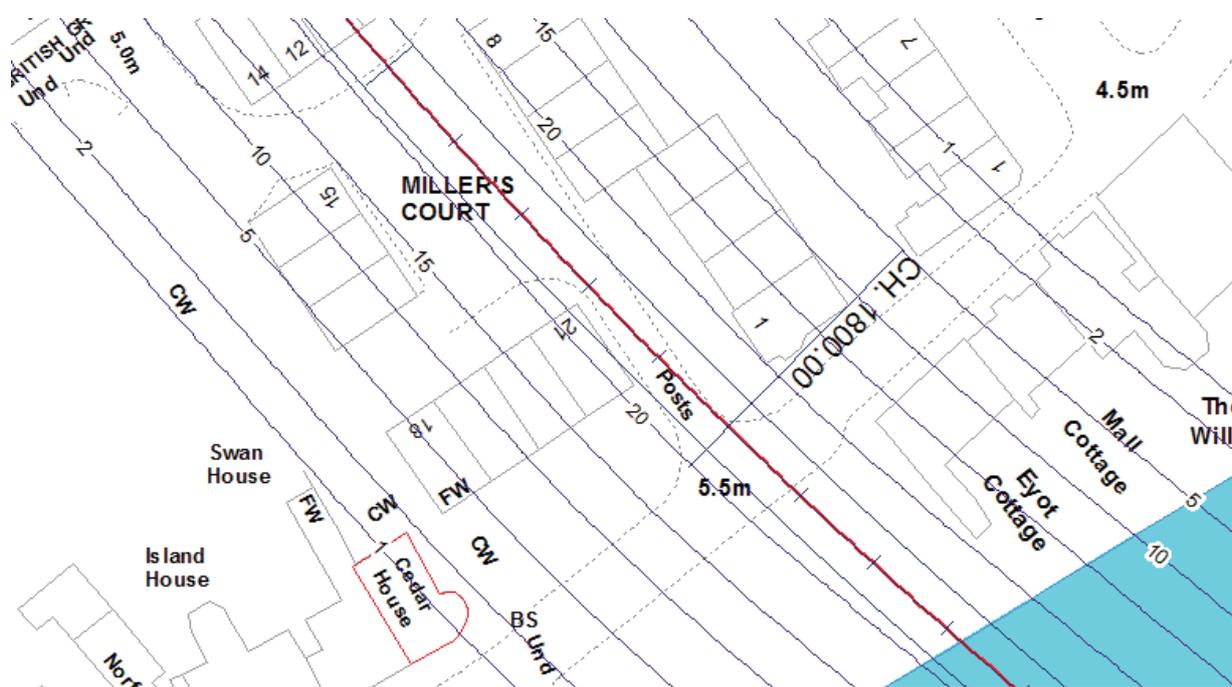
Settlement contours generated at +103.2mTD, approximate base slab level, assuming 1m below ground surface;

As shown above the building sits outside of the 1mm settlement contour modelled.

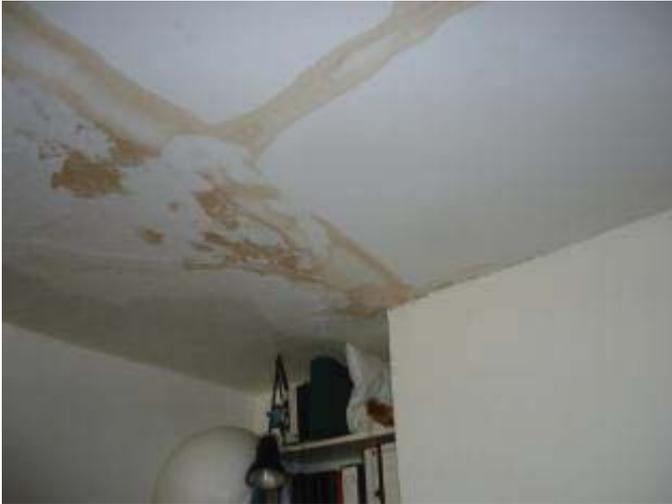
On the second floor there is an extensive build up of flooring in the northern room, reported to be 4 layers, and a grid of battens on the ceiling, apparently added as strengthening during WWII. In the southern room there are signs of water damage, caused by blocking of the internal gutter above the ceiling.

Example of internal water damage

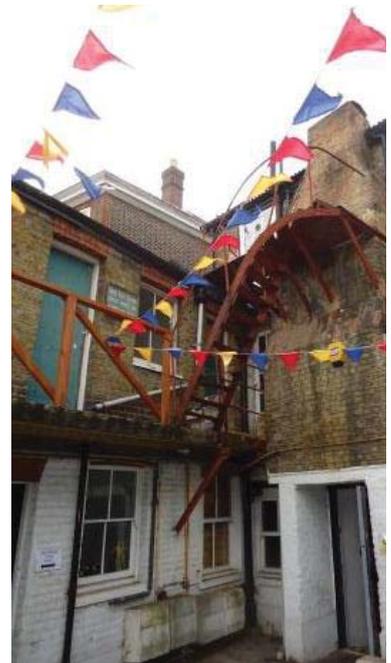
Iron stair to the rear of the building, in poor condition

The building is generally in good condition, with solid façades and no cracking to the external faces. However, the interior has experienced some water damage and is in need of some renovation. The vestiges of the iron fire escape to the east are in poor condition. The condition of the building as it is should not present any sensitivity to the movement that occurs during the Thames Tunnel construction; should the building be allowed to deteriorate it may become more sensitive. However, at present the occupiers of the building are conducting sensitive repairs with the agreement of the local authority, and this work is due to continue.

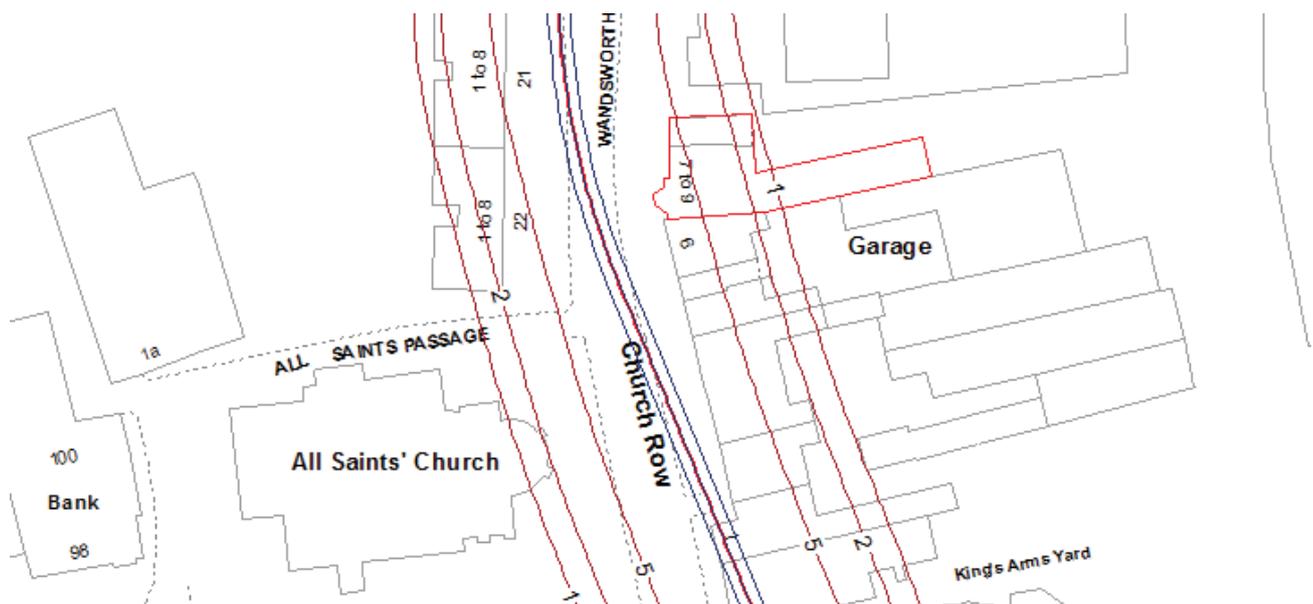
Settlement contours generated at +103.3mTD, assumed base slab level.

As shown above the buildings cross the 5mm, 2mm and 1mm settlement contours.

The results fell within the bounds of category 0, risk of negligible damage. A maximum tensile strain of 0.01% and a maximum settlement of 8mm were obtained for the building.

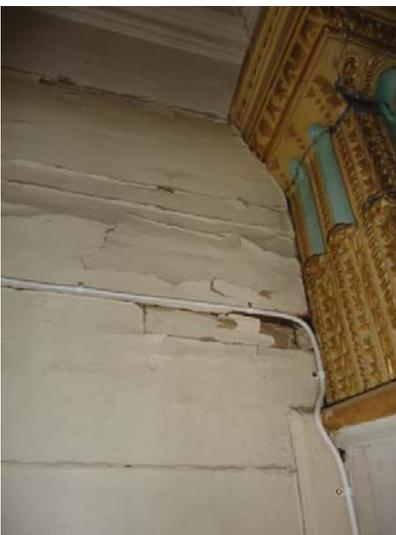
Detail of damage to plaster and decorative pilasters

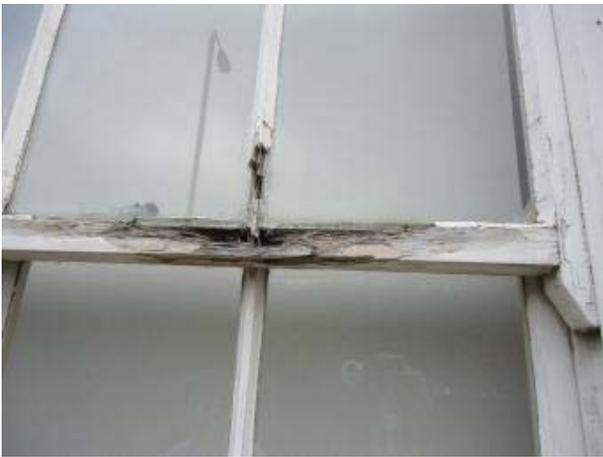
Example of degradation to timber sash windows

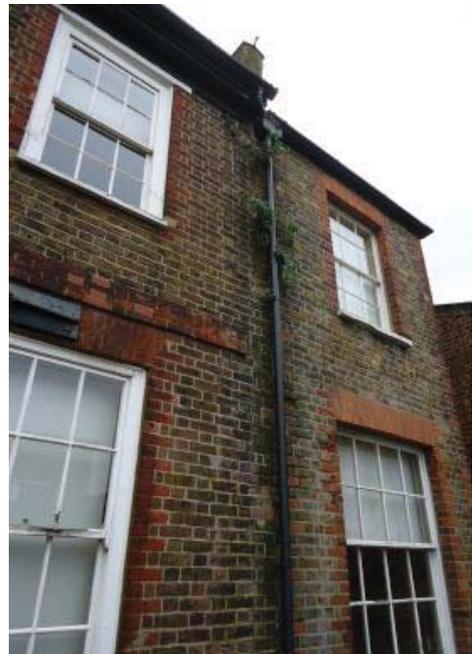
Water damage and vegetation due to faulty down-pipe

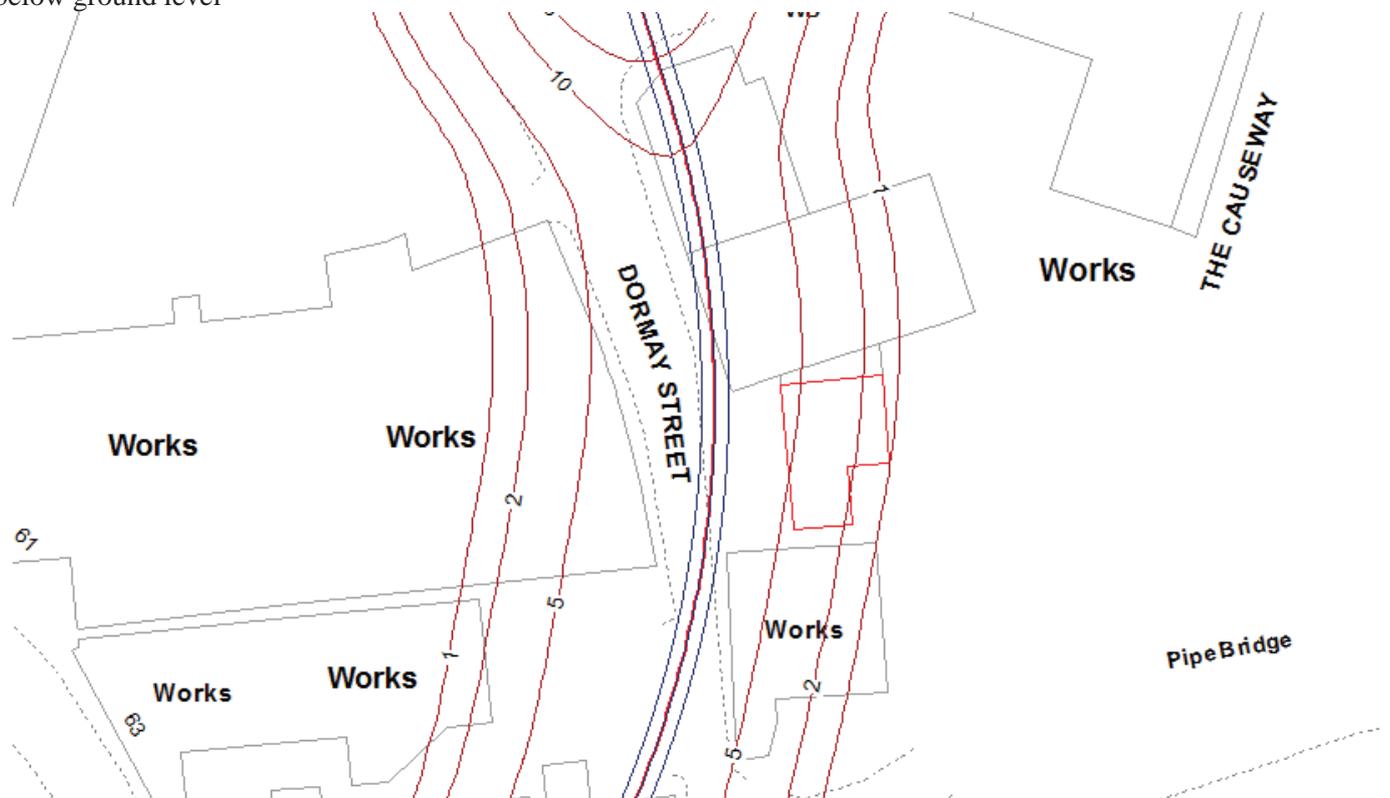
Settlement contours generated +103mTD, approximate base slab level for shallow ground bearing foundations, 1m below ground level

As shown above the building crosses the 5mm and 2mm settlement contours generated for the tunnel.

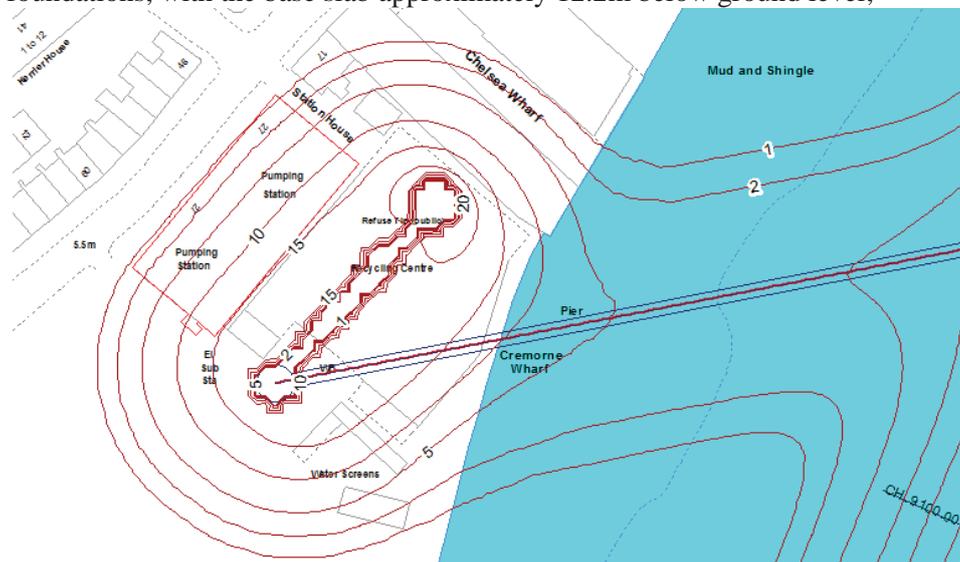
Settlement contours have been analysed at +92.8mTD and +96.0mTD to represent a variation in deep basement level above and below the Suction Culvert. Settlement Contours are presented for the deepest basement level +92.8mTD, assuming shallow foundations, with the base slab approximately 12.2m below ground level;

As shown above the building extends from the 15mm contour across the 10mm, 5mm, 2mm and 1mm contours.

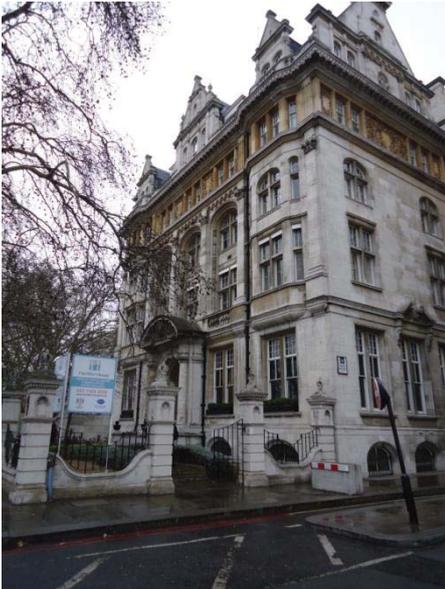
Front (south) elevation to Victoria Embankment

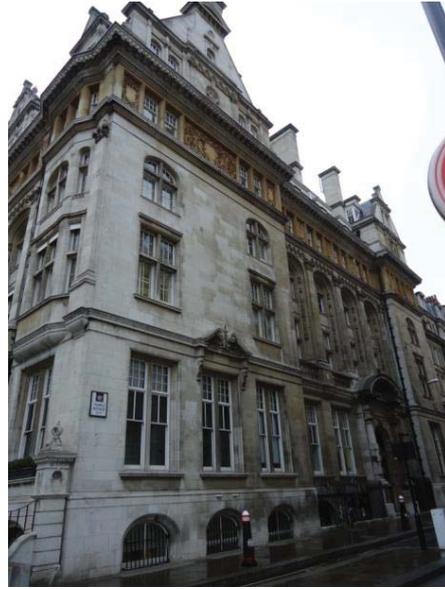
East elevation to Temple Avenue

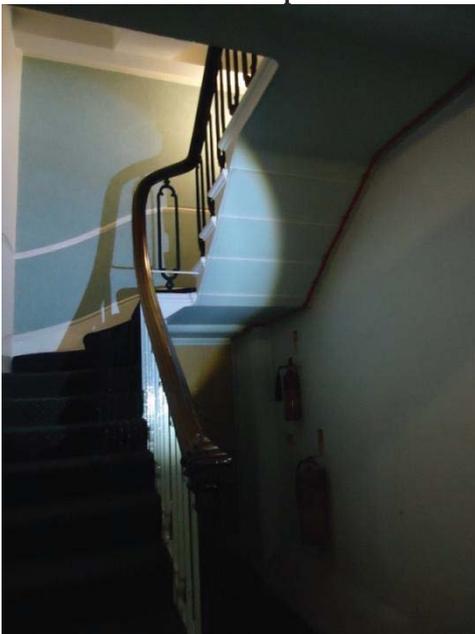
Secondary cantilevered stair

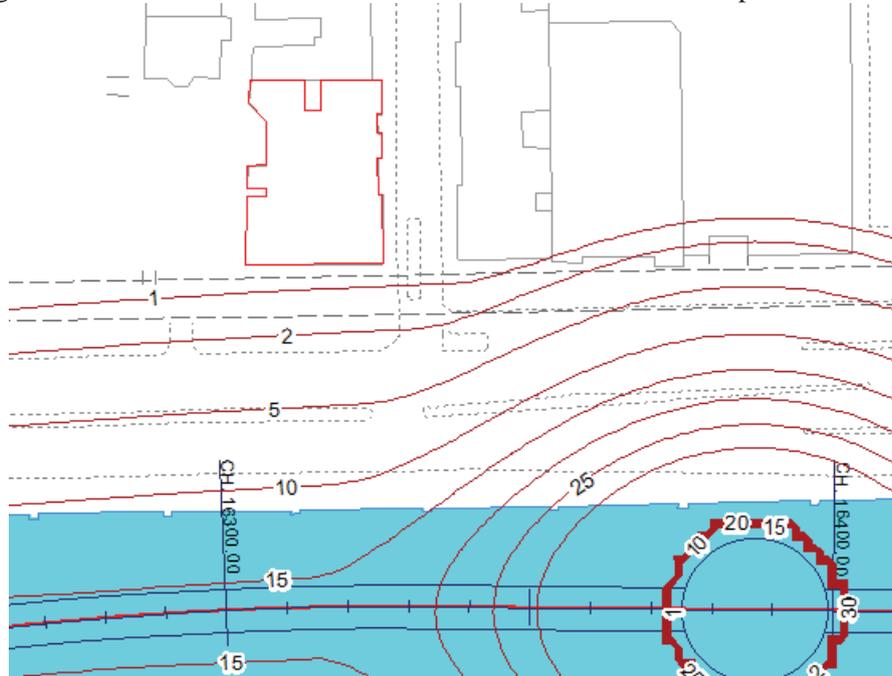
Settlement contours generated +100.1mTD, assumed base slab level, with a 4m deep basement

As shown above the building lies outside of the 1mm settlement contour.

The results fell within the bounds of category 0, risk of negligible damage. A maximum tensile strain of 0.004% and a maximum settlement of 0.7mm were obtained for the building.

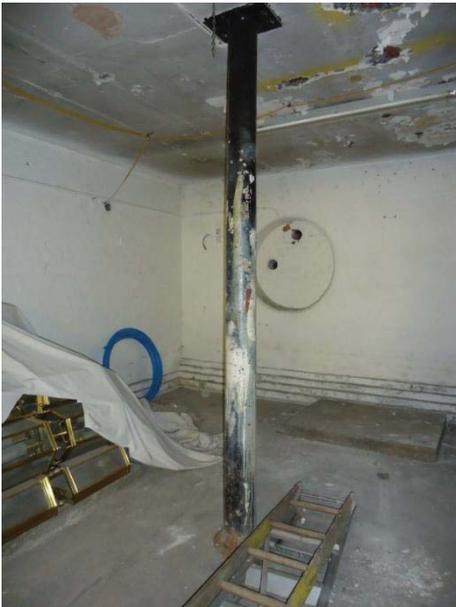
Internal cast iron column in basement – the pattern of columns is repeated throughout the building

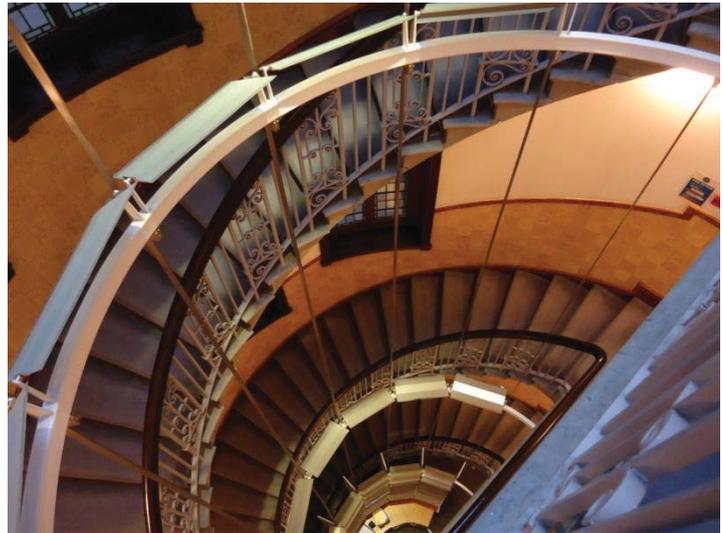
The larger central stair curves round an oval well. A number of partially open joints were identified at various levels. The wedge of stone around the upright at the edge of the landing closest to the stair flight has broken away and been replaced on most levels; it has broken out again at one level.

Principal cantilevered stair

Telephone House has particular heritage features, which may be sensitive to large movements and settlement. The cantilevered stairs are fragile and show some defects. Other sensitive features include the exterior stonework which is ornate and tightly jointed, and internal plaster and timber.

It is recommended that the stone is properly repaired and any open joints are grouted up using appropriate specialists.

It is recommended as a matter of general building maintenance that the stone stair is properly repaired and any open joints are grouted up using appropriate specialists.

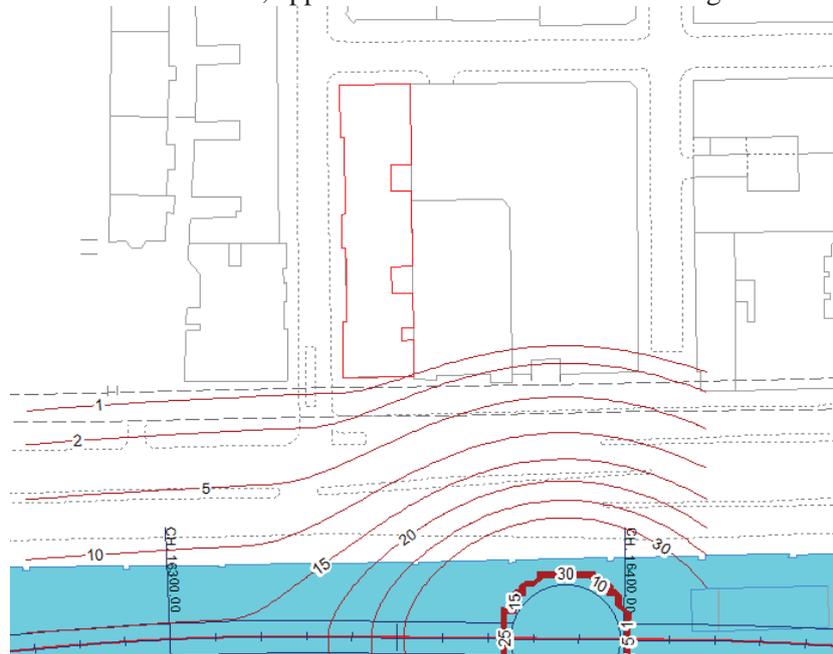
Settlement contours generated at +100.6mTD, approximate base slab level assuming a 4m deep basement;

As shown above the building sits just touches the 1mm ground settlement contour that has been generated.

The results fell within the bounds of category 0, risk of negligible damage. A maximum tensile strain of 0.009% and a maximum settlement of 1mm was generated for the structure.

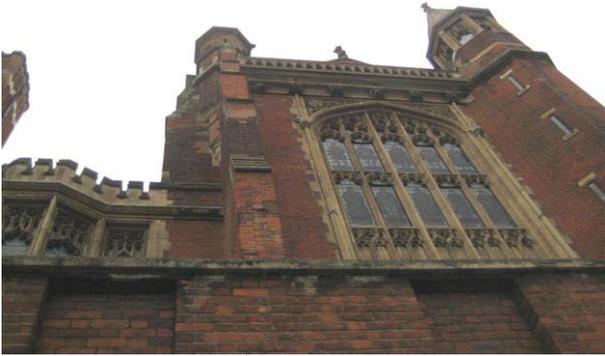
River façade showing 1st floor window at end of main hall

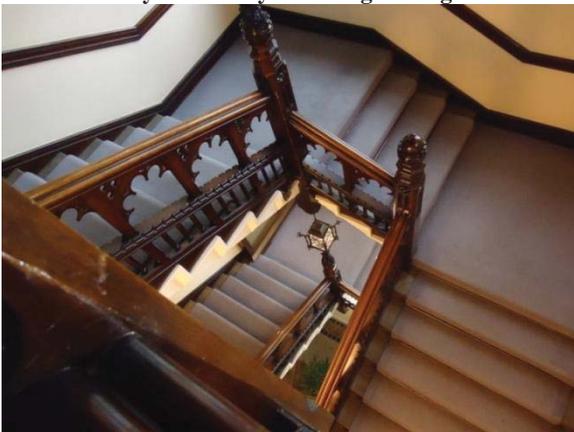
Principal stair, cantilevered with timber banisters and finials

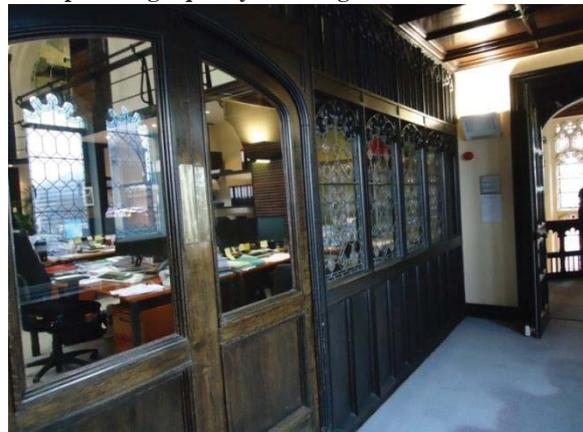
Timber screen with fine stained glass, delicately jointed

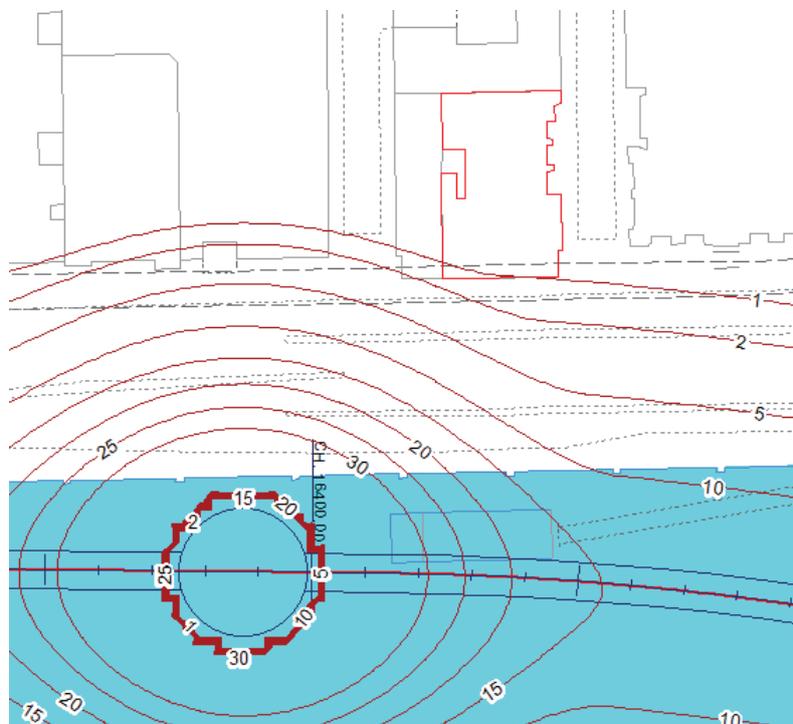
Settlement contours generated +104.2mTD, base slab level assumed to be 1m below ground level;

As shown in the extract above the building is located just within the 1mm settlement contour modelled for the tunnel.

All results fell within the bounds of category 0, risk of negligible damage. A maximum tensile strain of 0.008% and a

maximum settlement of 1.5mm were obtained for the building façades, when modelled as a 10m structure, without a basement (foundations at 1m bgl).

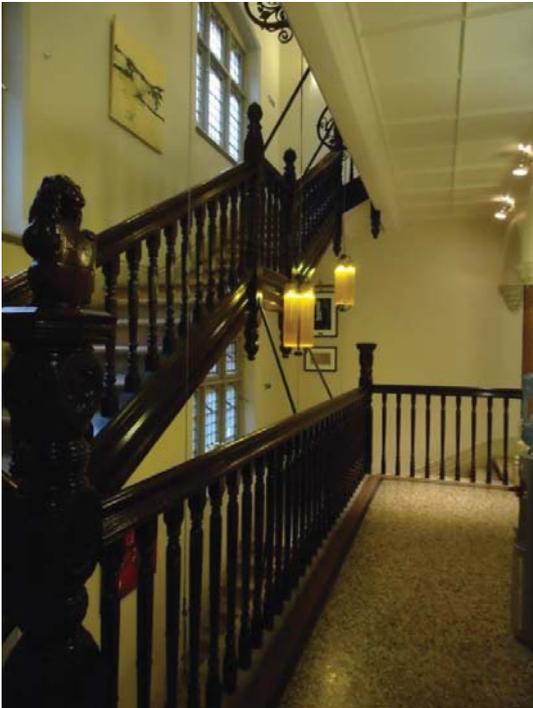
Condition	Good. Recent steelwork has been added to stiffen the stone cantilever stairs and handrails.
Assumed foundations	There is a single level of basement. All walls are assumed to be founded on shallow strip footings.
Façade material	Brick with stone dressings
Internal support system (i.e. superstructure)	Loadbearing masonry, including some loadbearing arches at ground floor.
Heritage	Good quality Tudor-Gothic façades with prominent oriel window to the southern elevation; interior original features including panelling, cornices, and excellent plasterwork especially to the library at the southern end of the building; good quality cantilevered stone stair.

Cantilevered stair showing later supports

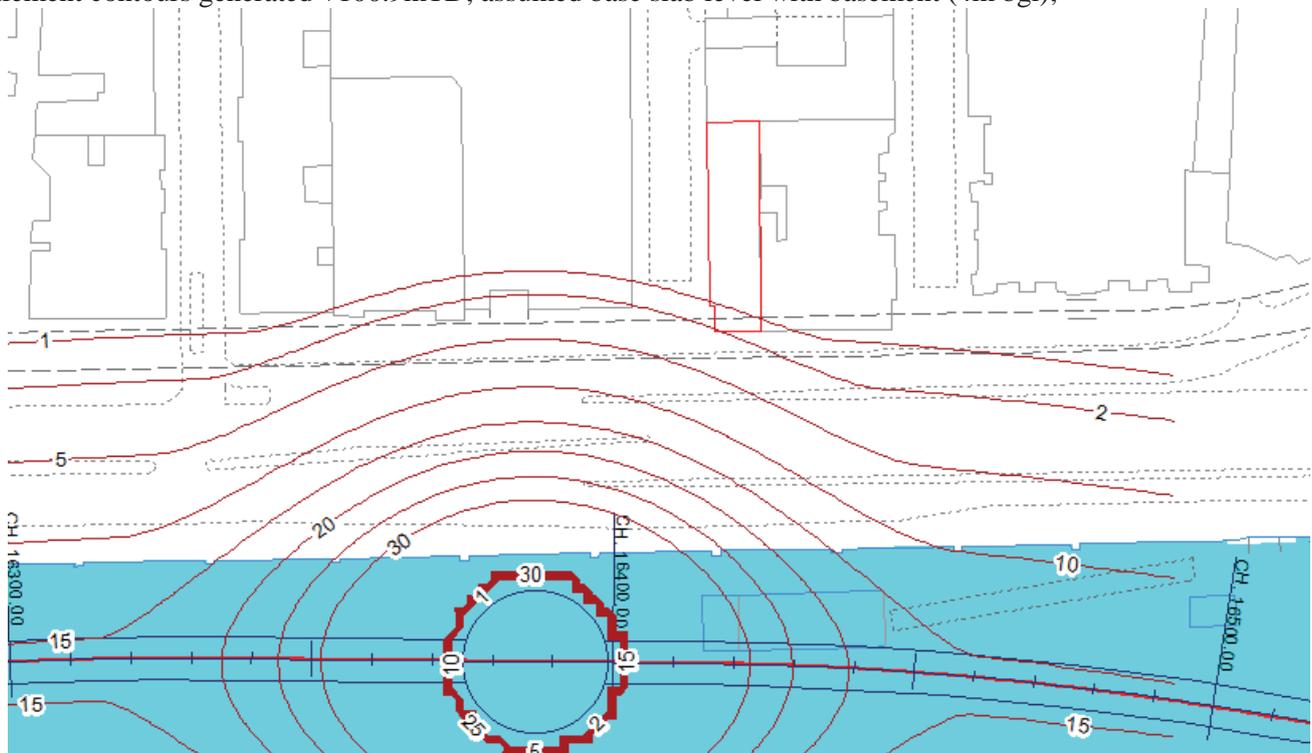
Settlement contours generated +100.9mTD, assumed base slab level with basement (4m bgl);

As shown above the building sits outside the 1mm settlement contour generated for the tunnel.

All results fell within the bounds of category 0, risk of negligible damage. A maximum tensile strain of 0.02% and a maximum settlement of 2mm were obtained for the building (settlement remained the same for both models,

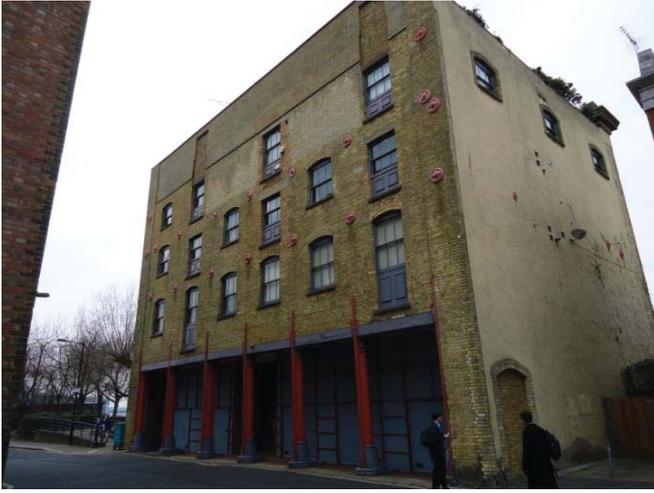
Road (south) elevation and east elevation

This building is in poor condition, with external cracking evident, particularly to the south-eastern corner of the building, where there may have been previous movement. There are also areas of spalled brickwork, probably due to the unsympathetic use of cement mortar when previous repairs have taken place. The movements that may occur due to settlement are likely to be concentrated at the locations of pre-existing cracks.

Because of the very small calculated movements, mitigation measures are not considered necessary. However, it is noted that there is significant existing cracking and it is important that a condition survey is undertaken before the works to avoid the risk of any dispute over the responsibility for the (pre-existing) cracking.

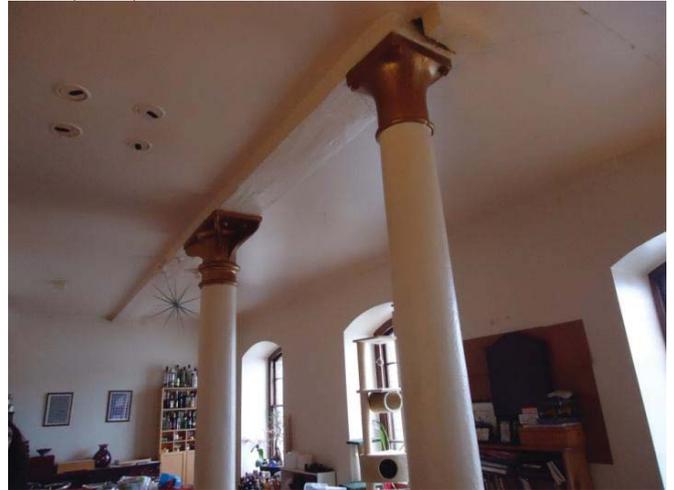
- Internally there has been local 2 to 3mm settlement of the ground floor internal walls relative to the cast iron columns.
- Where visible, the base of the internal cast iron columns are heavily pitted, showing historic corrosion no doubt due to the brackish water.

Example of cast iron columns, ground floor

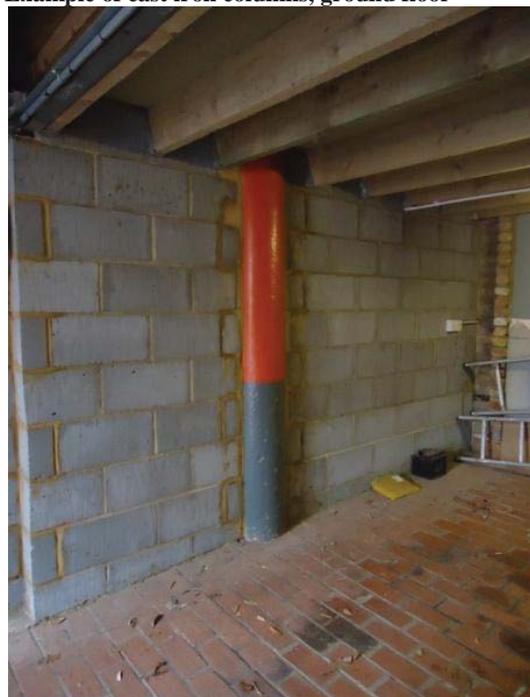
Cast iron column embedded in modern wall, ground floor storage area

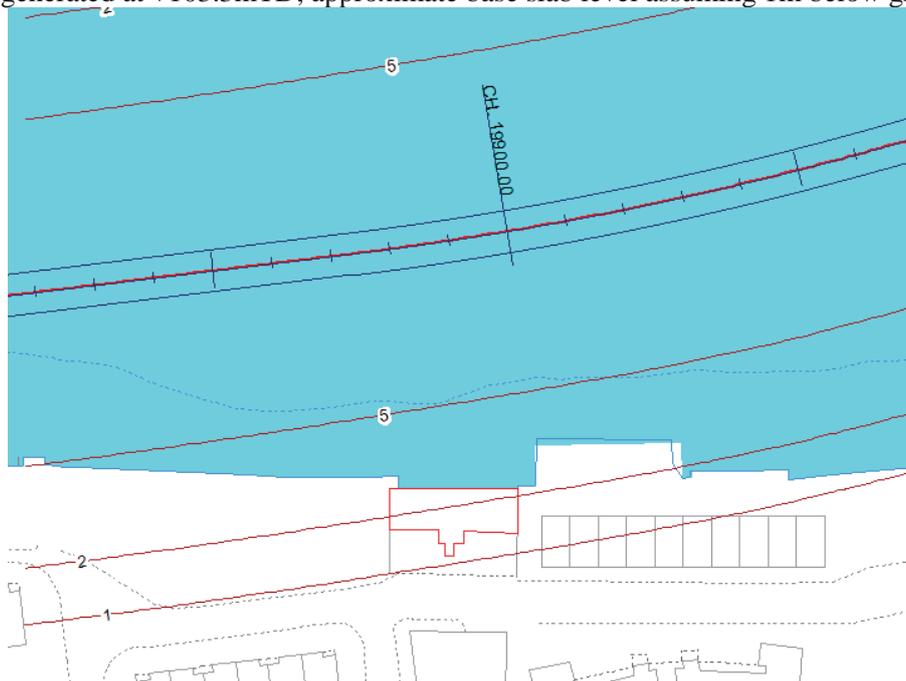
Settlement contours generated at +103.3mTD, approximate base slab level assuming 1m below ground level.

As shown above the building crosses the 2mm settlement contours, sitting between the 1mm and 5mm contours.

All results fell within the bounds of category 0, negligible damage. A maximum tensile strain of 0.005% was obtained when the building was modelled with piled foundations and a maximum settlement of 3mm was obtained for the structure, when modelled with shallow foundations.

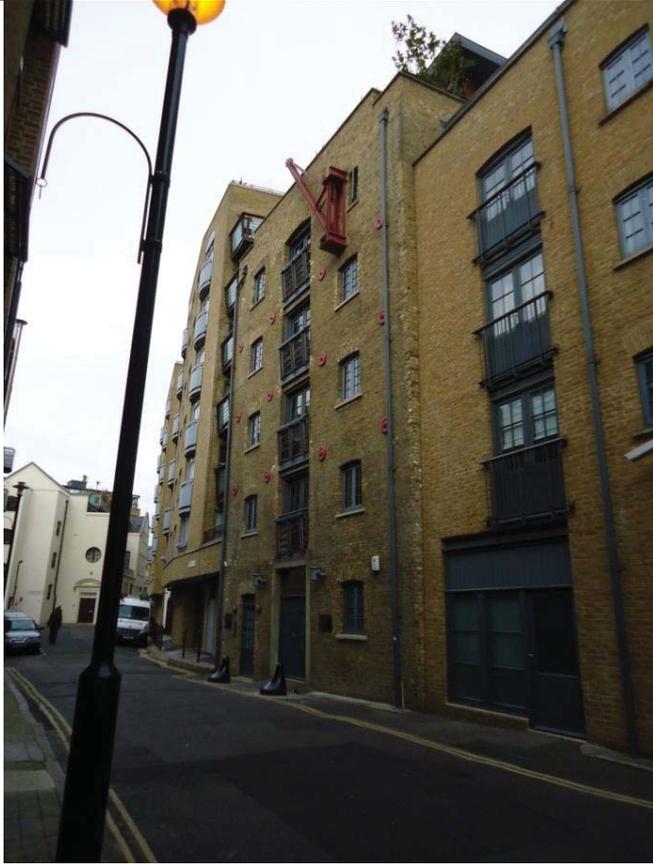
The condition is generally good. Each floor has 4 ties with buttress plates, visible from the street facade. There was evidence of previous repointing and replacement of brickwork on the external walls. Externally, a lean of the north and south facing facades (of about 200-250mm at the top) was visible, away from the river. The building has similar dimensions on plan as it does in height (i.e. 16m x 18m on plan, approximately 15m high), so assuming a rigid body rotation then for the building to lean 200-250mm at the head, this would imply a 200-250mm settlement of the south facade.

Southern elevation

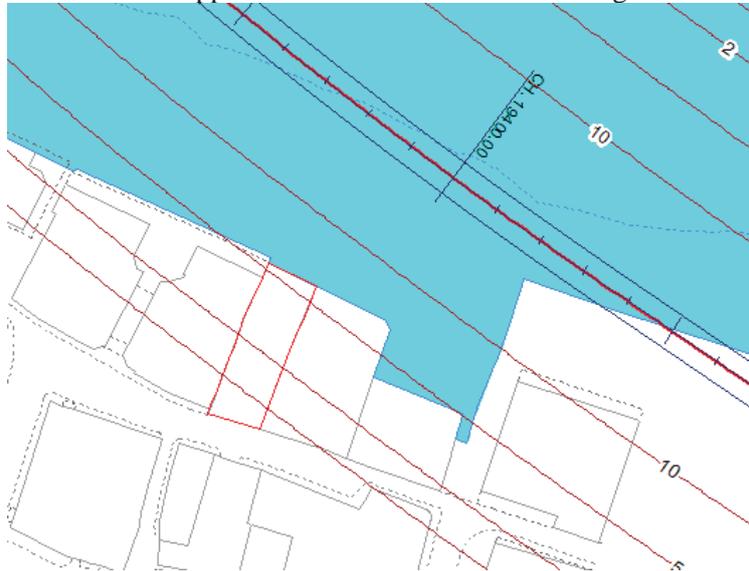
Settlement contours generated +99.7mTD approximate base slab level assuming 1m below ground level;

As shown above the building extends from the 5mm settlement contour across the 2mm and 1mm settlement contours generated for the tunnel.

All results fell within the bounds of category 0, risk of negligible damage. A maximum tensile strain of 0.01% was obtained when the structure was modelled with a basement and piled foundations (calculation at +90.03mTD) and a maximum settlement of 6mm when modelled with shallow foundations, without a basement (foundations at 99.7mTD).

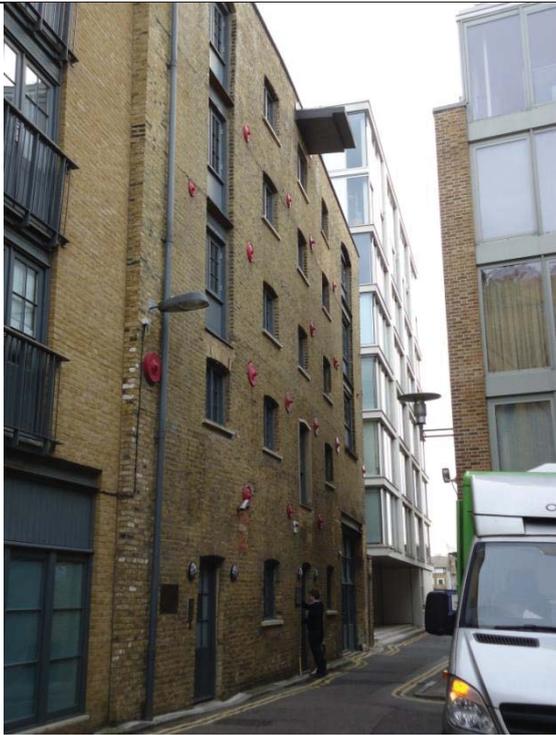
The condition is generally good. Externally, a lean of the north and south facing facades (of about 200-250mm at the top) was visible, away from the river. The building has similar dimensions on plan as it does in height (i.e. 16m x 18m on plan, approximately 15m high), so assuming a rigid body rotation then for the building to lean 200-250mm at the head, this would imply a 200-250mm settlement of the south facade. Each floor appears to have between 4 and 6 ties with pattress plates, visible from the street facade. There was evidence of previous repairs to cracks on the external wall and small cracks (~2mm) were visible inside the building between internal walls and the south facing facade.

Front (south) elevation

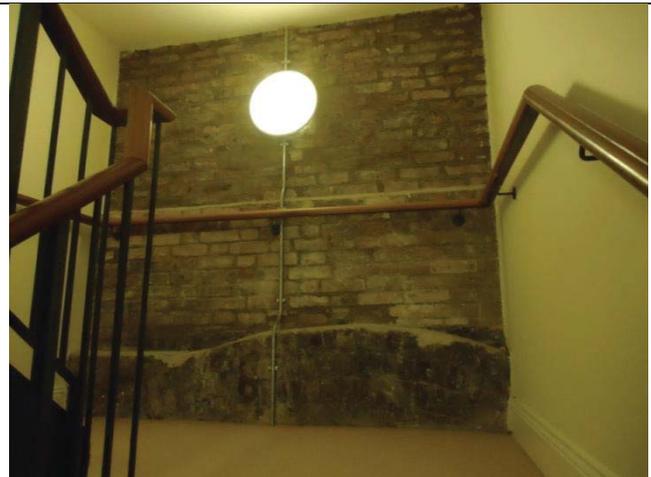
Evidence of arch, now filled in, west party wall (partially hidden by main stair)

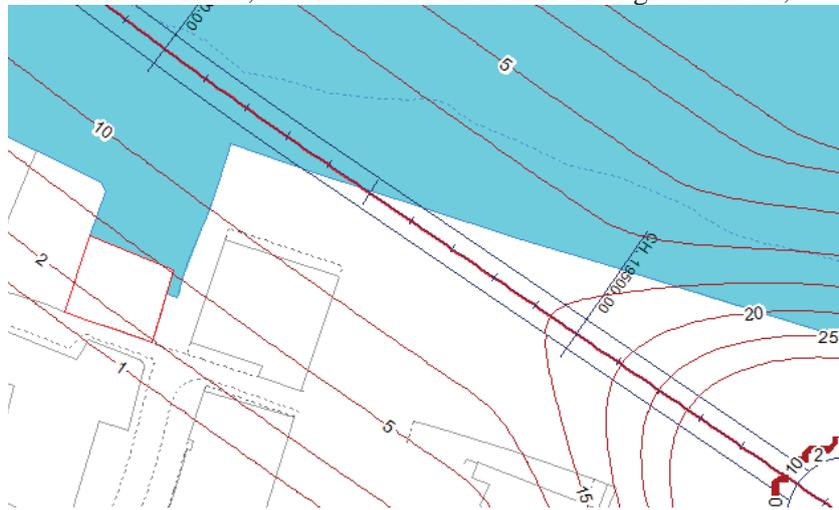
Settlement contours generated at +99.5mTD, assumes base slab is 1m below ground level;

As shown above the building sits above the 5mm and 2mm settlement contours generated for the tunnel.

All results fell within the bounds of damage category 0, risk of negligible damage. A maximum tensile strain of 0.009% and a maximum settlement of 5mm were obtained for the structure, when modelled on piles with a basement (calculated at +90.8mTD) and on shallow foundations without a basement (calculated at +99.5mTD) respectively.

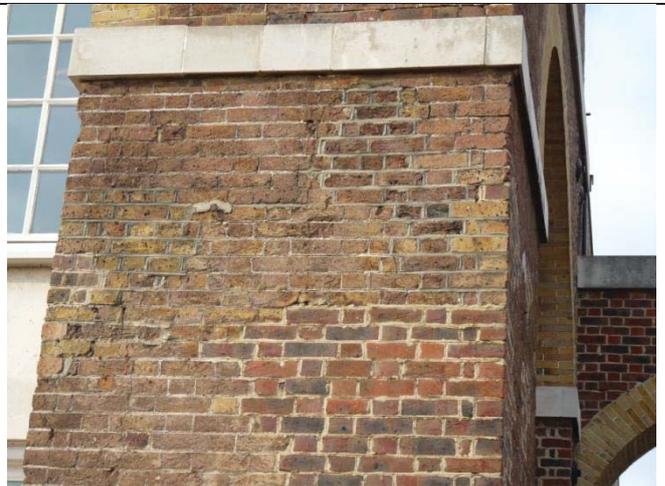
The external brickwork is generally in good condition as seen from ground level externally; there are large areas of new brickwork, seen at high level on both the east and west blocks and also areas where repairs have been carried out. A number of wall ties were observed, assumed to have been installed as part of the refurbishment works.

Example of variously coloured brickwork in poor condition

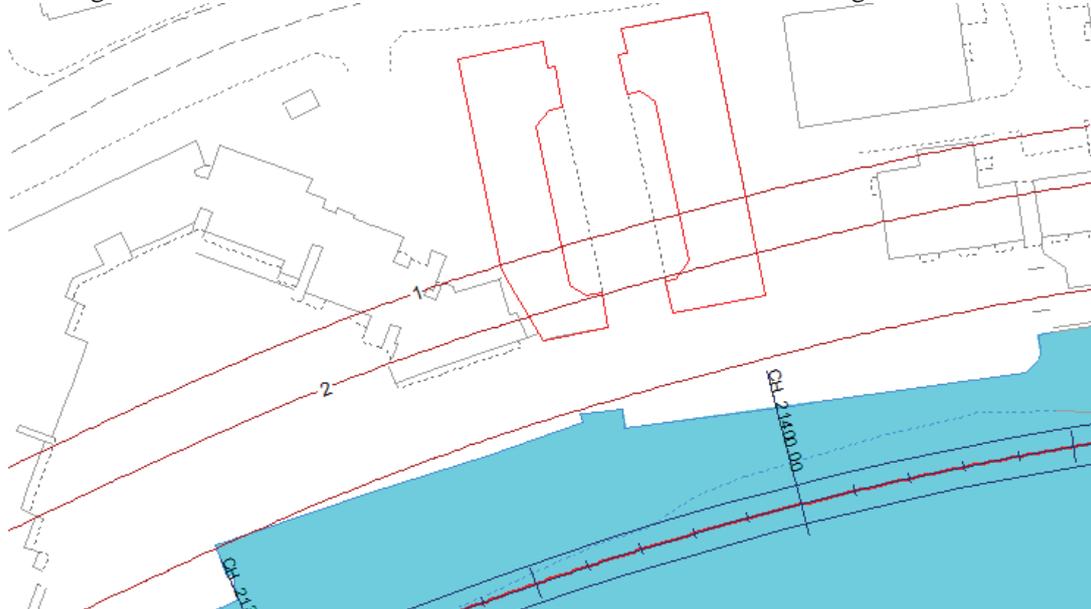
Settlement contours generated +104.8mTD, base slab level assumed to be 1m below ground level;

As shown above the buildings cross the 2mm and 1mm settlement contours that have been generated.

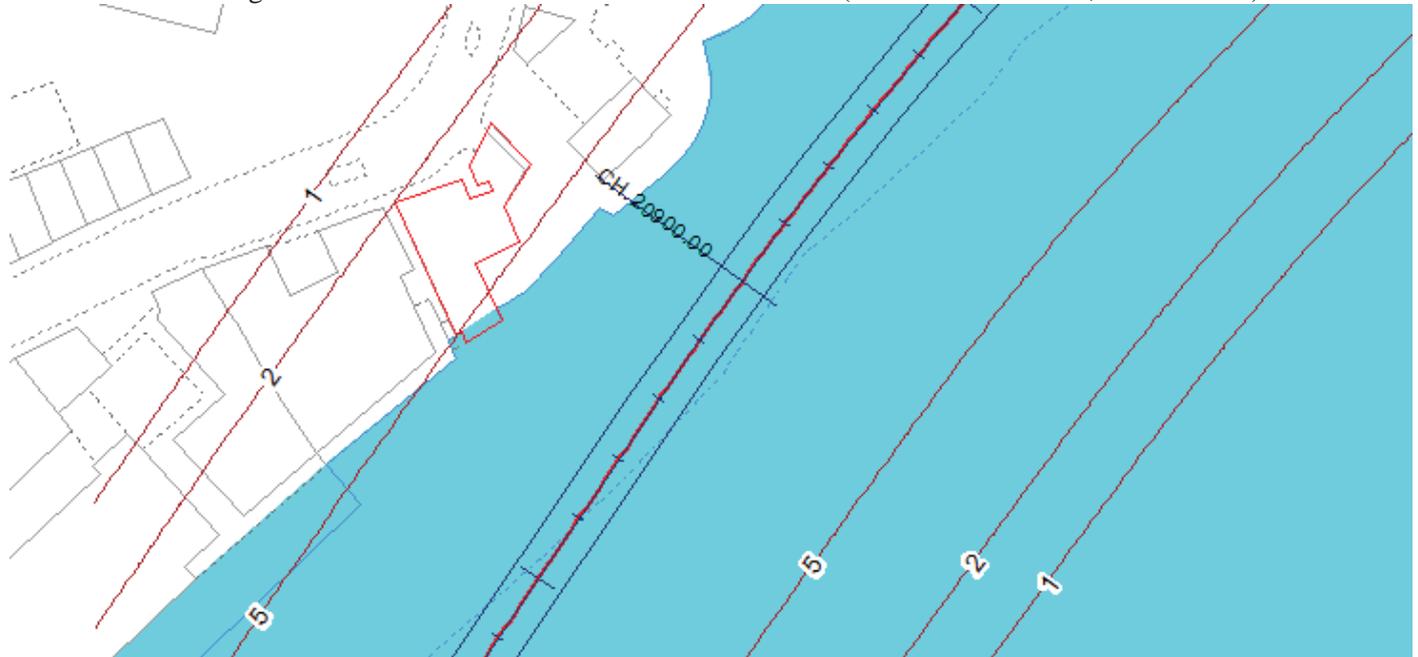
As shown above the building sits predominantly between the 2 and 5mm settlement contours.

All results fell within the bounds of category 0, risk of negligible damage. A maximum tensile strain of 0.004% and a maximum settlement of 6mm was obtained for the building, when modelling shallow 1m deep foundations.

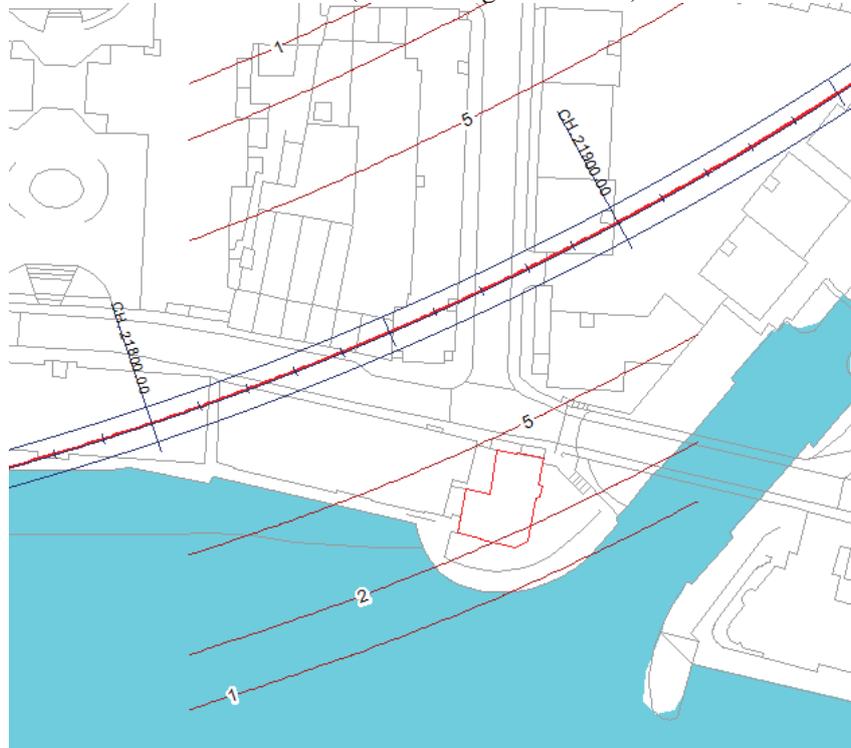
As shown above the building crosses the 2mm settlement contour.

All results fell within the bounds of category 0, risk of negligible damage. A maximum tensile strain of 0.002% and

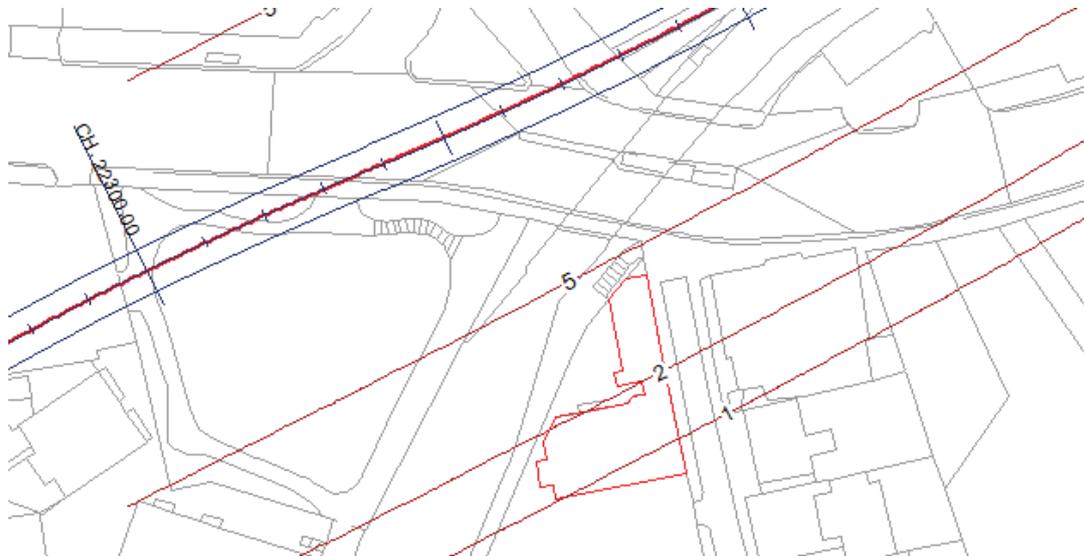
As shown above the building sits above the 2mm and 1mm settlement contours.

All results fell within the bounds of category 0, risk of negligible damage. A maximum tensile strain of 0.005% and maximum settlement of 4mm were obtained for the structure.

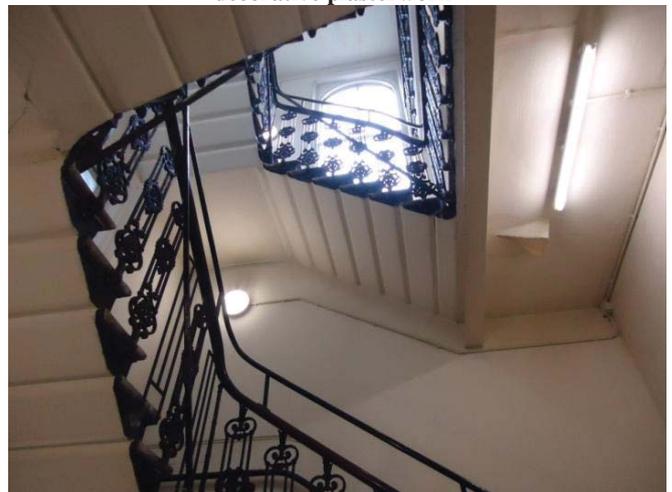
The 'back of house' stair has had modern intervention with steel beams added to support cantilevered 'stone' landings and diagonal braces added to provide restraint to handrails. The 'stone' landing at second floor has a crack that penetrates the full depth of the 'stone' (possibly explaining why a beam was added to provide additional support). Over the landing the ceiling has collapsed due to water ingress from the roof over. A vertical crack can be seen running the full height of the stair (west wall).

Secondary stair, with some minor cracking

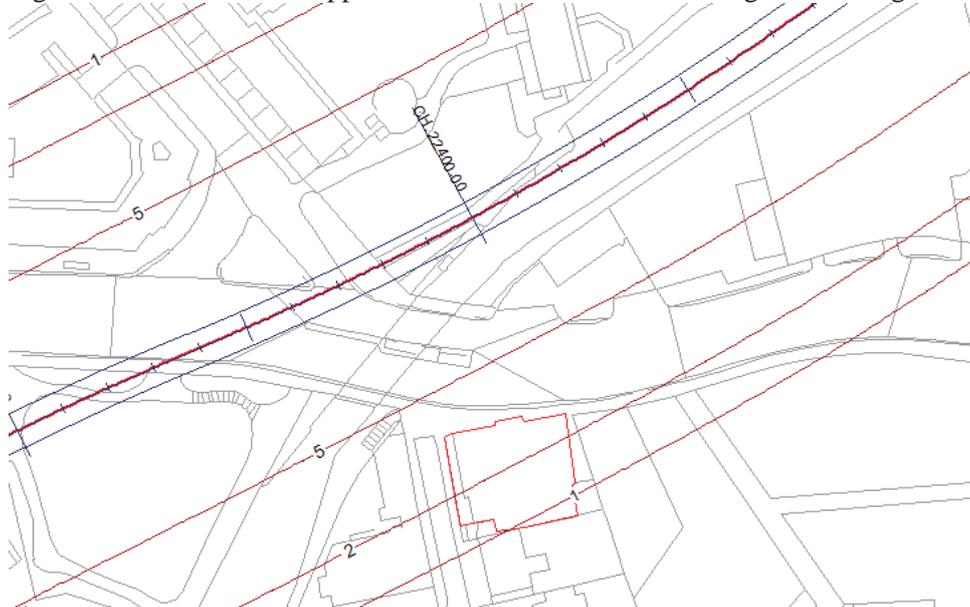
As shown above the building crosses the 2mm and 1mm settlement contours.

All results fell within the bounds of category 0, risk of negligible damage. A maximum tensile strain of 0.005% and maximum settlement of 4mm were obtained for the building. The maximum settlement is marginally greater where there is no basement and the maximum tensile strain increases slightly for a lower building.

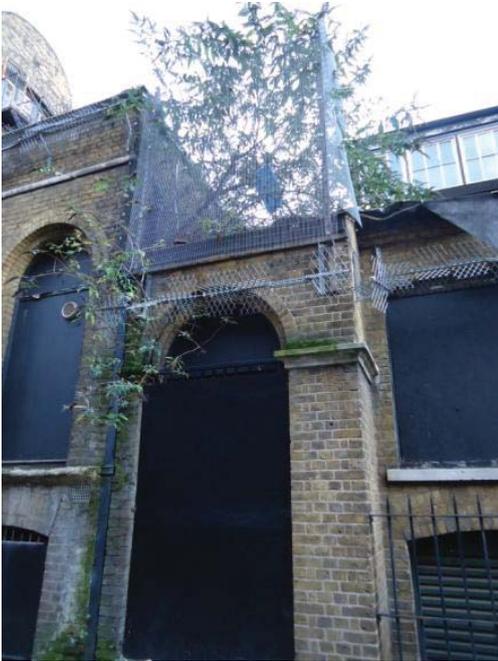
Example of vegetation growth to the southern end of the building

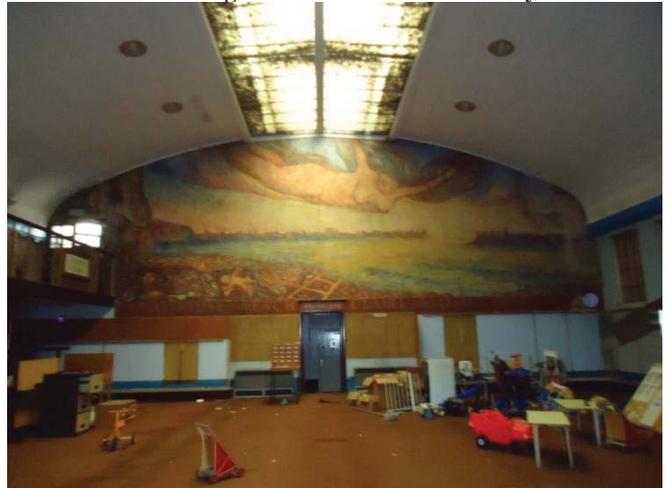
Main library space with fresco and side gallery, signs of water ingress

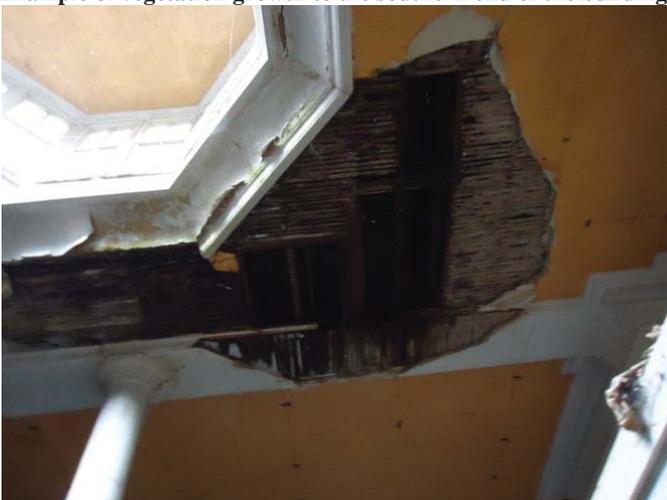
Damaged decorative features, and failure of lathe and plaster

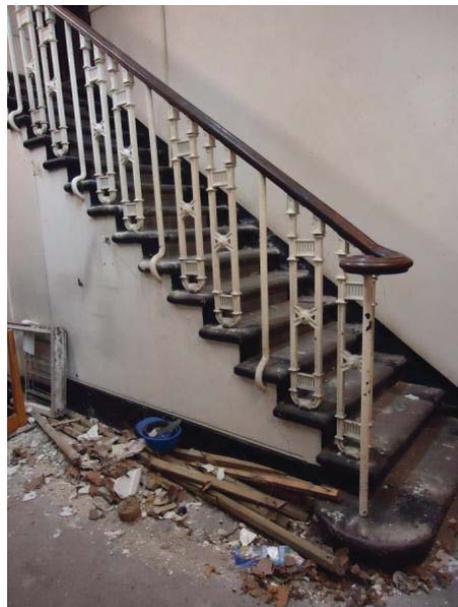
Main stair in neglected condition
