**Thames
Tideway Tunnel**

Environmental Statement

Volume 3: Project-wide effects assessment appendices

E.1 Building damage assessment Stage 3 report – Listed Buildings

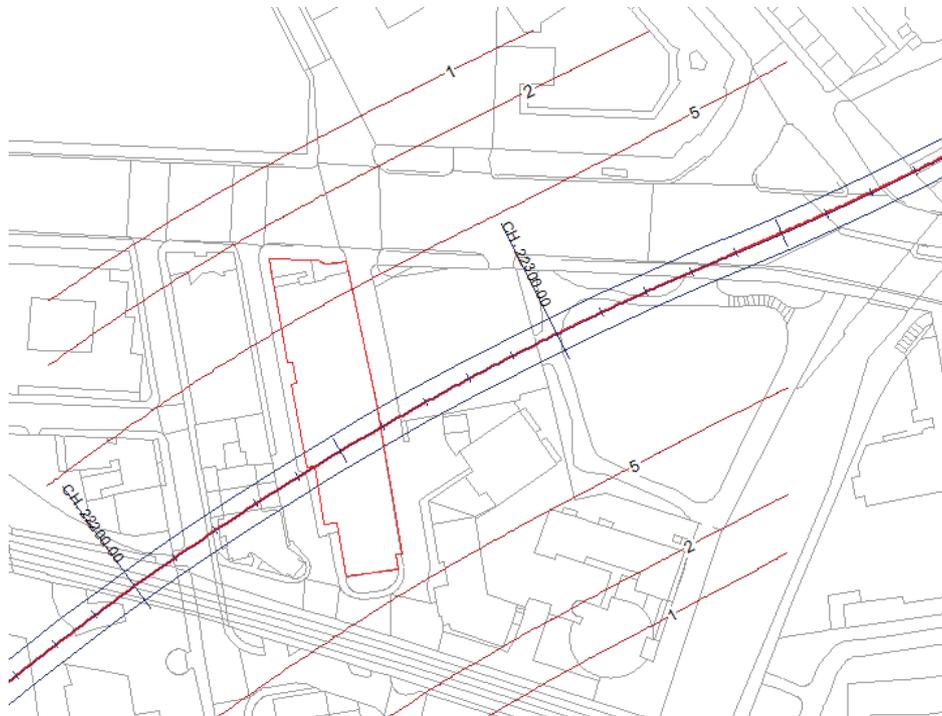
As shown above the building straddles the tunnel and extends across the 5mm settlement contour to the north.

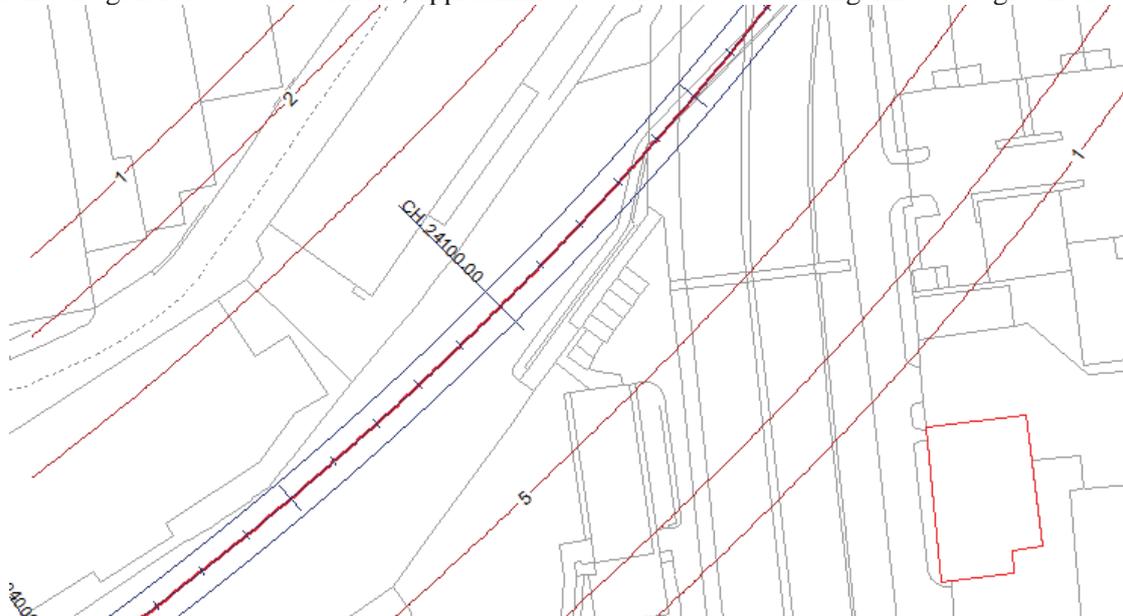
As shown above the building sits outside of the 1mm settlement contour that has been generated.

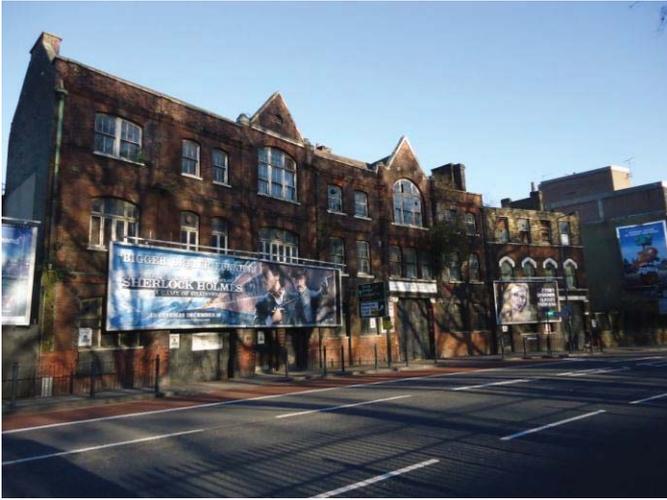
Southern elevation to Commercial Road

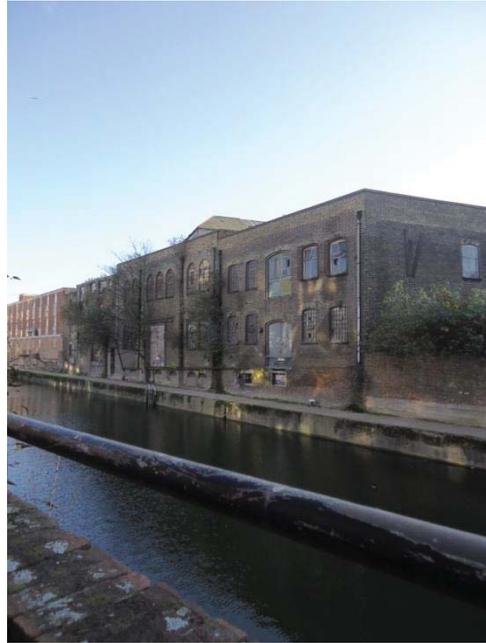
Rear elevation to Limehouse Cut

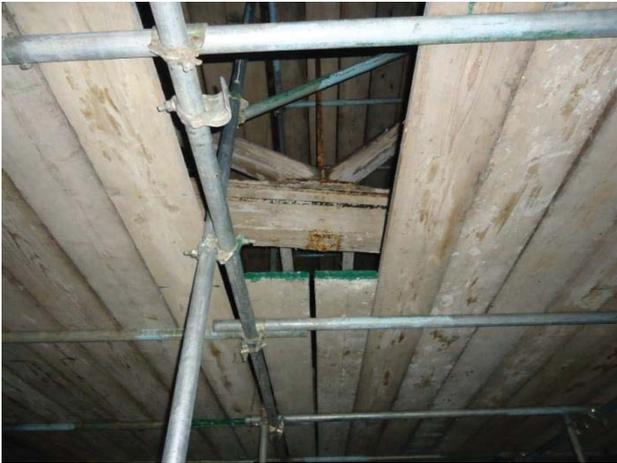
View of queen-rod truss through scaffolding

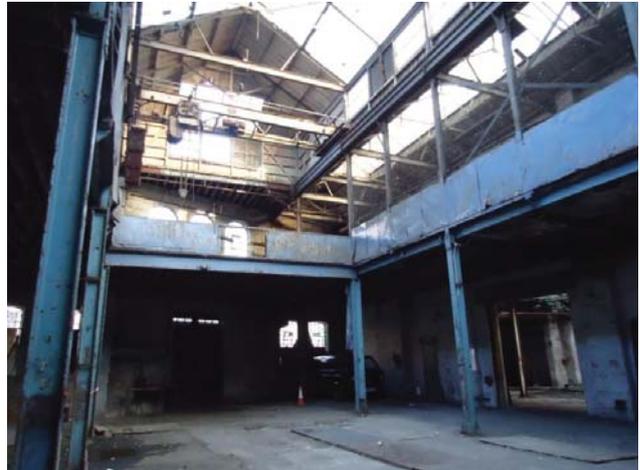
General view of industrial interior

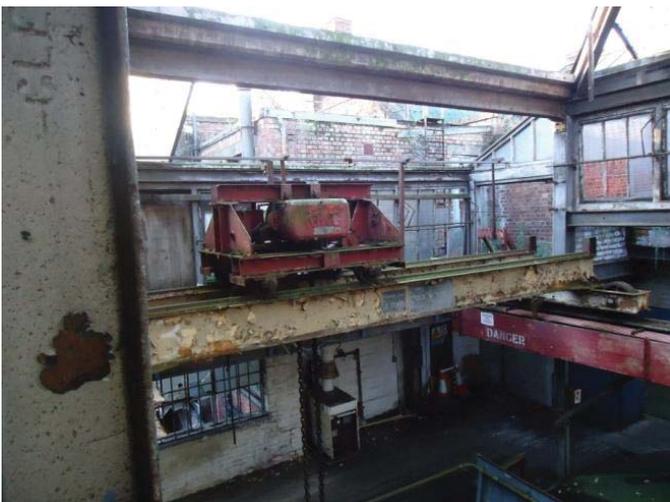
Example of retained machinery showing poor condition

This building is on the English Heritage Buildings at Risk register, and is categorised as priority A: "Immediate risk of further rapid deterioration or loss of fabric; no solution agreed". Urgent works were undertaken to make the building more weather-tight in 2010, however this has been restricted to the sail-maker's loft, which has also been boarded and scaffolded internally. The building is in very bad condition, with loss of roof coverings, deterioration and damage of walls and all timberwork, and severe damp and failure of plaster and areas of roof timbers in the offices. The condition of this building will make it more sensitive to movement, however, the calculated settlement in this area is very small, and there is no differential movement which could further seriously damage the fabric of the building. However, there is risk of minor deterioration of the condition during the works.

Condition sensitivity score is therefore assessed to be 2.

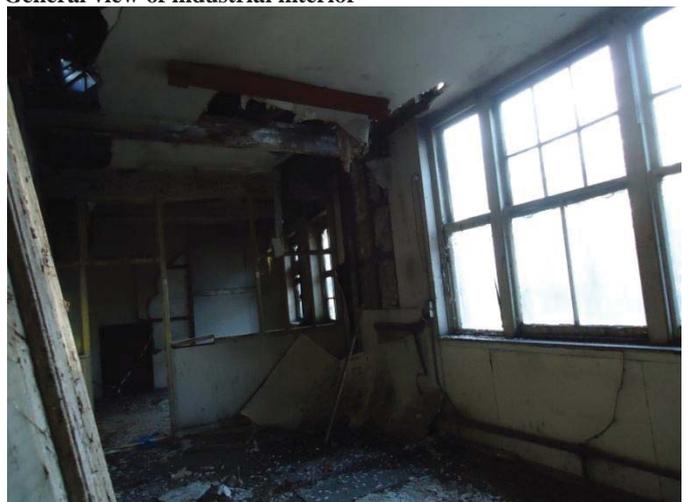
Interior of office range in poor condition

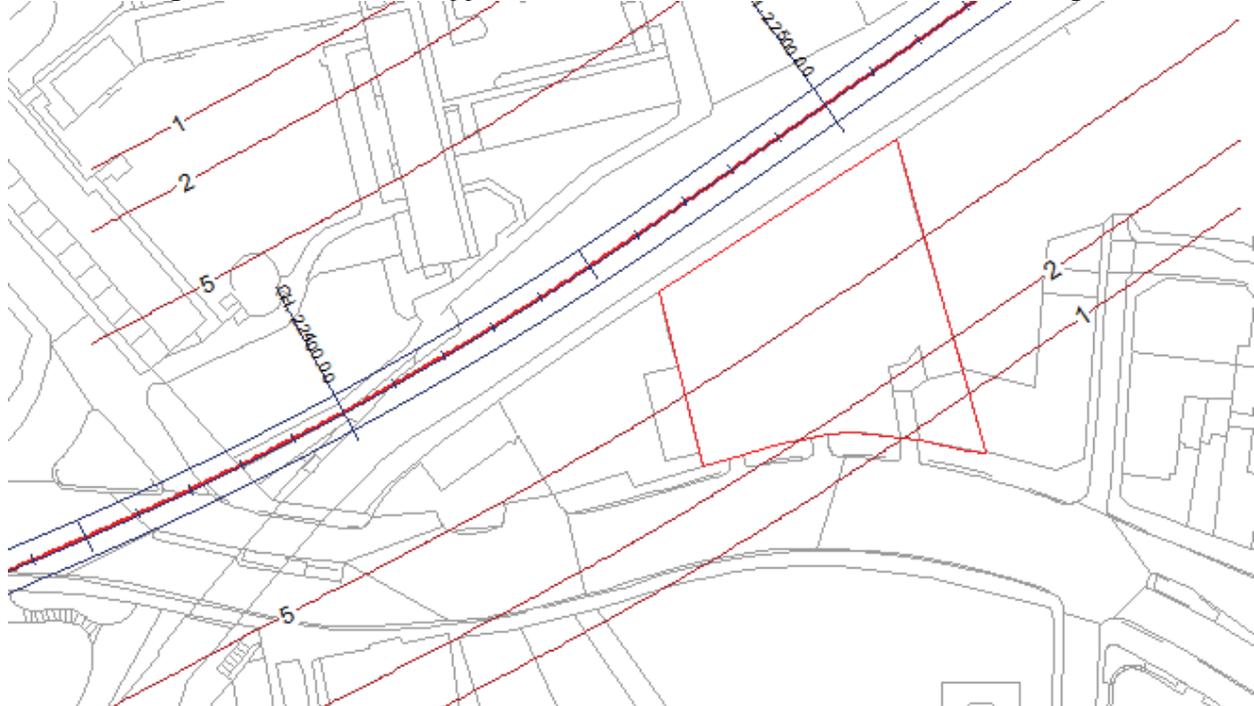
Settlement contours generated +99.1mTD, approximate base slab level assumed to be 5m below ground level;

As shown above the building crosses the 5mm, 2mm and 1mm settlement contours.

All results fell within the bounds of category 0, risk of negligible damage. A maximum tensile strain of 0.006% and maximum settlement of 8mm were obtained for the building when modelled as a 10m high structure with a 5m deep basement.

The calculated ground movements are small and the pattern of settlement contours suggests that the building would respond as a single block, tilting from Commercial Road towards the canal. It is not anticipated that the impact of the settlement will be of significance. To the extent that movement does occur pre-existing cracks in the walls running north-south will open very slightly further.

Conservative inputs have been used to calculate ground movements, as such the settlements are expected to be less. Mitigation measures in the form of physical intervention (i.e. soil grouting, underpinning etc) are likely to cause more damage than what would be expected from the construction of the tunnel.

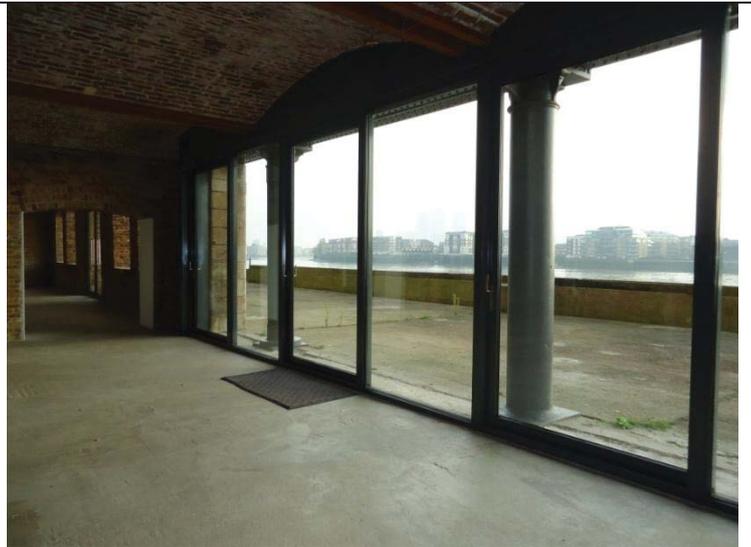
View of rear pier from ground floor

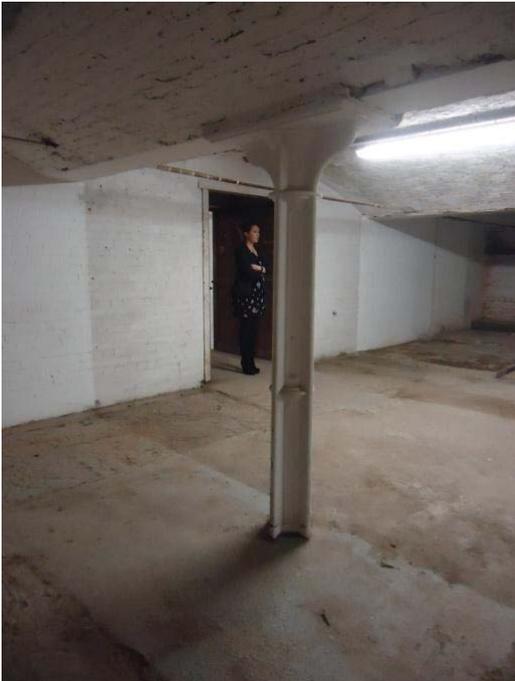
A basement extends the full footprint of the building. The basement structure comprises masonry external walls with cruciform iron columns supporting wrought iron beams and tied brick jack arches. A new concrete floor screed has been laid. The rear basement wall has openings leading to concrete shafts leading to ground level over. These showed water staining and water was pooled on the floor (likely from the cover over rather than from water penetration through the walls themselves). The basement structure was generally in fair condition with some localised cracking in the masonry.

Typical basement view

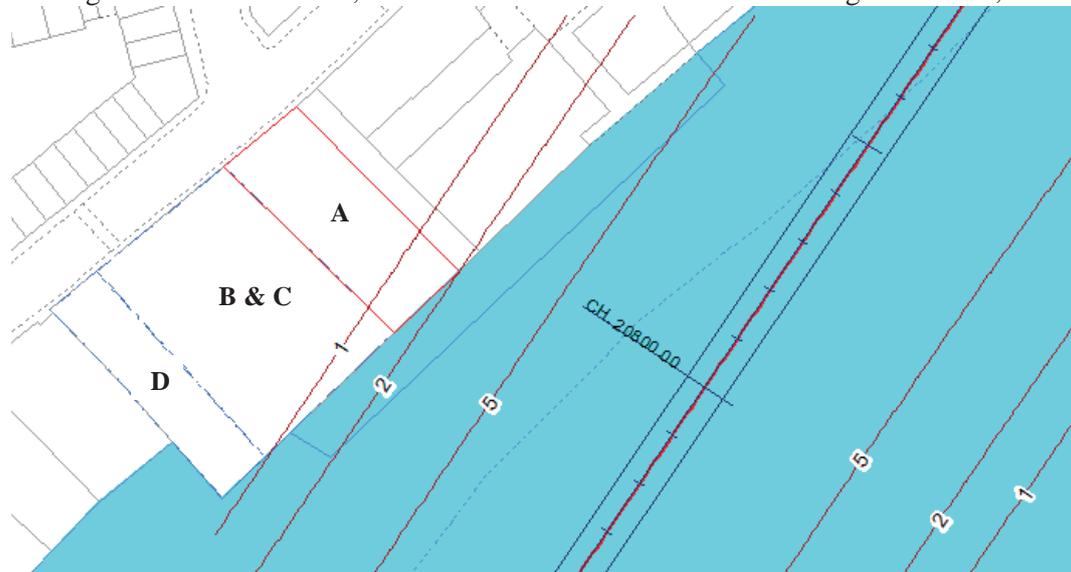
Settlement contours generated at +0.4mTD, base slab level assumed to be 1m below ground level;

Warehouse 'A' assessed in this report – Warehouse 'B & C' and Warehouse 'D' subject of separate reports

As shown above the building crosses the 1mm settlement contour and extends to the 2mm contour.

The results fell within the bounds of category 0, risk of negligible damage. A maximum tensile strain of 0.005% and a maximum settlement of 2mm were obtained for the building with and without the basement.

On reflection of the combined score and taking into account the structural and heritage features of the building and its condition, this building will not require further assessment as part of the Damage Assessment process, and will not require mitigation measures.

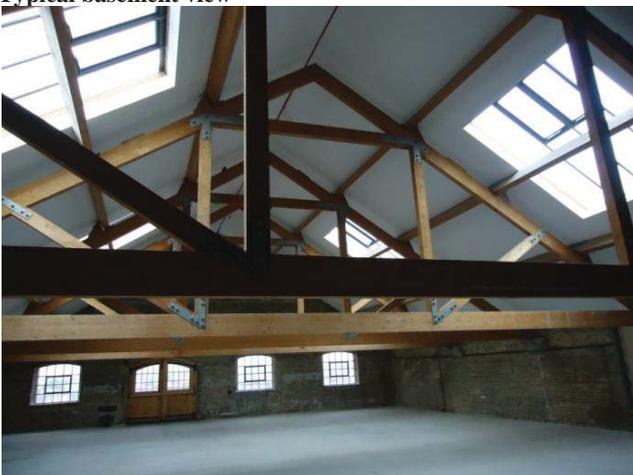
The roof is pitched with timber queen-post trusses. The riverside half of the building retains the original trusses in good condition whilst the trusses to the front of the building are new. There is evidence of crack repairs to the masonry walls.

Typical roof truss throughout 'B and C' Warehouses

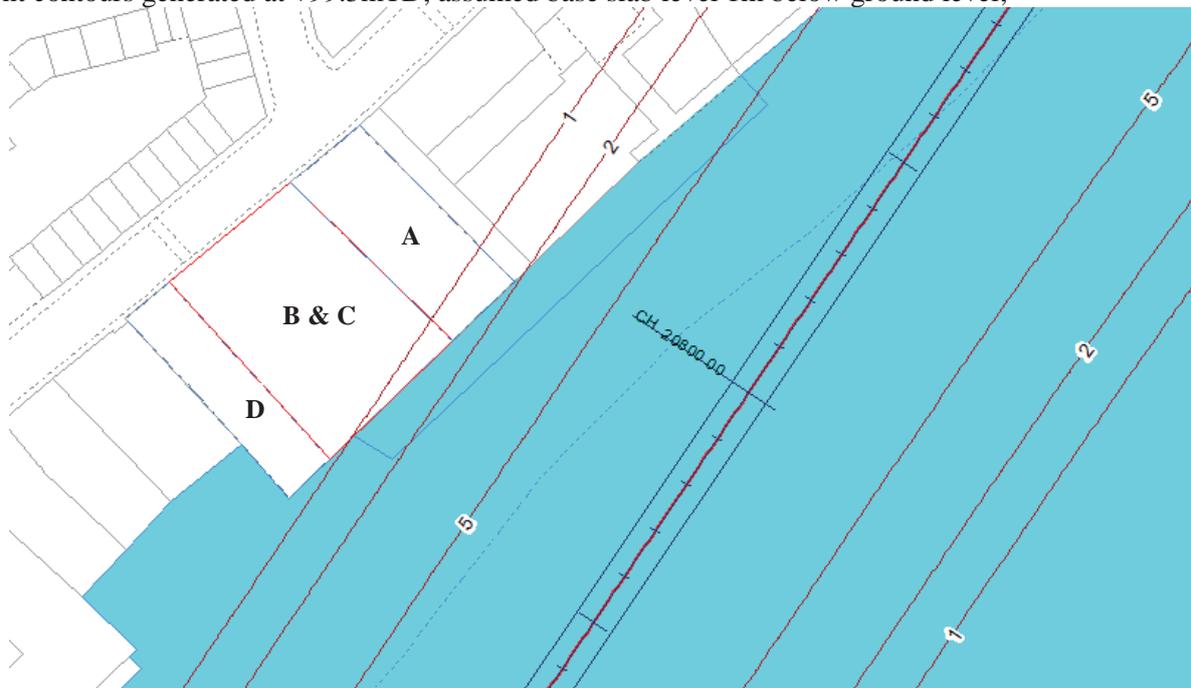
Settlement contours generated at +99.5mTD, assumed base slab level 1m below ground level;

Warehouse 'B & C' assessed in this report – Warehouse 'A' and Warehouse 'D' subject of separate reports

As shown above the building crosses the 1mm settlement contour.

The results fell within the bounds of category 0, risk of negligible damage. A maximum tensile strain of 0.005% and a maximum settlement of 1.5mm were obtained for the building.

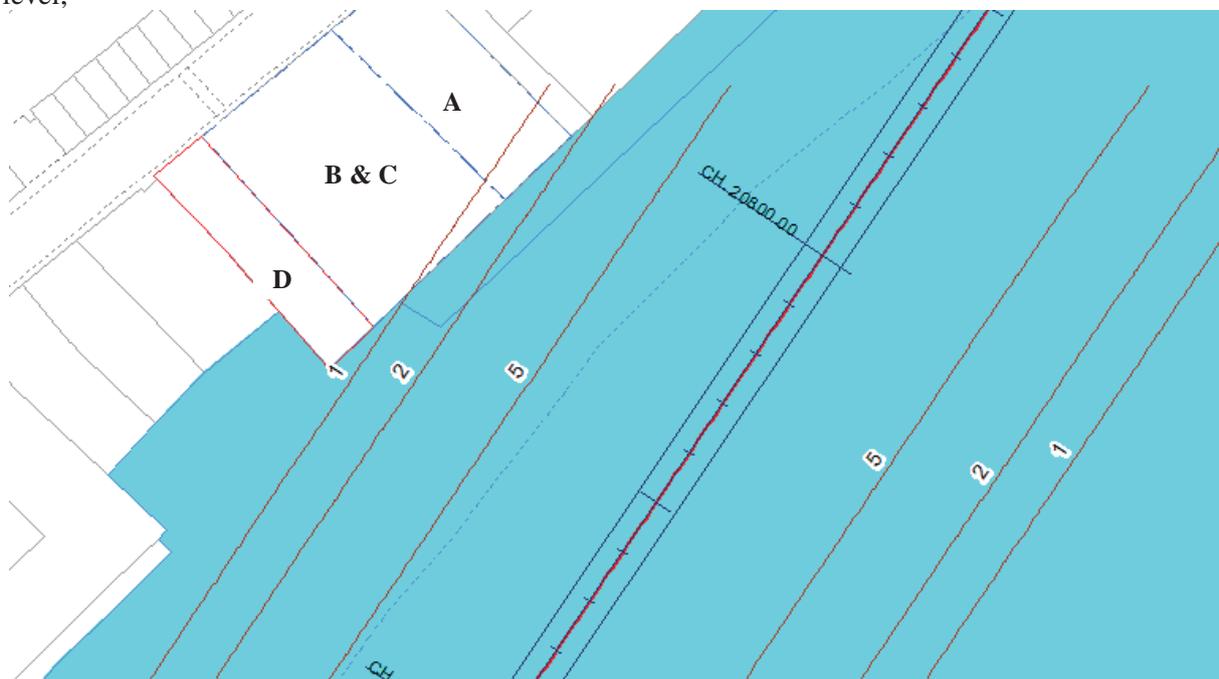
Settlement contours generated -98.7mTD, assumed base slab level with a basement and shallow foundations 4m below ground level;

Warehouse 'D' assessed in this report – Warehouse 'A' and Warehouse 'B & C' subject of separate reports

As shown above the building sits outside of the 1mm settlement contour.

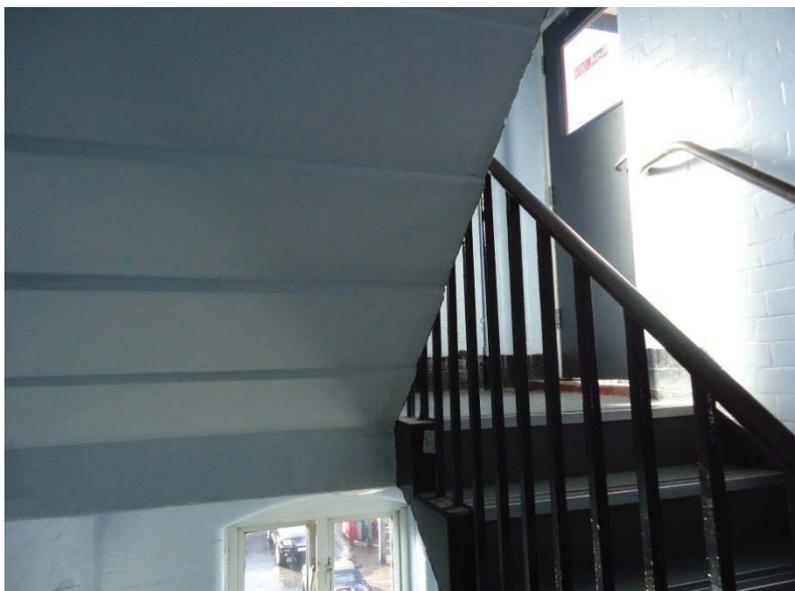
Cantilevered stair

Internally, the cantilevered stair, which does add considerable interest to the building, is suffering from a number of defects. This would make it sensitive to large movements; however, the maximum strain assessed for this building will not cause further damage to the heritage significance of the stair.

The condition of this building is generally good, other than where there are specific defects in certain areas. Of note are the open joints identified in the cantilevered stair, which may cause some sensitivity to more movements and should be pinned up as a matter of general maintenance. The attic storey flats are still in some disrepair. However, these are being refurbished, and at the time of the proposed Thames Tunnel works will be fully in use and renovated. The whole building is undergoing maintenance at the time of this report. It is unlikely that the calculated strain and settlement will cause more than a very minor amount of further deterioration in the condition of this building.

This building will not require mitigation or further assessment as part of the damage assessment. However, it is advised that a defect survey concentrating on the stair tower and cantilevered stair be carried out prior to commencement of works, to enable any further cracking to be noted.

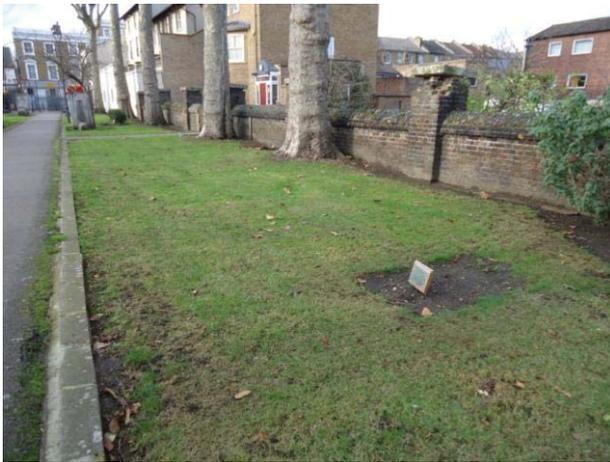
The boundary walls are of varying brick construction around the perimeter of the churchyard and show some signs of deterioration and distress. To the north the wall is low, with taller piers at regular spacing. There are a number of mature trees in close proximity and it is likely that these are contributing to the deterioration of the wall.

Boundary wall in poor condition

Those areas of the boundary wall noted as being in poor condition currently will also be most sensitive to future movement. However the north wall and the east wall (together with the chanel house) lie outside the 1mm contour and would therefore not be expected to be affected by the calculated ground movements.

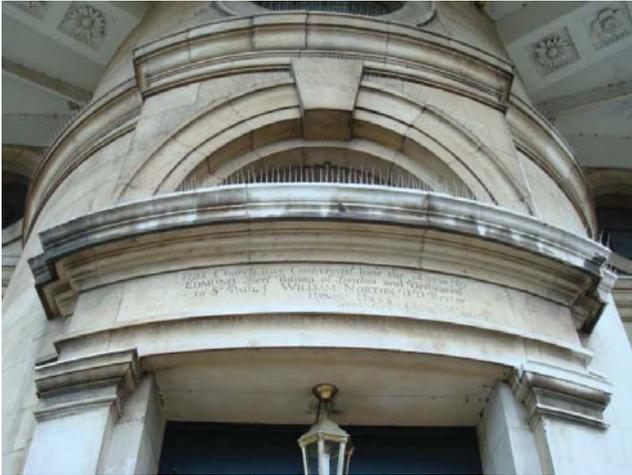
Stonework above western entrance showing opening of joints

This building is generally in good condition, with some minor wear and tear caused in part by a previous lack of maintenance, although the building is currently being well cared for. Of most note is some separation of stone jointing, and slight cracking to the western end of the exterior. The listed boundary wall is in poor condition, and there are some areas of piecemeal repair and distinct failure. The condition of the church itself is unlikely to deteriorate due to the calculated settlement, however the boundary wall may become more unstable.

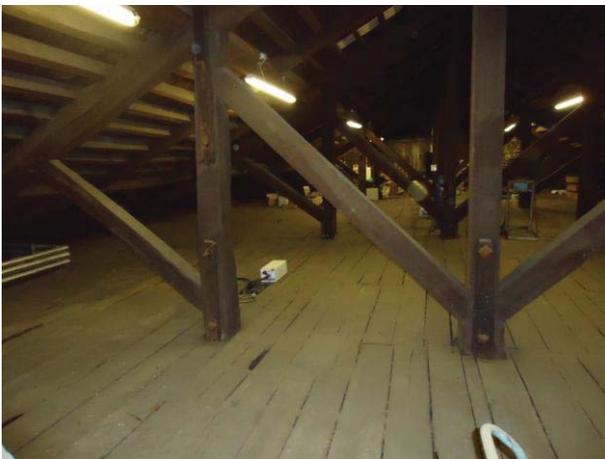
The roof is generally in good condition; there are a few leaks at the east end and the main roof timbers show some splits. The connectors are unusually large elements.

Truss in roof space

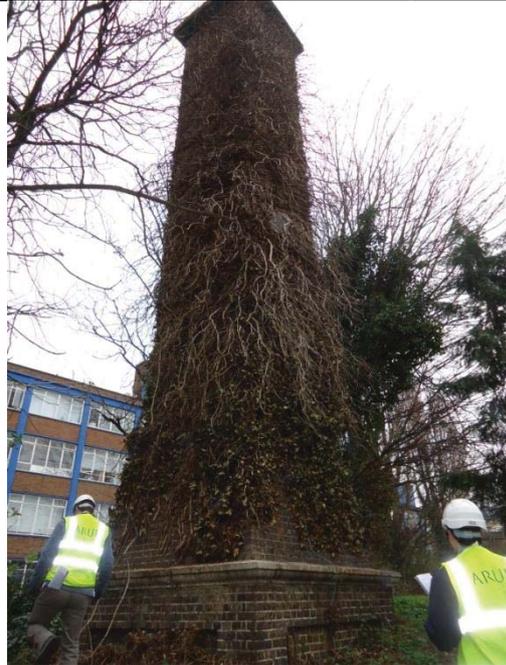
Ivy-covered chimney-vent to the centre of the site

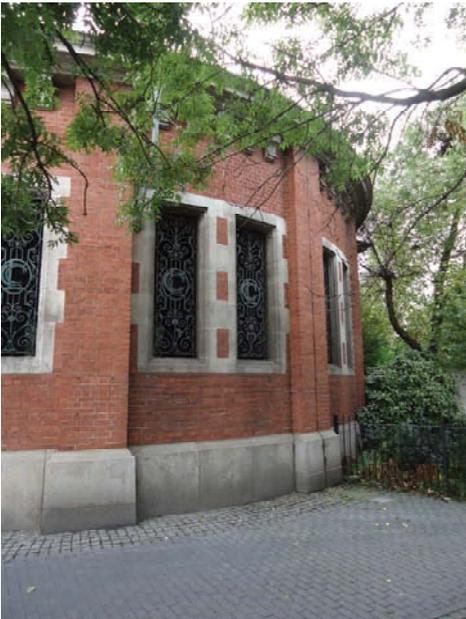
Condition	Fair – some minor deterioration of brickwork and small cracks
Assumed foundations	Founded at depth on the tunnel structure
Façade material	Brick with Portland stone dressings
Internal support system (i.e. superstructure)	
Heritage	The building has historical and aesthetic significance. Particularly significant elements include the window openings and iron grilles with LCC lettering, the general shape and appearance of the building within its context, and the internal stair and lamp standards.

Caption 3 - Detail of eastern side of the building, with LCC grilles showing clearly

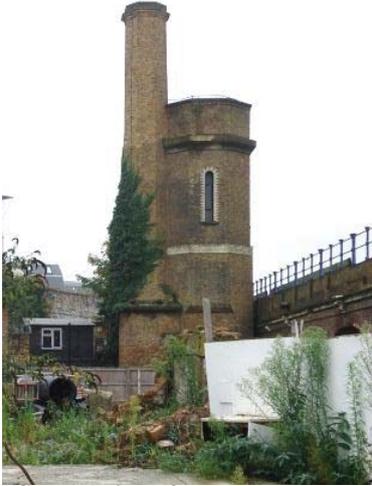
Condition	Fair, with obvious repairs and brick replacement. Evidence of eroded brickwork to the ground floor, and vegetation growth to the north eastern side of the building.
Assumed foundations	Assumed to be shallow. However, as an engineering structure more care is likely to have been taken over the depth and founding strata compared with typical buildings of this date.
Façade material	Brick with stone and white brick dressings.
Internal support system (i.e. superstructure)	Assumed to be load bearing brickwork throughout.
Heritage	The heritage significance of this building is predominantly in its position and former use; particular features of interest include the octagonal shape, chimney, and brick and stone dressings. No machinery remains inside the building.

Caption 1 - General view of structure

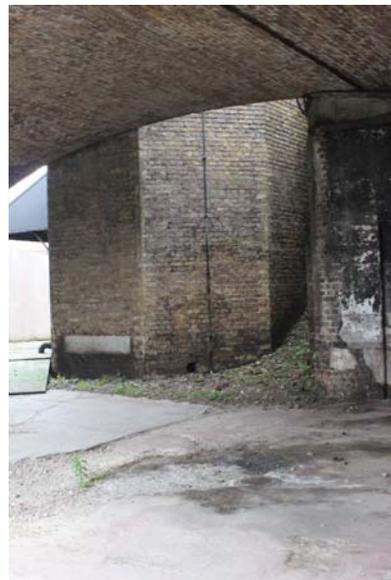
Caption 4 – Base of tower structure

Close up inspection was not possible but from a distance the building appears to be in fair condition, with evidence of repairs and brick replacement. There is vegetation growth, however this does not appear to be destabilising the structure. The condition of the building will not exacerbate the level of damage assessed during the works.

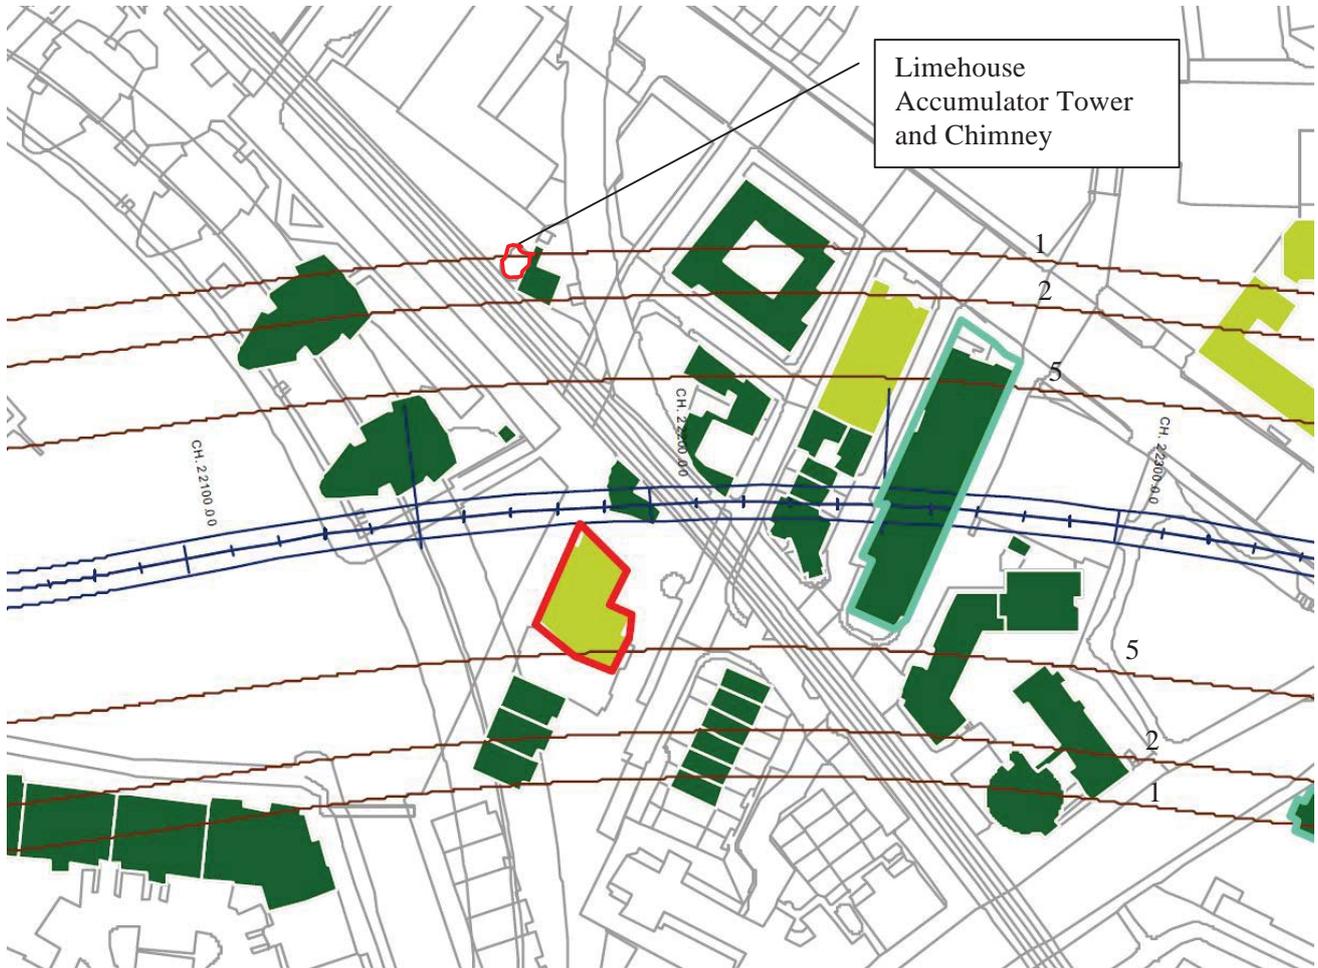
Settlement contours (mm) generated 1m below ground level

As shown above, the building lies between the 2mm and 1mm contours.

The results fall within category 0, risk of ‘negligible’ damage, with a maximum tensile strain of 0.004% and maximum settlement of 1.5mm calculated.

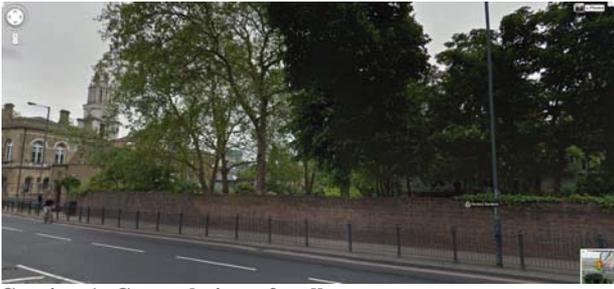
Condition	Poor; deteriorating lime mortar, and evidence of cracked bricks where cement mortar has been used. Vegetation growth to eastern end.
Assumed foundations	It is assumed that the foundations are very shallow brick strip footings; foundations to walls were often minimal
Façade material	Brick
Internal support system (i.e. superstructure)	N/A
Heritage	The wall is of interest due to its group value with the surrounding historic environment. Particular features of interest include its profile, becoming narrower at the top of the wall, and the area of 16 th century brick , with regular brick caps.

Caption 1: General view of wall

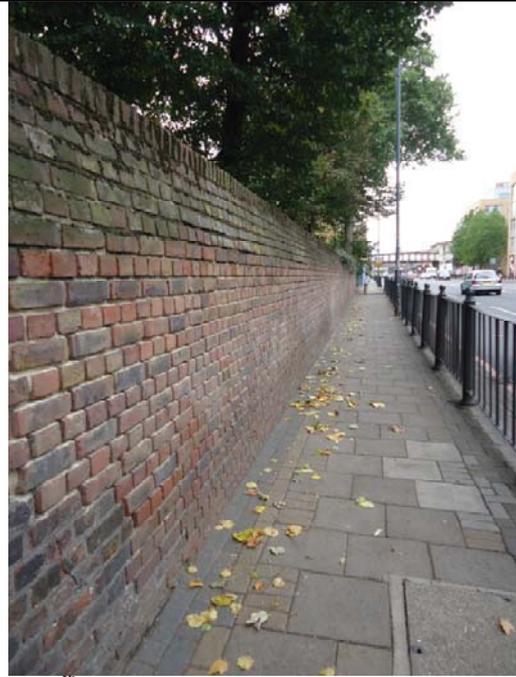
Caption 2: 19th century section of wall (western end)

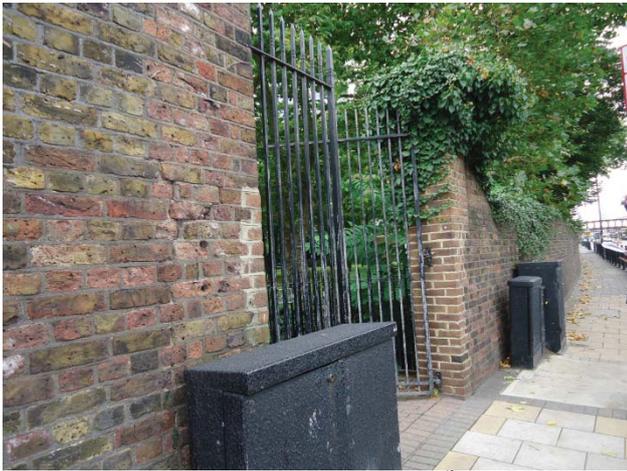
As described above the wall consists of two distinct phases; the east end (approx 20m) comprises older stock bricks repointed in cement mortar. There is a fine crack (approx 1mm) running from the base to mid height at the junction where the western end has been rebuilt. A further, full height, fine crack is evident in the east end of the wall approximately 9m from the gate opening. The pier at the east end of the wall (on the west of the gate opening) has been previously rebuilt with a lime based mortar. There is a 0.5-1mm crack running vertically at the interface between the pier and wall. The pier to the east of the gate opening exhibits a similar vertical crack.

Caption 3: Eastern end of wall, showing 16th century brick and vegetation growth

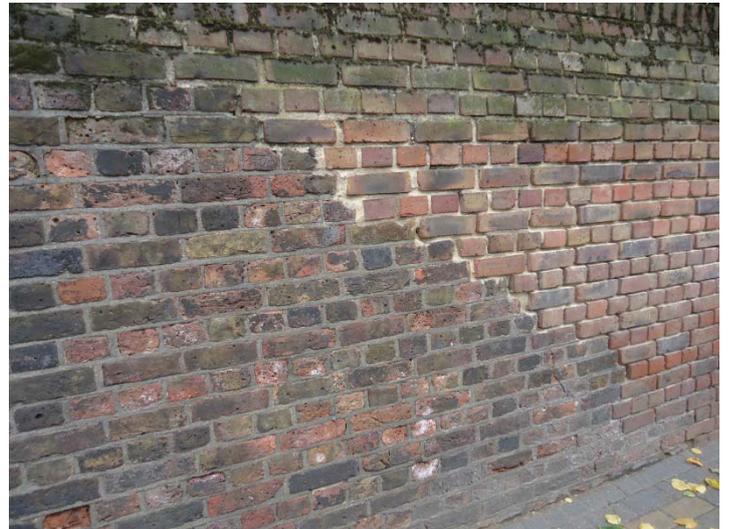
Caption 4: Junction of 16th and 19th century brick

The wall spans the tunnel route, with the area of most movement at the junction between 16th and 19th century brick. The wall in this area shows some cracking, and the 16th century brick is vulnerable to settlement due to the use of inflexible cement mortar. Therefore, although movements are calculated to be negligible, there may be some widening of cracks or development of new cracks. However, this damage will not impact upon the heritage significance of the wall.

The condition of the wall is poor, and there are existing cracks to the centre of the wall, at the point of the highest settlement. These cracks may widen, and new cracks form, due to the current condition of the wall.

The heritage features of the garden wall are not sensitive to the levels of settlement and strain calculated, though the condition of the wall may deteriorate. While the structural form makes it sensitive to ground movements, the magnitude of the settlements are negligible and are not considered of structural consequence. Therefore the wall will not be taken forward for further damage assessment and will not require mitigation.

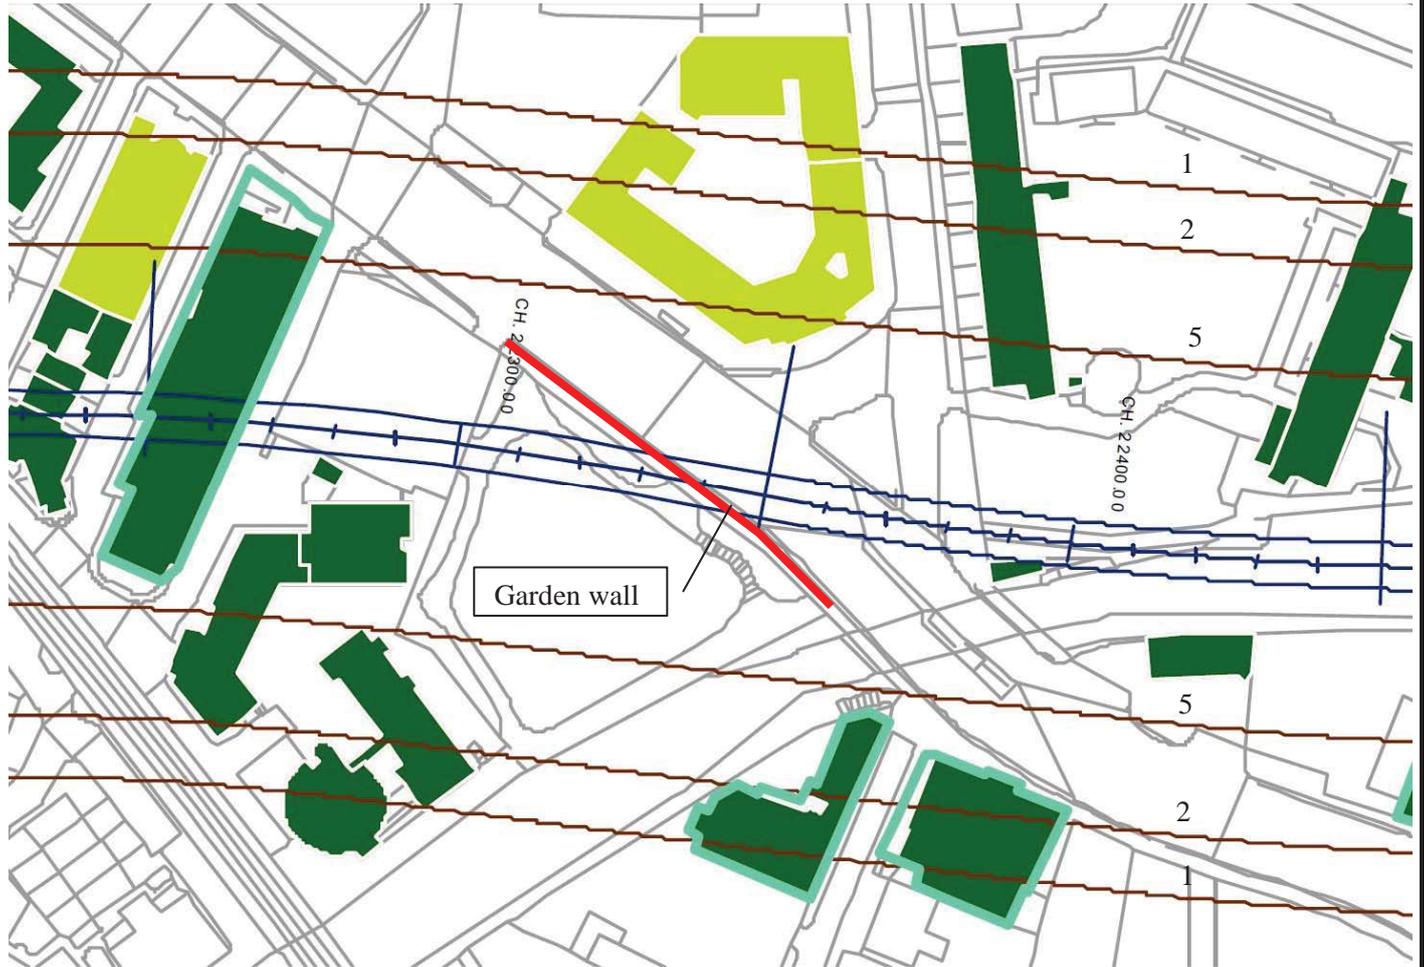
Settlement contours (mm) generated 1m below ground level

As shown above the wall spans the proposed tunnel alignment and lies between the two 5mm contours.

The results fall within category 0, risk of negligible damage, with a maximum tensile strain of 0.0006% and maximum settlement of 8.5mm calculated.

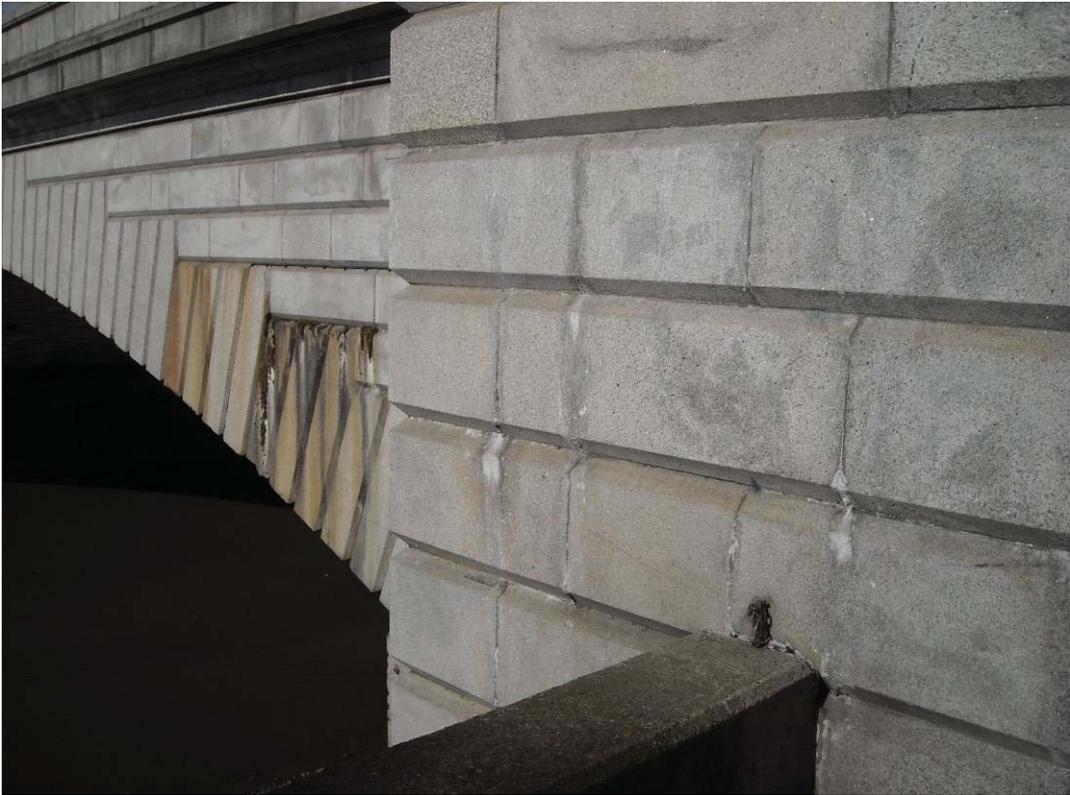
Vol 3 Plate E.10 Detail of north abutment and span 5 showing effects of leaching

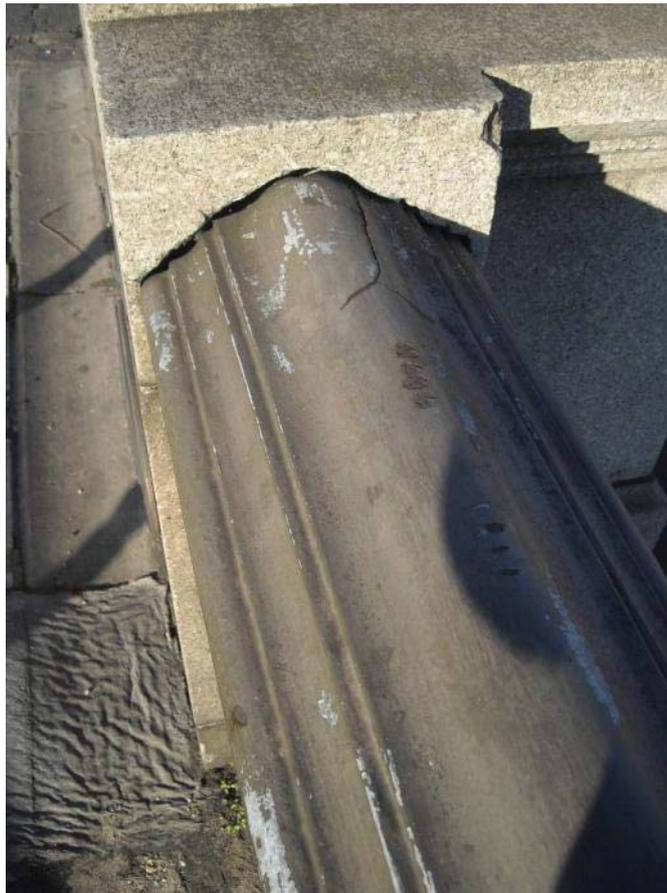
Vol 3 Plate E.22 Typical cracking to cast-iron balustrade

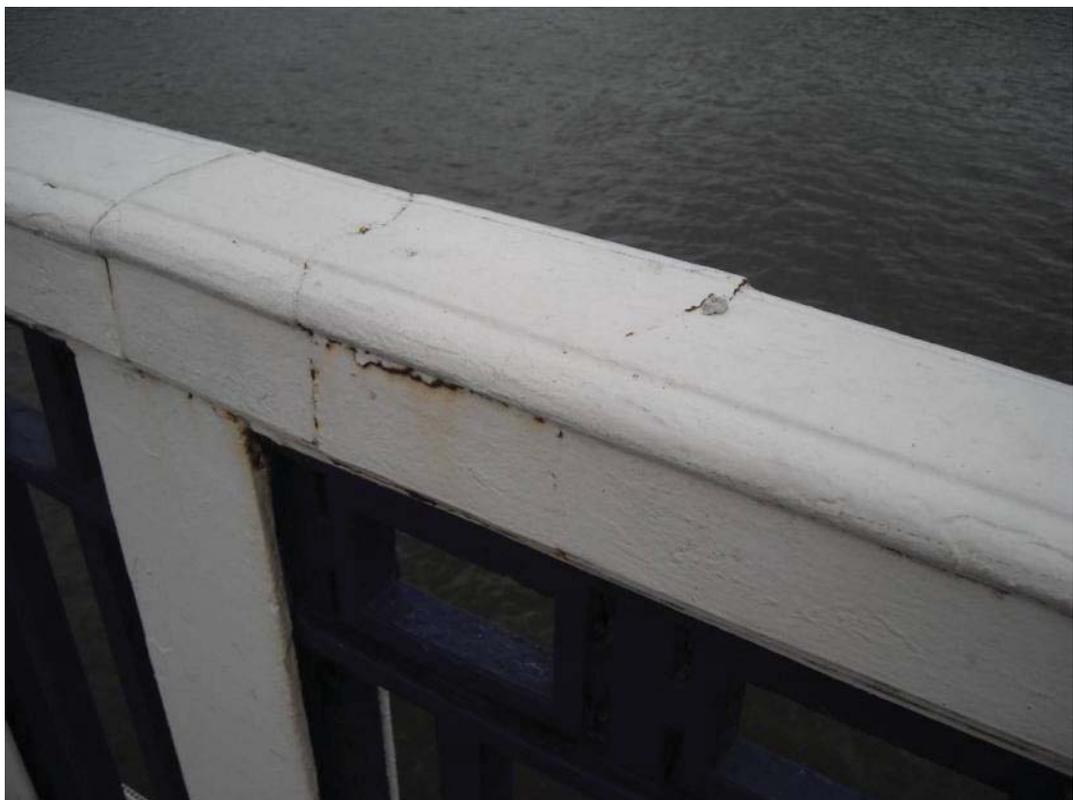
Vol 3 Plate E.38 Detail of cracking to handrail

E.3.137 At the time of the inspection the bridge appeared to be in good condition. Some minor weathering to the decorative coatings and minor cracking to the decorative balustrade was noted, but otherwise the structure appeared to be in excellent order.

- E.3.145 Further detailed inspection of the joints and bearing would be undertaken prior to tunnel construction to ensure that these remain in sound and operable condition. The expansion joints would be examined to ensure that they have sufficient capacity to accommodate the additional movement due to tunnel construction in addition to the normal thermal movements.

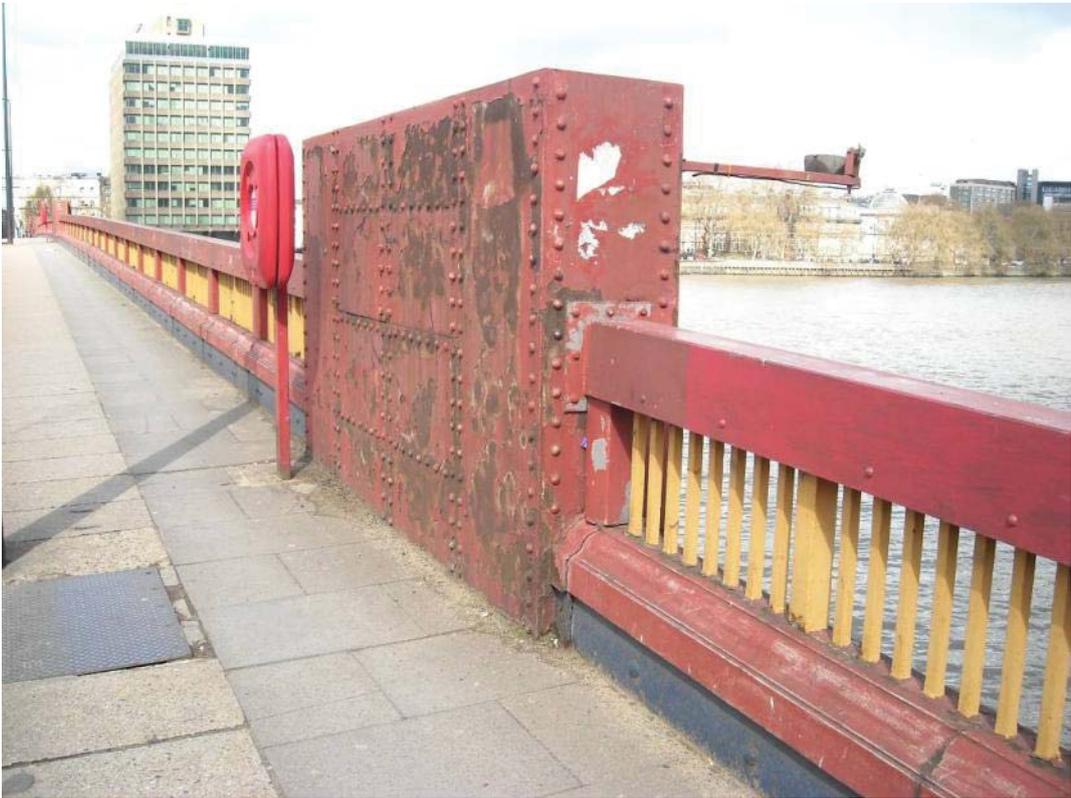
Vol 3 Plate E.58 East parapet showing typical failure of surface coatings & corrosion

- E.3.180 The bridge was observed in detail from street level during the walkover survey. From visual observation the bridge appears to be in “fair” condition.

- E.3.181 The bridge appears to be structurally sound and maintained. However, it is now overdue for redecoration. The surface coatings are life expired, exposing the underlying metal to corrosion and creating a somewhat shabby appearance. If left unchecked the corrosion effects will over time become more serious.

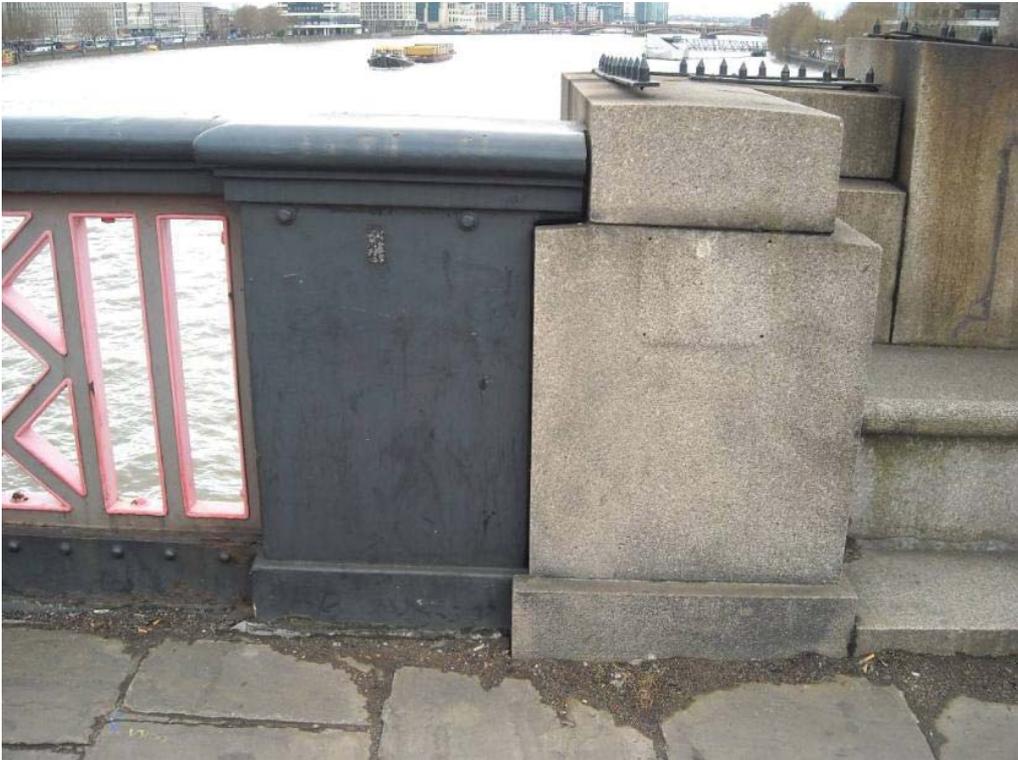
Vol 3 Plate E.65 Detail of junction between balustrade/parapet and pier

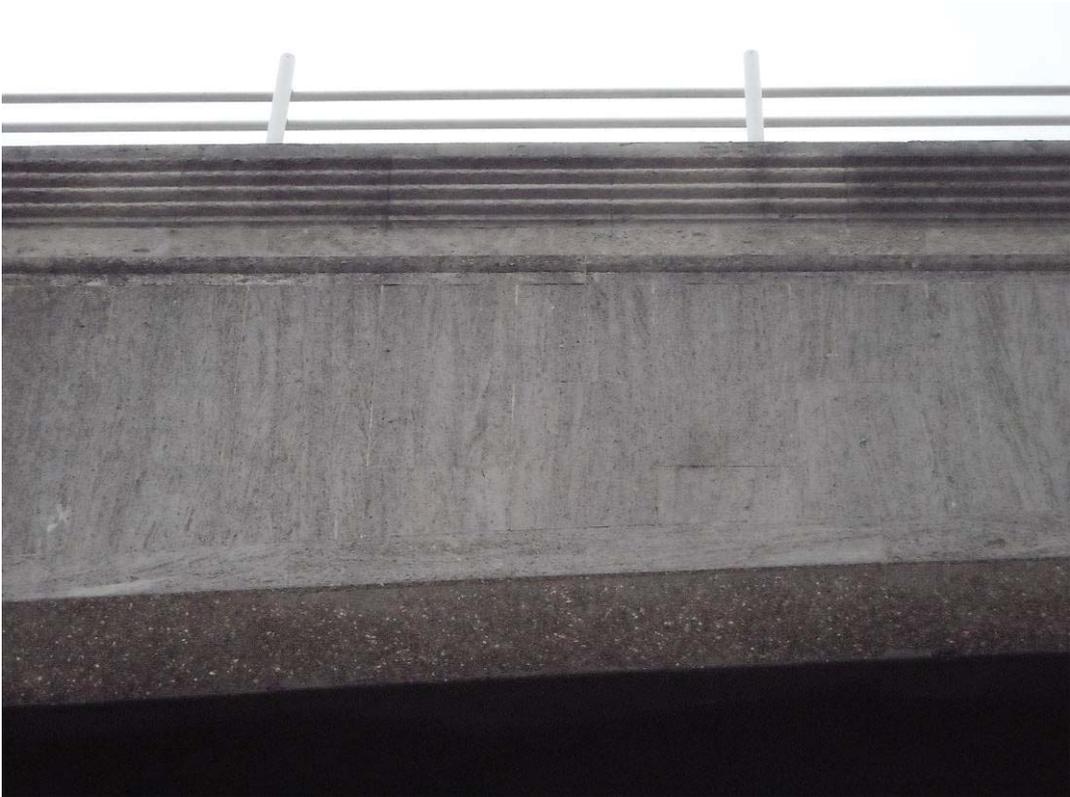
Vol 3 Plate E.77 Detail of stone clad reinforced concrete box girder

- E.3.273 Generally, the bridge appears to be structurally sound and well maintained.
- E.3.274 Areas of spalling of the concrete can be seen across the underside of the bridge, with corroding reinforcement visible in places. Rust staining is visible in many places including below the joints of the central span drop in section. Isolated cracking is also visible. The defects although widespread are relatively minor in nature and should not affect the structural performance of the bridge. Deterioration of the concrete is most likely related to localised defects in the mix and placing of the concrete, and in insufficient cover to the underlying reinforcement. At deck level, the paving slabs to the footways are extensively broken and the movement joints appear silted up.
