**Thames
Tideway Tunnel**

Environmental Statement

Volume 3: Project-wide effects assessment appendices

E.1 Building damage assessment Stage 3 report – Listed Buildings

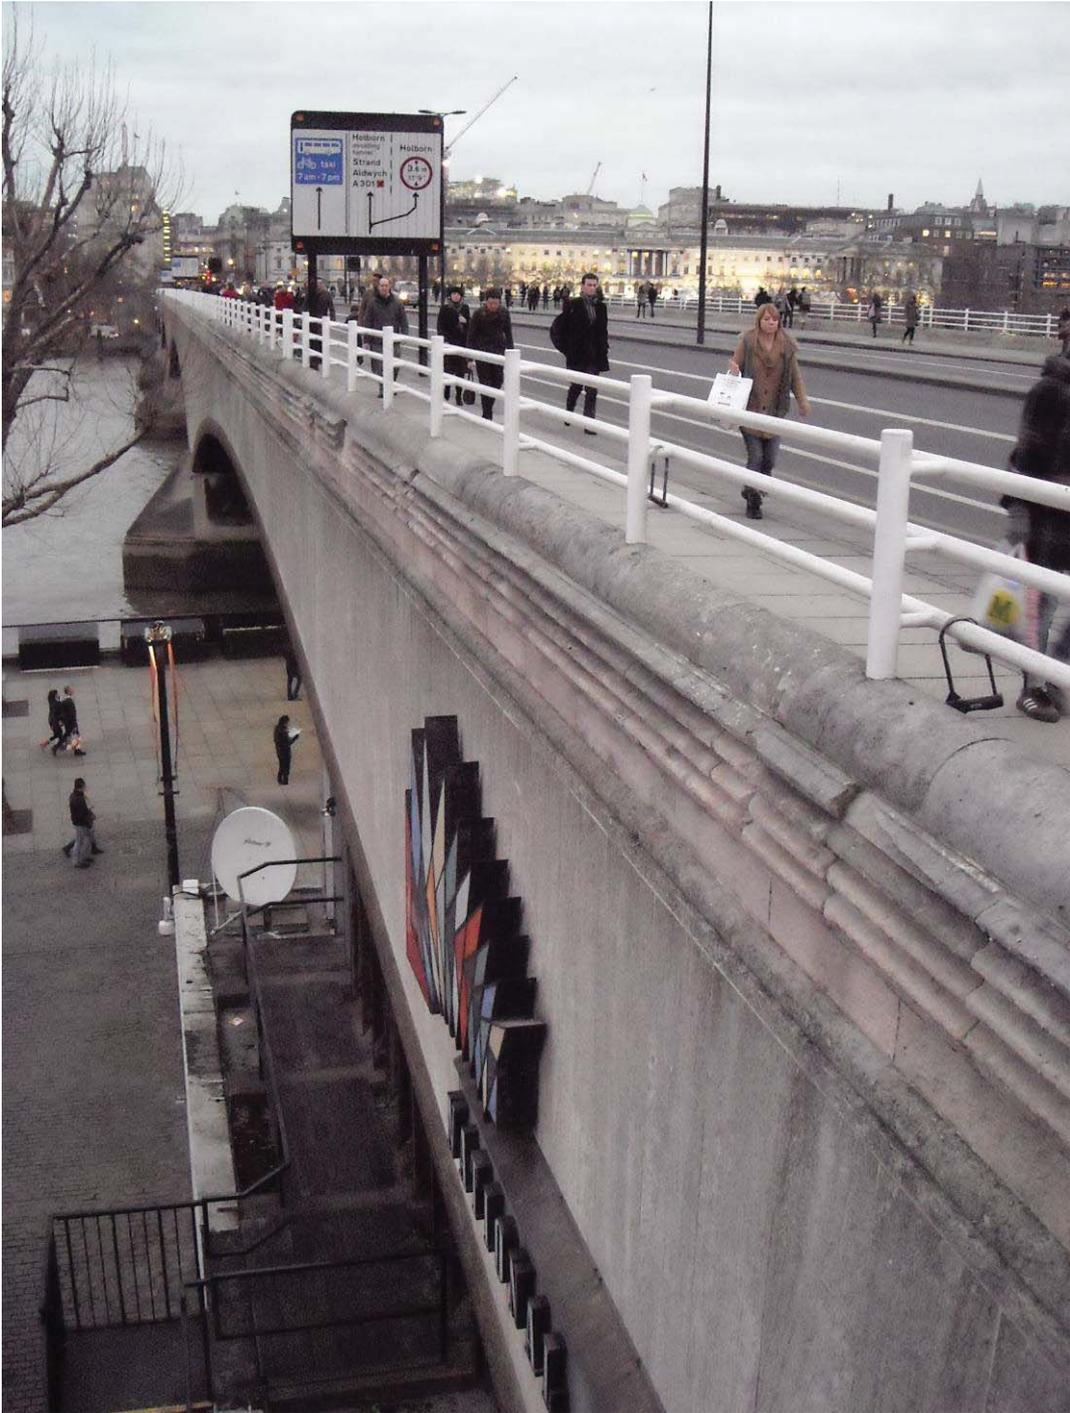
Vol 3 Plate E.78 Waterloo Bridge looking north

- E.3.272 The bridge was observed in detail from street level during the walkover survey. From visual observation the bridge appears to be in “good” condition, but minor sign of deterioration were noted.

- E.3.273 Generally, the bridge appears to be structurally sound and well maintained.
- E.3.274 Areas of spalling of the concrete can be seen across the underside of the bridge, with corroding reinforcement visible in places. Rust staining is visible in many places including below the joints of the central span drop in section. Isolated cracking is also visible. The defects although widespread are relatively minor in nature and should not affect the structural performance of the bridge. Deterioration of the concrete is most likely related to localised defects in the mix and placing of the concrete, and in insufficient cover to the underlying reinforcement. At deck level, the paving slabs to the footways are extensively broken and the movement joints appear silted up.

- E.3.280 Further detailed inspection of the joints and bearings would be undertaken in advance of tunnel construction to ensure that these remain in a sound and operable condition. The expansion joints would be examined to ensure that they have sufficient capacity to accommodate the additional movement due to tunnel construction in addition to the normal thermal movements.

- E.3.281 The bridge would be monitored prior, during and after the construction of the tunnel to determine its behaviour as described in the Thames Water *Code of Construction Practice (CoCP)*, Appendix A, section 13.2. The foundations would be monitored to ensure that the actual movements are within the limits predicted, and control limits established to quantify when intervention is required to prevent damage to the structure. As described in the CoCP, the design and installation of instrumentation and monitoring would be undertaken by the contractor in agreement with Thames Water and the asset owner.

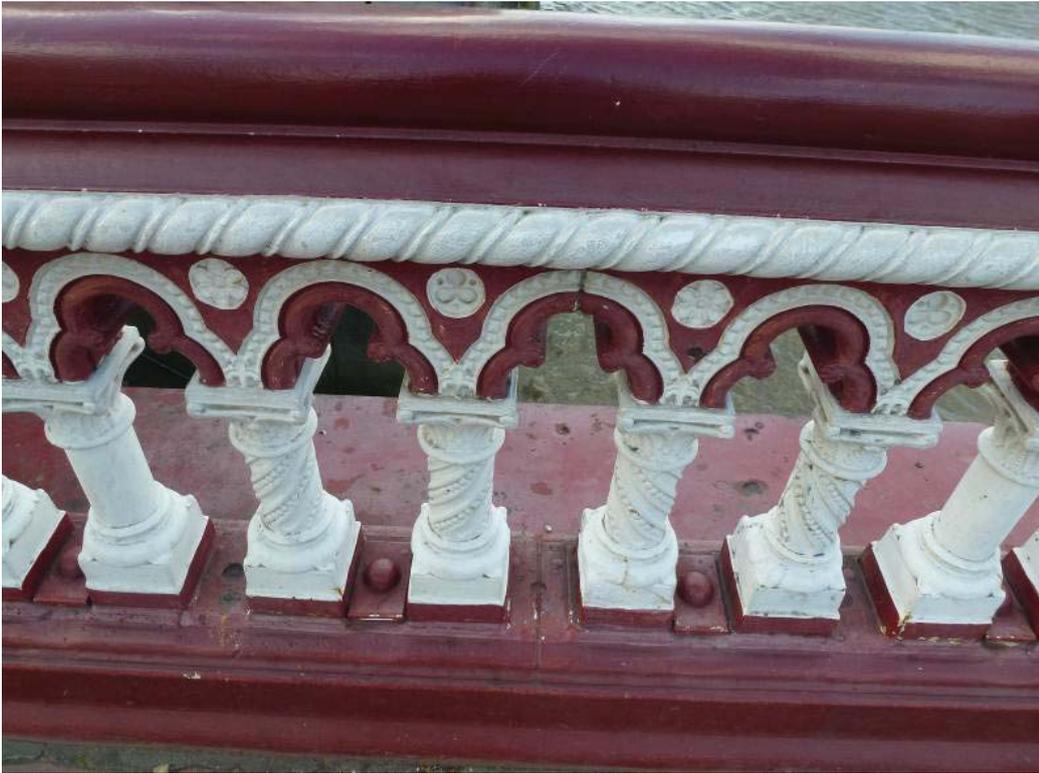
Vol 3 Plate E.79 Detail of the cast iron balustrade

- E.3.292 The bridge was observed in detail from street level during the walkover survey. From visual observation the bridge appears to be in "good" condition.
- E.3.293 The bridge appears to be structurally sound and well maintained.
- E.3.294 There is rusting to small areas of steelwork, and isolated cracks and staining to the piers and abutments.
- E.3.295 The paving to the footways is cracked throughout.
- E.3.296 The parapet is lightly corroded and cracked in places.

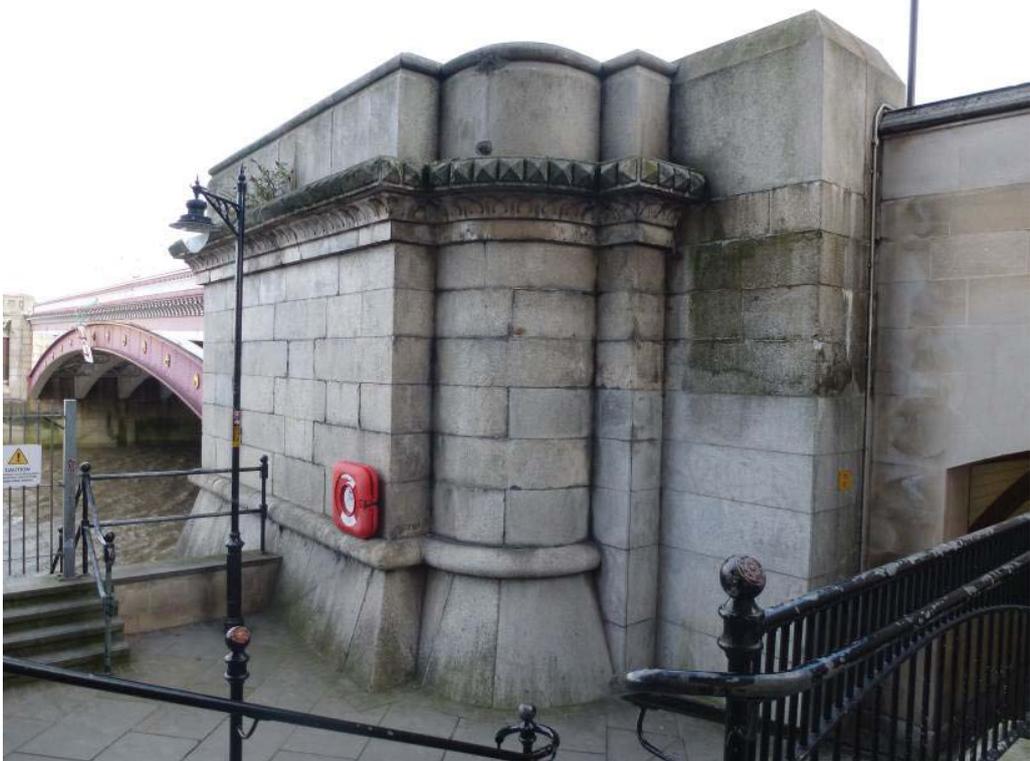
Vol 3 Plate E.80 The southern granite clad abutment

E.3.300 The granite abutments are robust structures that are unlikely to be significantly damaged.

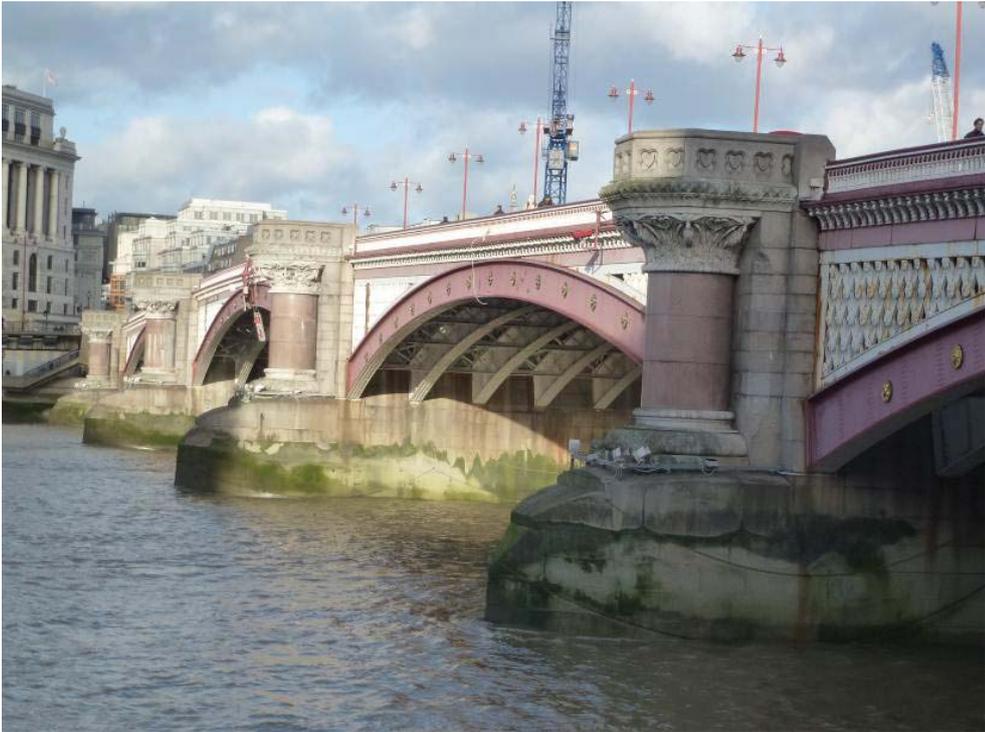
Vol 3 Plate E.81 The bridge piers

Bridge piers with finely decorated engaged column supporting the seating areas over the pier ends

- E.3.289 The piers are a particularly significant element of the bridge. They are clad in granite and have engaged polished red granite end columns, with Portland stone capitals and bases (see Vol 3 Plate E.81). The capitals are very ornate with carved sea birds and other decorative devices. The only classical elements are the ovolo column bases and medallions on the wrought iron arched girders. At road level there are seating areas, with laminated sandstone seats that project out from the bridge over the ends of the piers on either side of the bridge, their ends being supported on the red granite engaged columns. The cast iron balustrade is hollow but is elaborately decorated, with the balusters having varied gothic capitals and variedly decorated shafts. The arches above the balusters have trefoil heads (see Vol 3 Plate E.79). Below the balustrade projecting base of the bridge parapet balustrade is supported on decorative cast iron brackets.

E.3.299 The granite piers are in good condition and the significance of the decorative elements, especially the engaged columns, with their bases and capitals, would be adversely affected if they cracked. Detailed structural calculations undertaken by Thames Water indicate that this is not expected to take place.

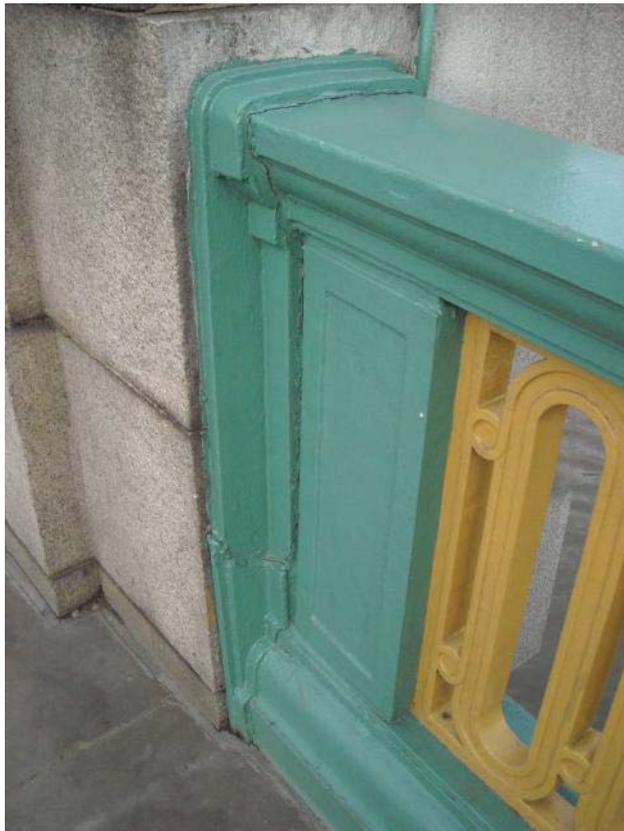
Vol 3 Plate E.94 Typical damage to cast-iron balustrade

- E.3.322 At the time of inspection the décor was generally in excellent condition with just a few isolated areas of deterioration. There is some cracking within the masonry of the abutments, most likely as a result of settlement. The piers appear to be free of cracking, although some of the stones have become separated with loose and open joints, and vegetation is gaining a hold on the cutwaters. The asphalt carriageway and York stone paving are worn with cracking clearly visible above the piers and abutments. The cast-iron handrail has become displaced and cracked where it adjoins the piers. Some of the cracking is visually prominent.

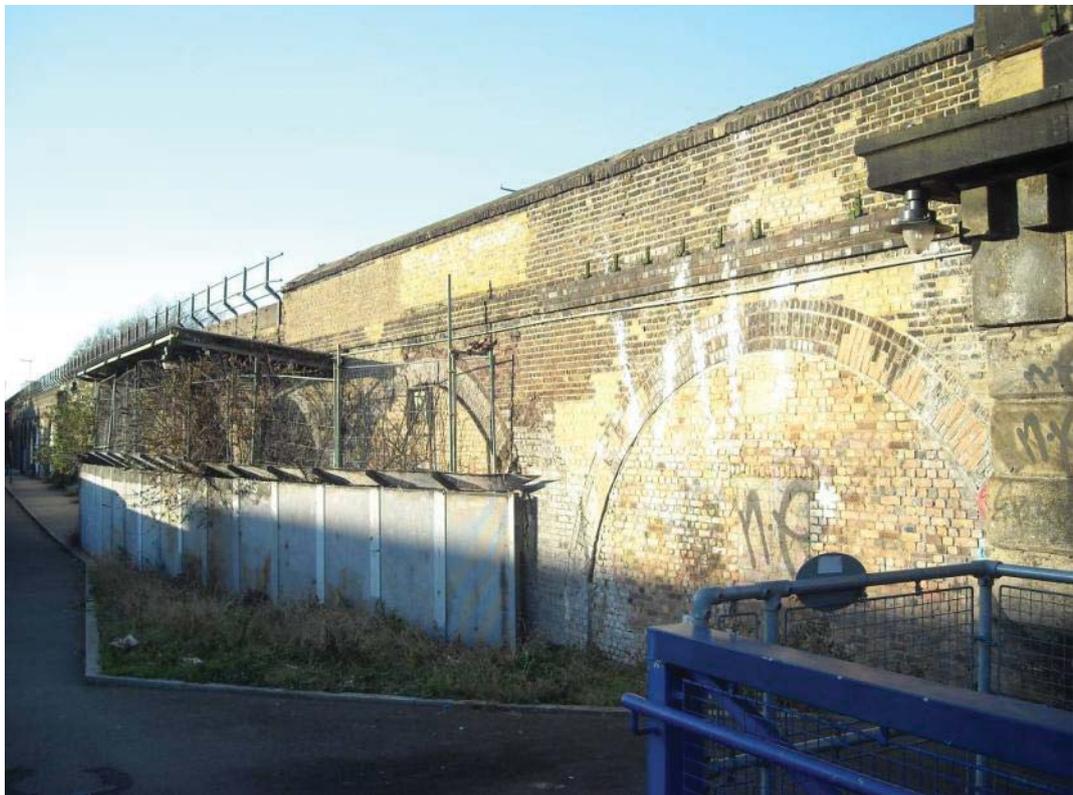
Vol 3 Plate E.109 Sun Wharf Viaduct viewed from south-east, note displaced brick panel in second archway

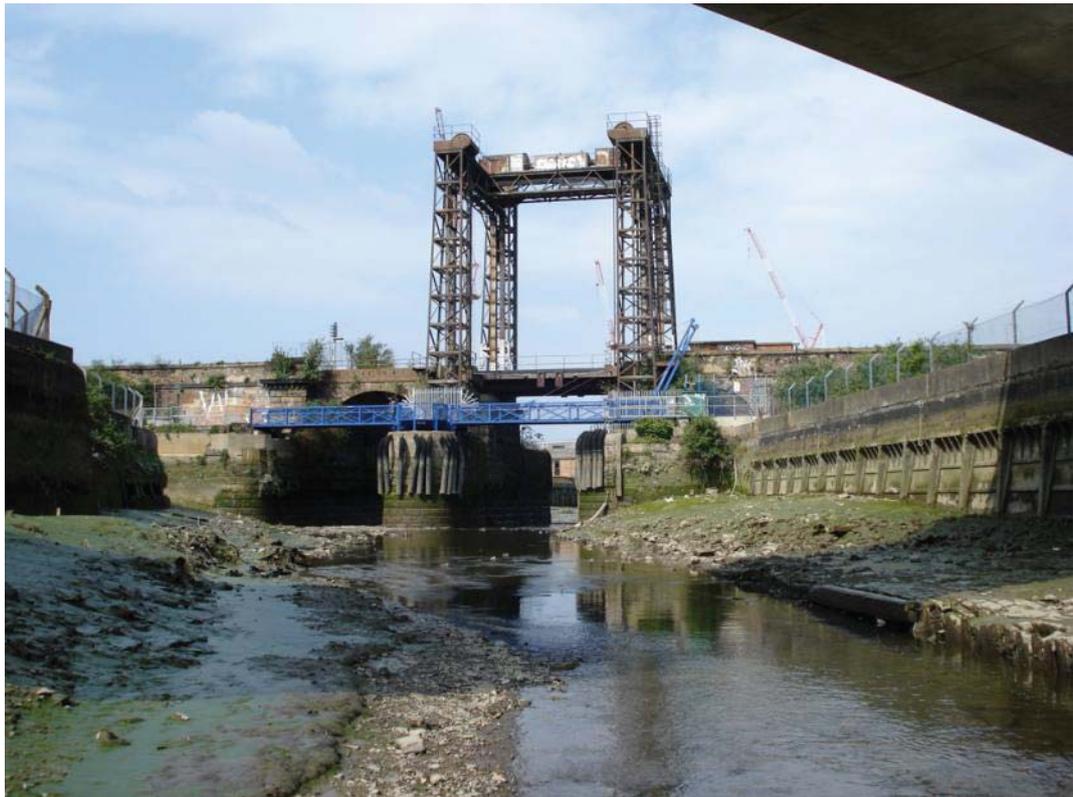
Vol 3 Plate E.122 Deptford Creek Lifting Bridge viewed from south

- E.3.559 The south side of the bridge was observed from the adjacent public footpath and footbridge during the walkover survey. From visual observation the bridge appears to be in “fair” condition.

- E.3.560 Although the bridge appears to be structurally sound, maintenance works are becoming necessary. The surface coatings appear to have weathered away, exposing the underlying metalwork, and surface corrosion is now widespread. This gives the bridge a somewhat dilapidated appearance.

- E.3.561 The concrete bank seats supporting the lifting deck are weathered and covered with a heavy build-up of guano.
- E.3.562 Self-set vegetation is gaining a hold on the central pier and abutments. The stonework on the south side of the west abutment is heavily eroded in its upper section, including to the dentils set below the deep cornice. There is a heavy build of sulphates which will cause further damage to the masonry in the longer term. Above the cornice, the stonework appears to have been displaced. Beneath the span of the bridge, the west abutment is open jointed at lower level.

potentially loose. At higher level on this face, there is evidence of horizontal cracking within the stones themselves. Whether this is as a result of historic movement or cramp damage would require further investigation.

- E.3.564 The east abutment is similarly eroded at low level with deep open joints and areas of loose stonework.
- E.3.565 The brickwork on the south face of the west span is spalling and displays some surface efflorescence, probably as result of water permeating through the bridge deck above. The erosion is exacerbated by the hard cementitious mortar used in subsequent repointing.
- E.3.566 The viaduct to the west has been much patched. The two adjacent arches have been infilled in brickwork on their south side, although they remain open to the north. The brick panel in the 2nd arch west from the bridge is out of plumb and leaning outwards from the structure. The brickwork does not appear to be bonded or tied to the viaduct itself and appears to be poorly founded.

- E.3.572 The effects of ground movements on the arch have been found to be minimal. A hairline crack of 0.1mm may develop in the arch barrel due to the differential settlement. This would not affect the significance, appearance or strength of the structure.

- E.3.573 The abutments have been assessed and compared with the damage risk categories defined by Burland (1977) and Boscardin & Cording (1989); the likely level of damage risk falls within Category 0 – Negligible degree of severity of damage; typically this is no more than hairline cracks.

- E.3.576 Route wide monitoring measures would be adopted during construction, as described in the Thames Water *Code of Construction Practice* (CoCP), Part A, section 13.2, to ensure that the actual ground movements are within the limits predicted, and control limits established to quantify when intervention may be required to prevent damage to the structure. As described in the CoCP, the design and installation of instrumentation and monitoring would be undertaken by the contractor in agreement with Thames Water and the asset owner.

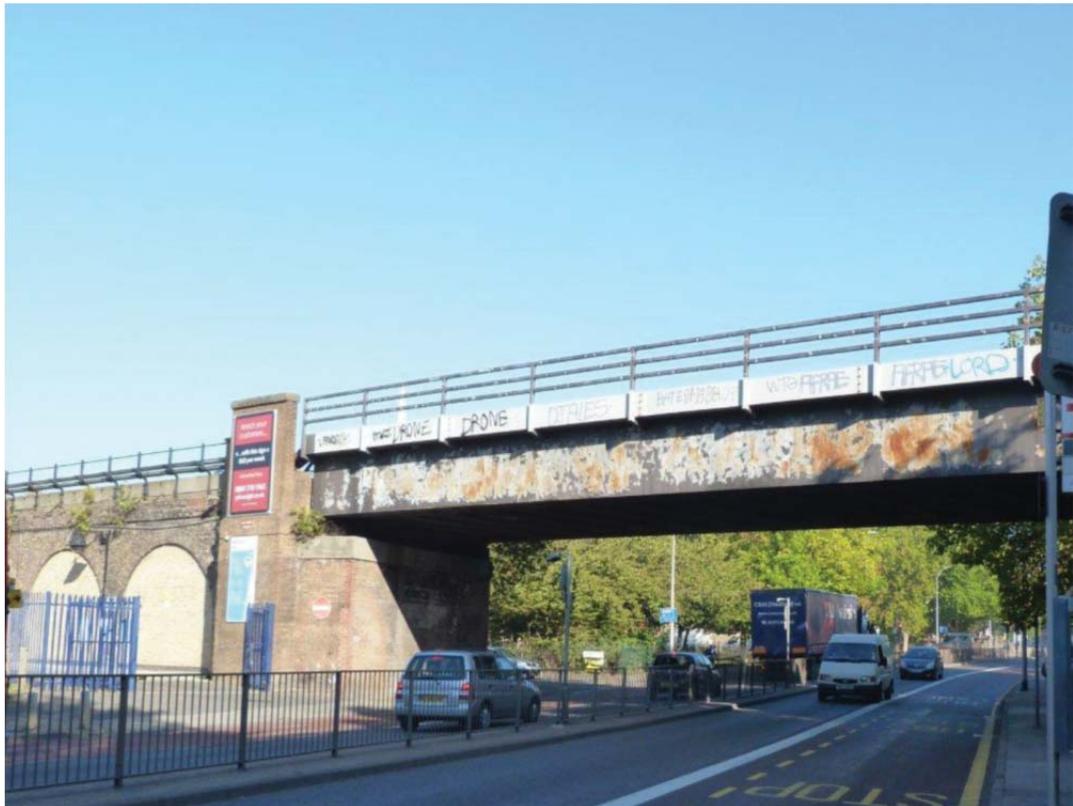
Vol 3 Plate E.123 Railway Bridge over Deptford Church Street viewed from south

- E.3.591 Both sides of the bridge were observed from street level during the walkover survey. From visual observation the bridge appears to be in "fair" condition.
- E.3.592 The bridge appears to be structurally sound and reasonably well maintained. The surface coatings to the metalwork, however, are heavily weathered, exposing the underlying metalwork, and as a result surface rusting is widespread.

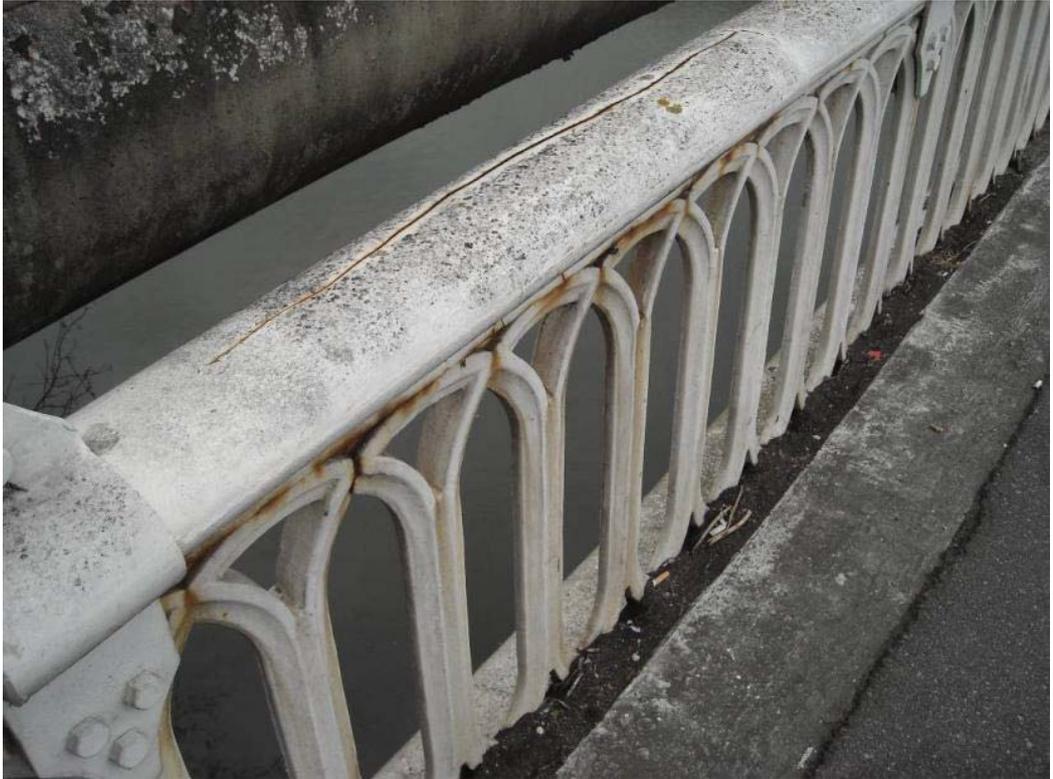
Vol 3 Plate E.134 Cast-iron balustrade and handrail, note cracking
